West Wycombe Parish Council

**YOU ARE SUMMONED TO ATTEND A MEETING OF THE PARISH COUNCIL
TO BE HELD ON THURSDAY 10th NOVEMBER 2022 IN THE CHURCH ROOM, WEST WYCOMBE**

AGENDA

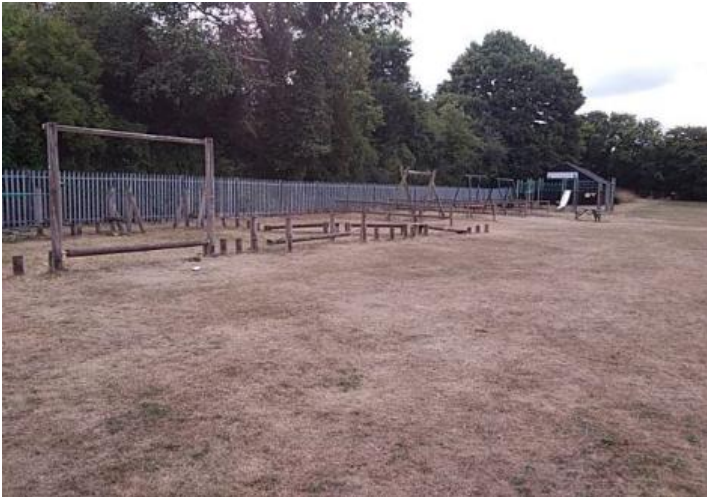
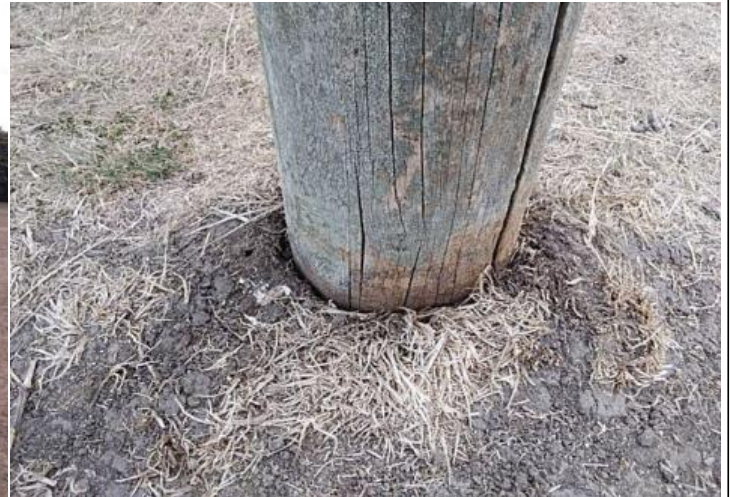
There is some strimmer / machinery damage apparent on the posts, this can penetrate the preservative applied to the timber and accelerate the rotting process - Monitor for any deterioration (rot) and replace as required

Item: Ancillary Items - Site General
Manufacturer: Owner/Operator

Finding: There is some strimmer / machinery damage apparent on the posts, this can penetrate the preservative applied to the timber and accelerate the rotting process

Action: Monitor for any deterioration (rot) and replace as required

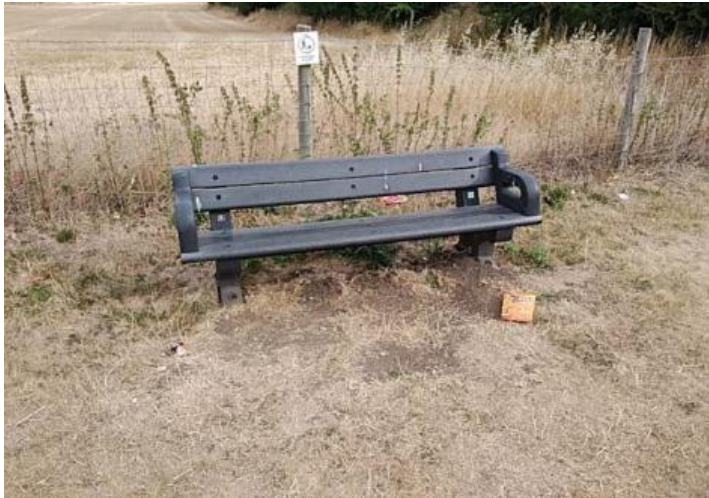
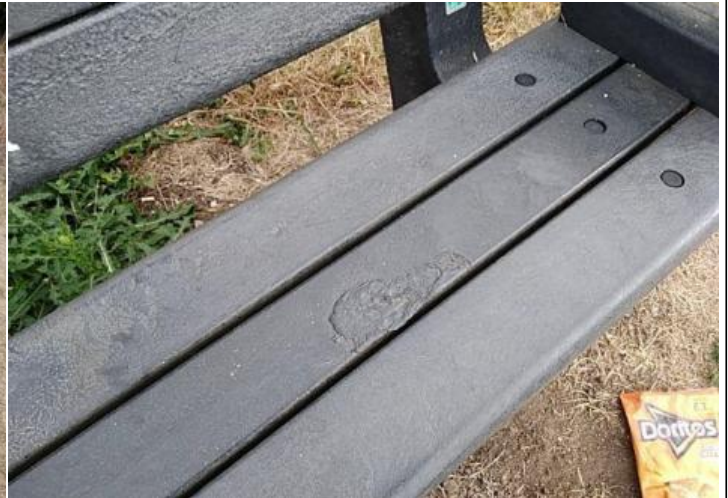
There is some evidence of fire damage to the item - Monitor for any further deterioration and repair as required

Item: Ancillary Items - Bench
Manufacturer: Owner/Operator

Finding: There is some evidence of fire damage to the item **Action:** Monitor for any further deterioration and repair as required

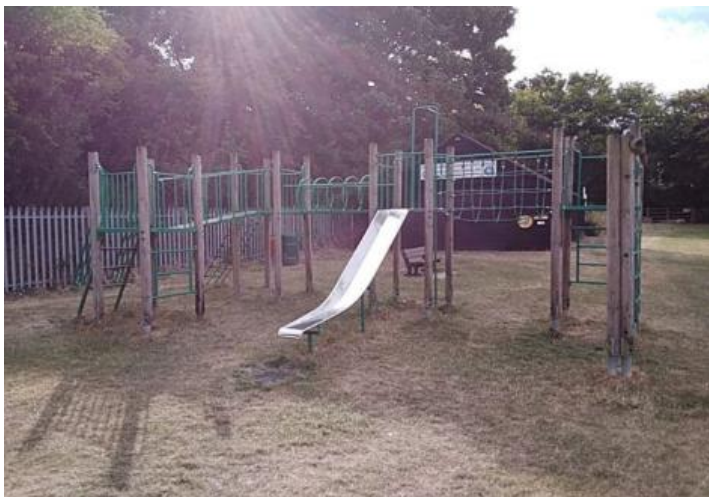
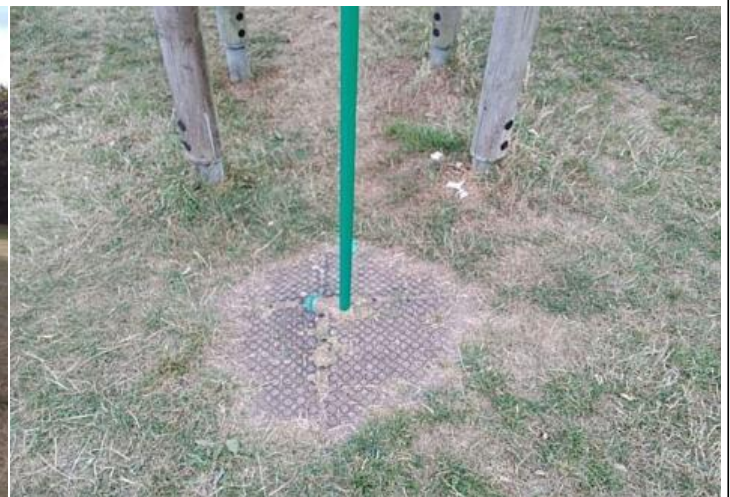
The grass mats are silted up and the soil is compacted; this may have an effect on the impact absorbing properties of the surface - Consider HIC testing impact absorbing properties to ensure the correct surface qualities are maintained for the equipment and replace as required

Finding: The grass mats are silted up and the soil is compacted; this may have an effect on the impact absorbing properties of the surface

Action: Consider HIC testing impact absorbing properties to ensure the correct surface qualities are maintained for the equipment and replace as required

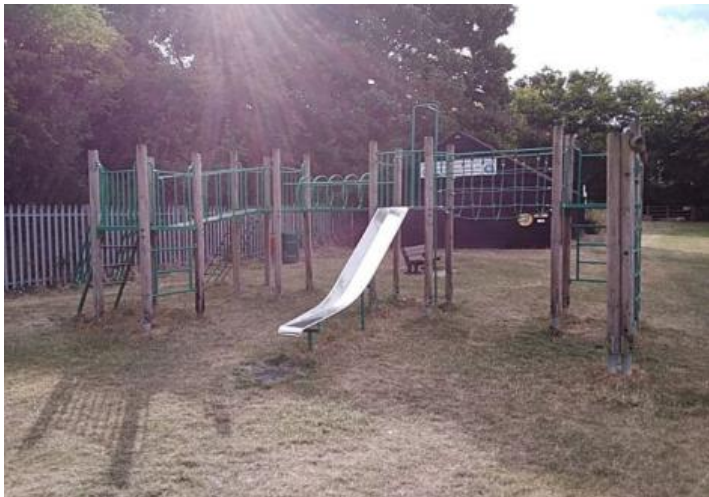
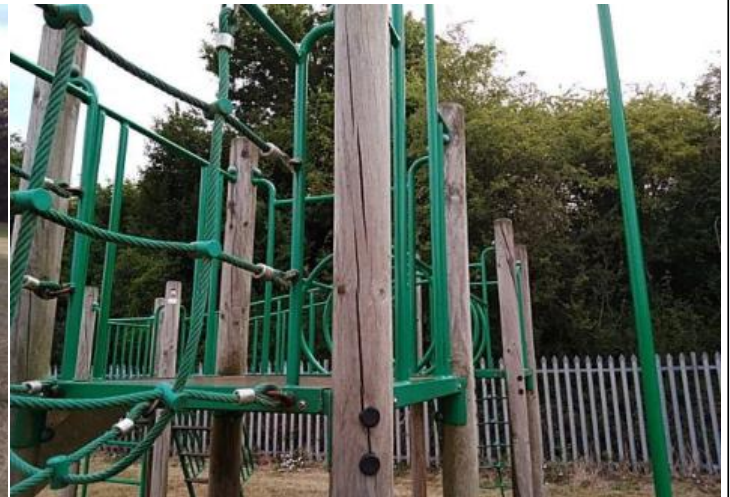
Finding: The timber has a number of splits/shakes or air cracks and this may affect the stability or allow water ingress which will accelerate the rotting process

Action: Monitor to ensure the splits do not cross through fixing points of the structure and/or cause any instability

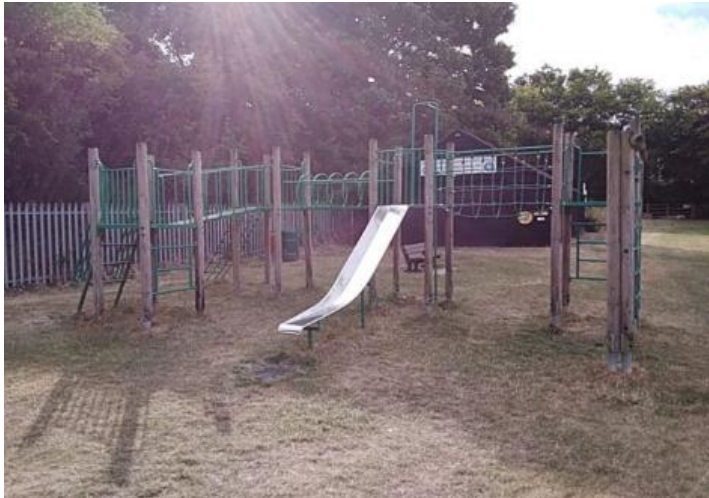
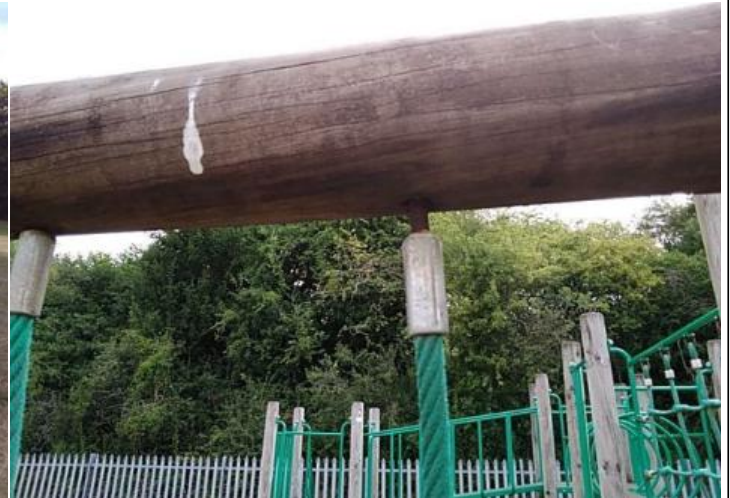
A number of fixing(s) have worked loose on the rope net - Secure all loose fixings

Finding: A number of fixing(s) have worked loose on the rope net

Action: Secure all loose fixings

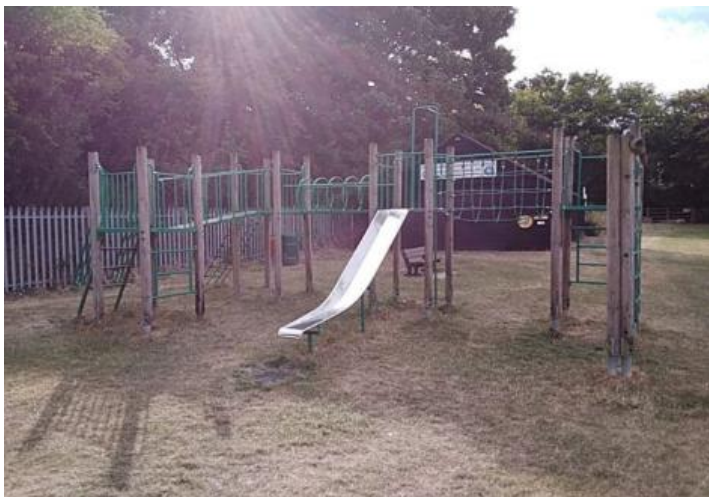
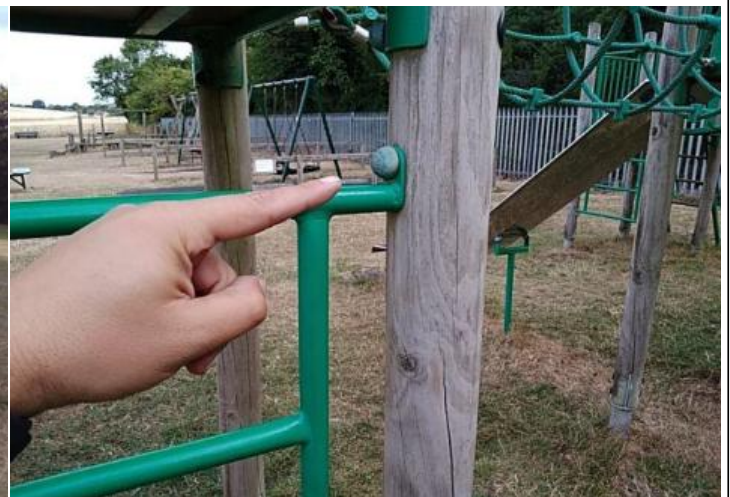
A number of fixing(s) have worked loose on the access element - Secure all loose fixings

Finding: A number of fixing(s) have worked loose on the access element

Action: Secure all loose fixings

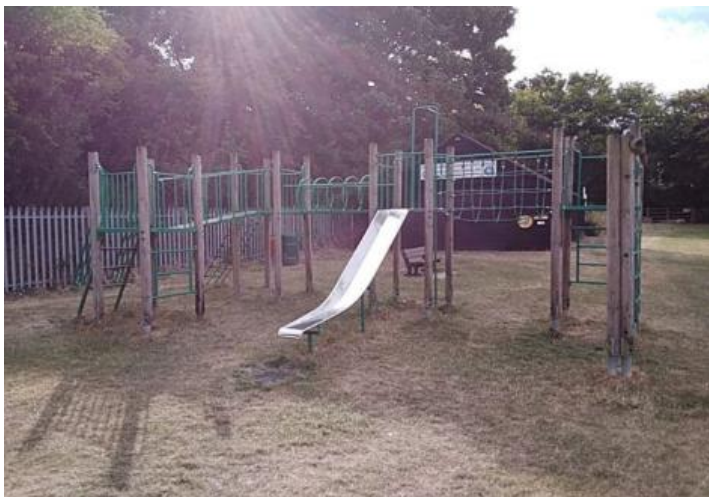
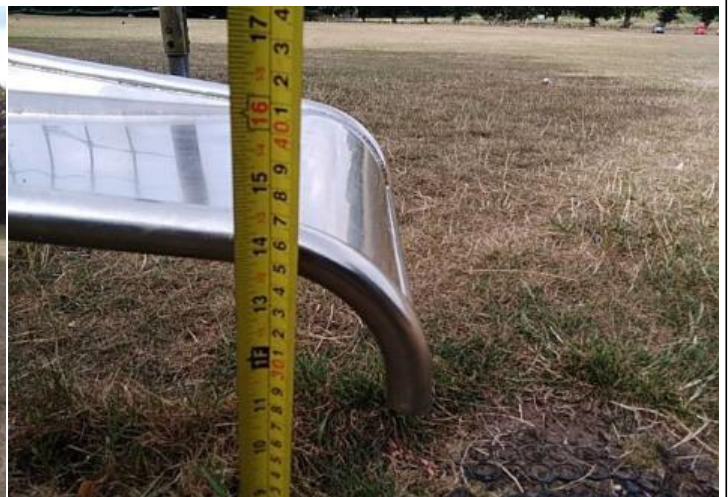
The height of the slide runout is in excess of 350mm and fails the requirements of BS EN 1176: Part 3 - Monitor - No remedial work recommended

Finding: The height of the slide runout is in excess of 350mm and fails the requirements of BS EN 1176: Part 3

Action: Monitor - No remedial work recommended

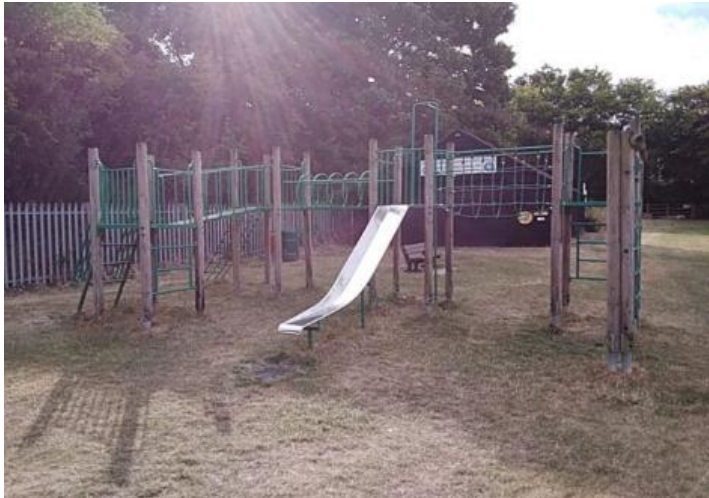
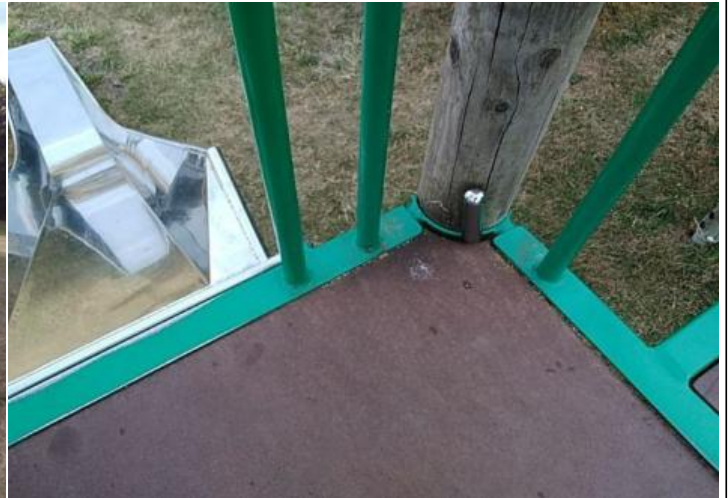
There is/are finger entrapment/s in the slide starting section and the item fails to meet the requirements of BS EN 1176 Part 1 4.2.7.6 Entrapment of fingers - Monitor - No remedial work recommended

Finding: There is/are finger entrapment/s in the slide starting section and the item fails to meet the requirements of BS EN 1176 Part 1 4.2.7.6 Entrapment of fingers

Action: Monitor - No remedial work recommended

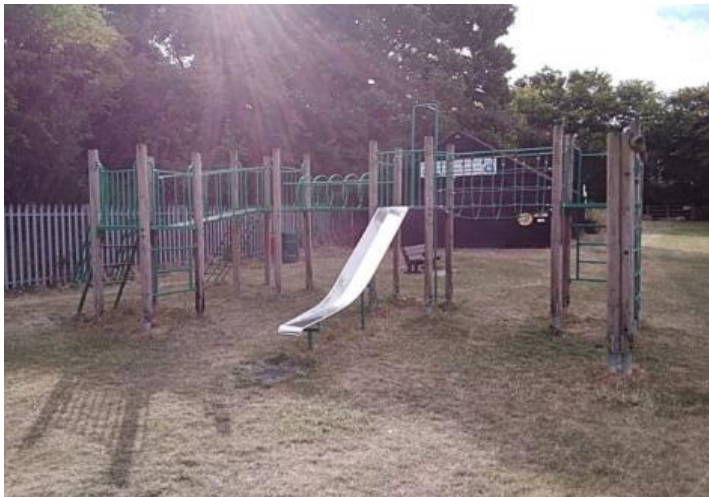
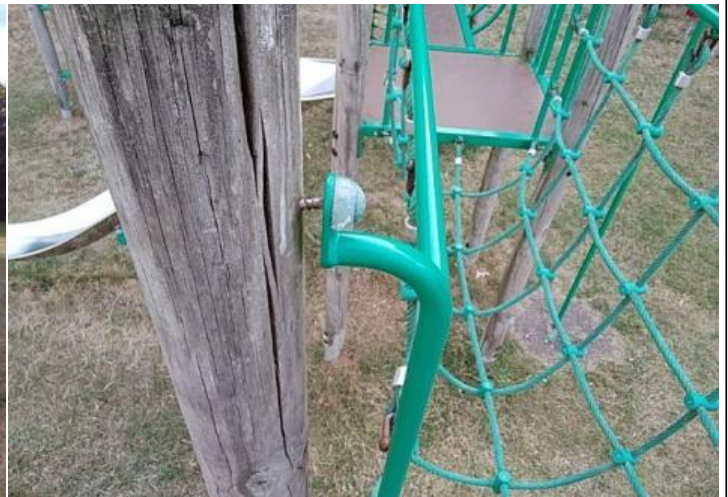
A number of fixing(s) have worked loose on the rope bridge - Secure all loose fixings

Finding: A number of fixing(s) have worked loose on the rope bridge

Action: Secure all loose fixings

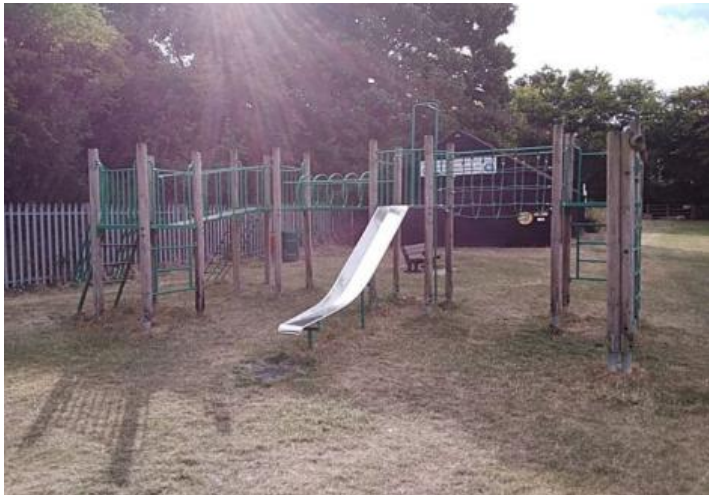
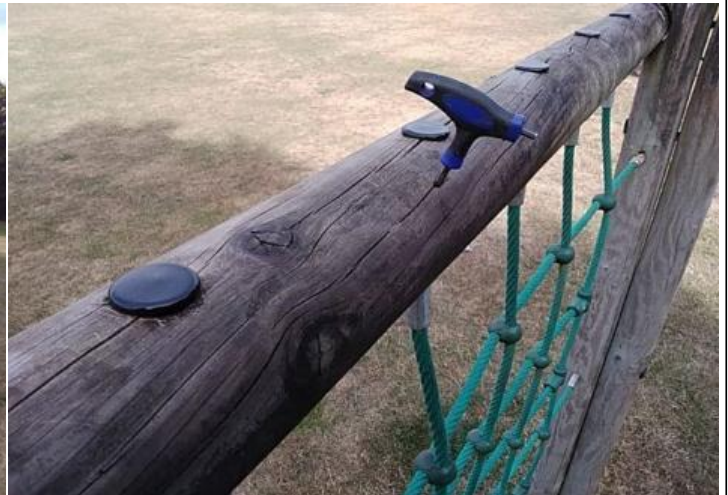
There are areas or parts of the timber rope net crossbeam on the structure that have rotted. Office contacted to inform client - Replace all affected timbers

Risk Level: H - High Risk
Surface: Grass Matrix Tiles

Finding: There are areas or parts of the timber rope net crossbeam on the structure that have rotted. Office contacted to inform client

Action: Replace all affected timbers

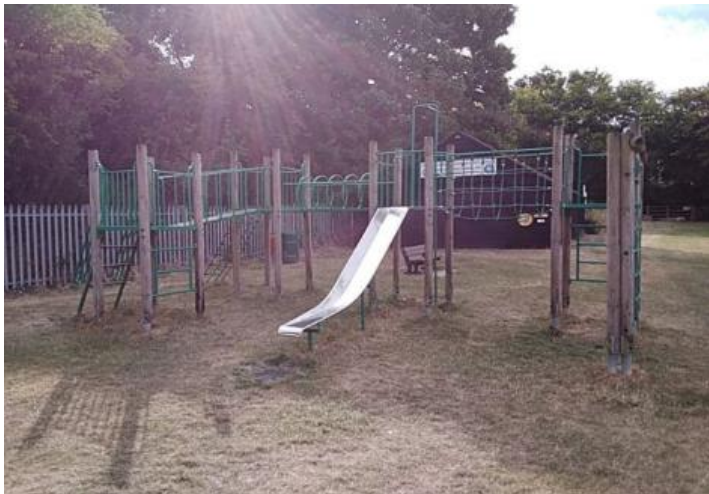
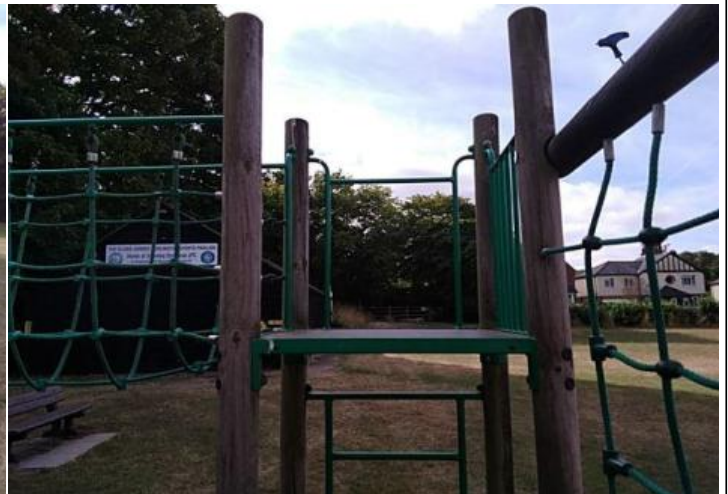
There is an opening in the barriers exceeding the width allowed (500mm) in BS EN 1176, and no guardrail has been provided; this is a low risk failure and no remedial action is required - Monitor - No remedial work recommended

Finding: There is an opening in the barriers exceeding the width allowed (500mm) in BS EN 1176, and no guardrail has been provided; this is a low risk failure and no remedial action is required

Action: Monitor - No remedial work recommended

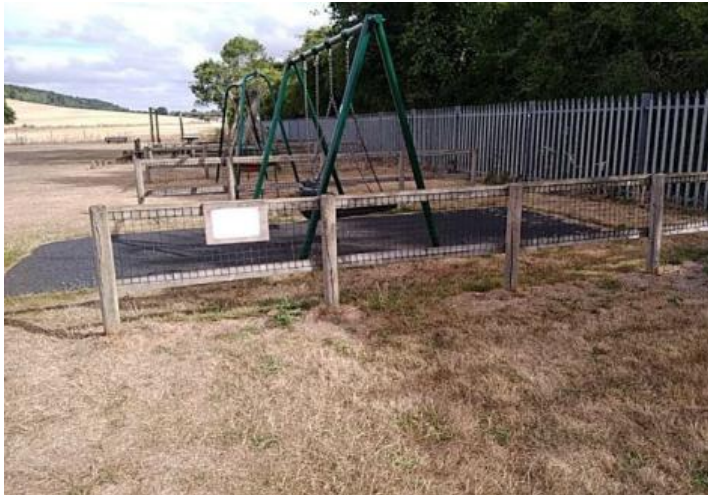
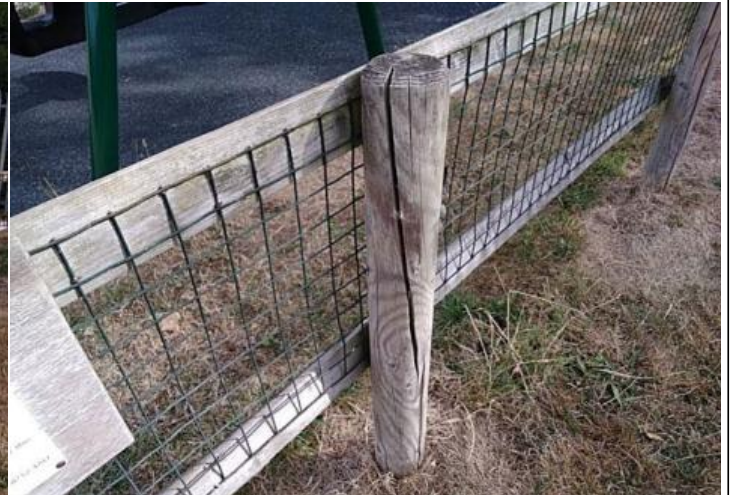
Finding: The timber has a number of splits/shakes or air cracks and this may affect the stability or allow water ingress which will accelerate the rotting process
Action: Monitor to ensure the splits do not cross through fixing points of the structure and/or cause any instability

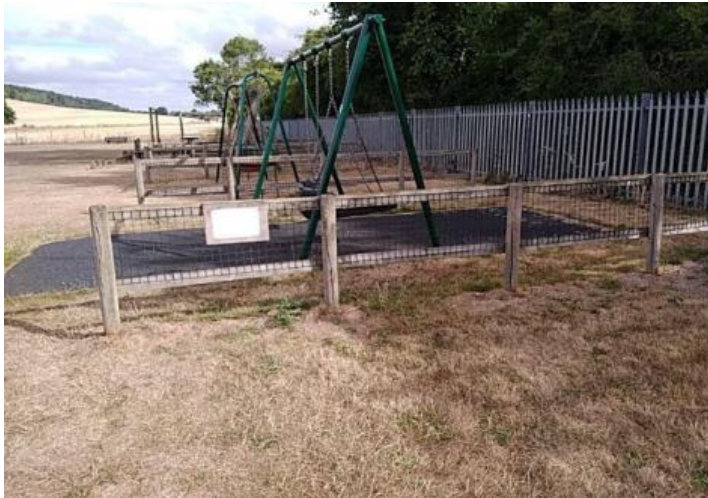
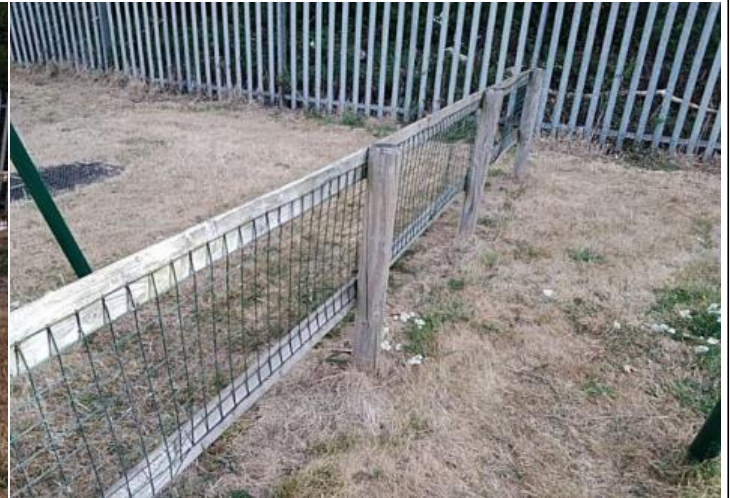
The item is slightly loose in its foundations - Monitor for any further deterioration and repair as required

Finding: The item is slightly loose in its foundations

Action: Monitor for any further deterioration and repair as required

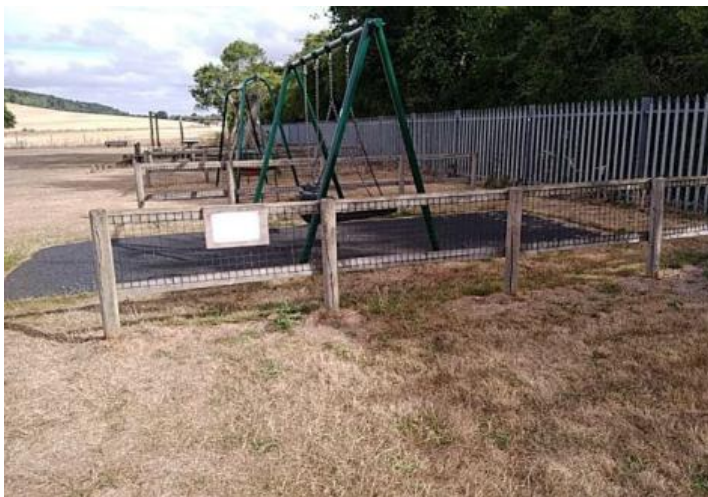
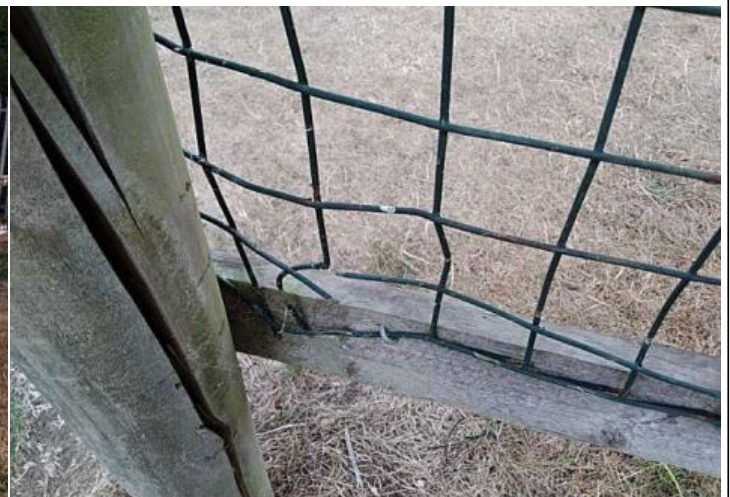
The item has been damaged - Monitor for any further deterioration and replace as required

Finding: The item has been damaged

Action: Monitor for any further deterioration and replace as required

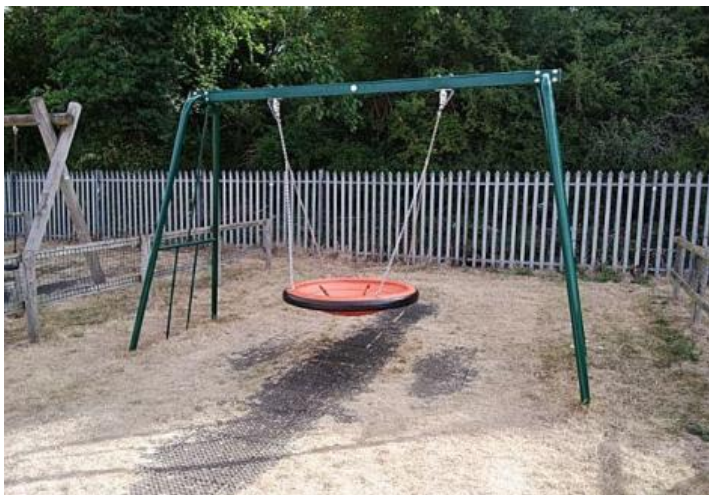
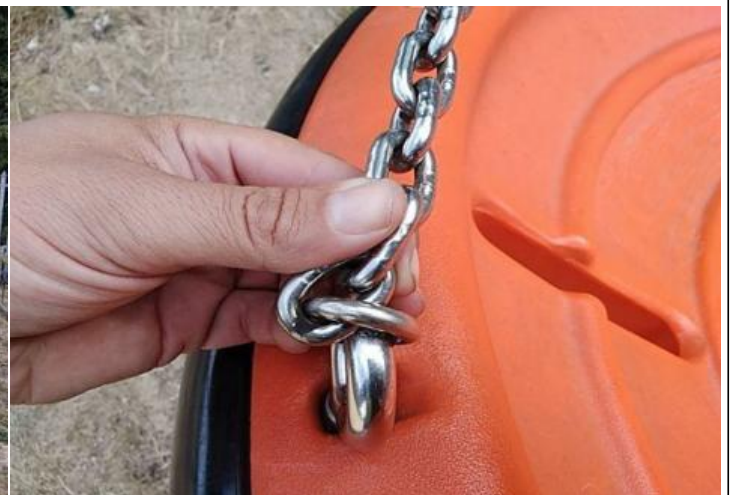
Finding: There is some notable evidence of chain wear

Action: Monitor for any further deterioration and replace when 40% worn

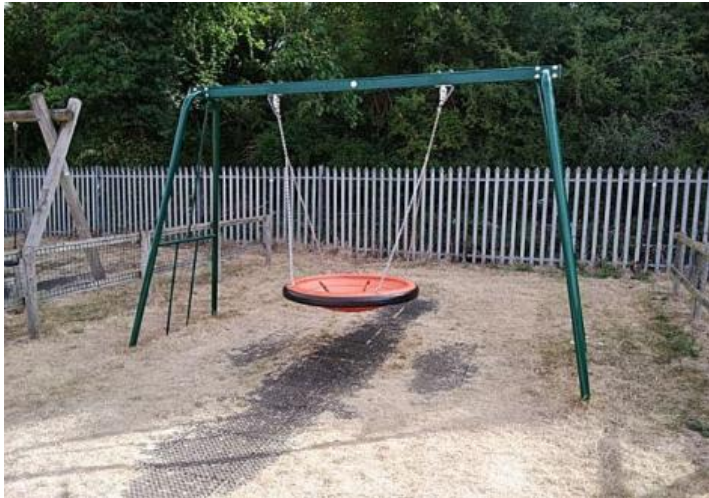
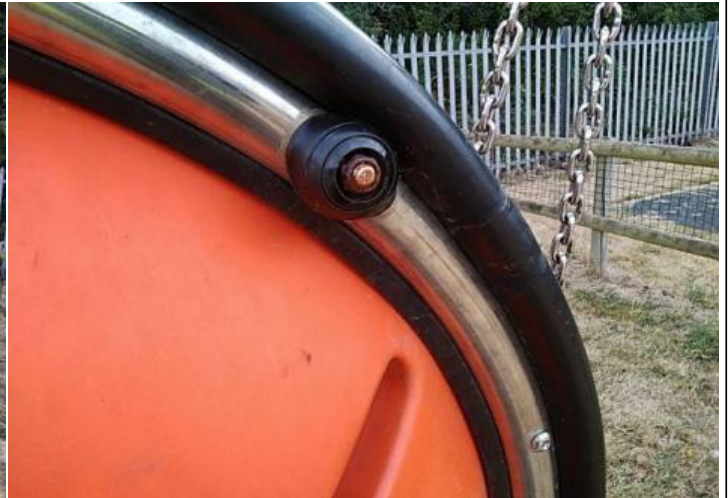
There are caps missing from the underside of the seats -
Replace missing caps under the seats

Finding: There are caps missing from the underside of the seats

Action: Replace missing caps under the seats

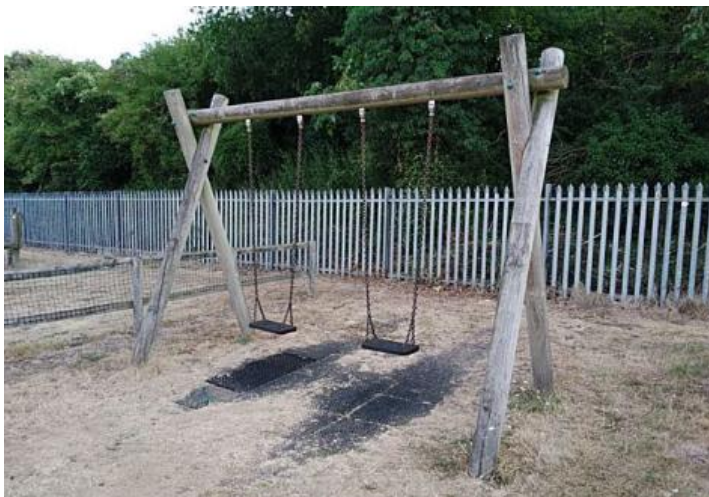
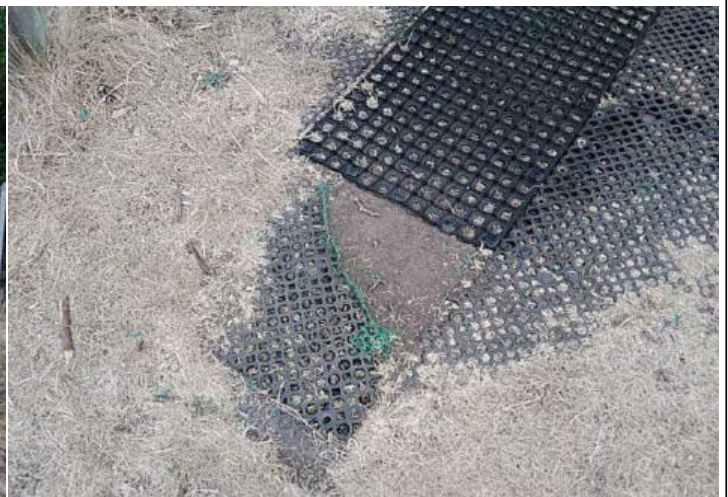
There is moderate damage to the surface - Repair the damaged areas of surfacing

Finding: There is moderate damage to the surface

Action: Repair the damaged areas of surfacing

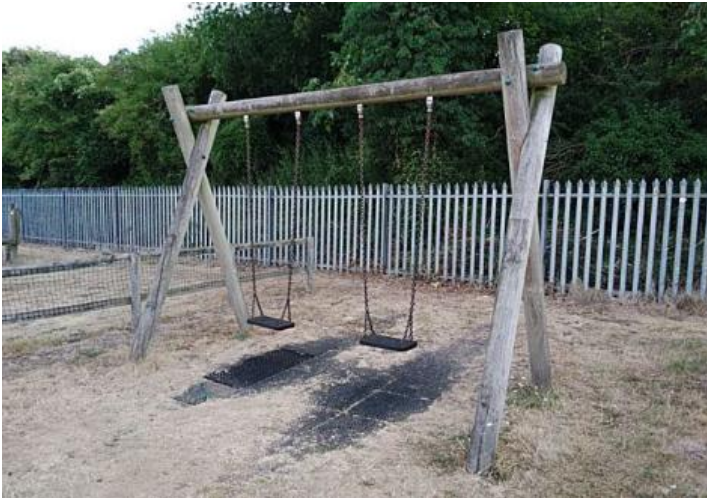
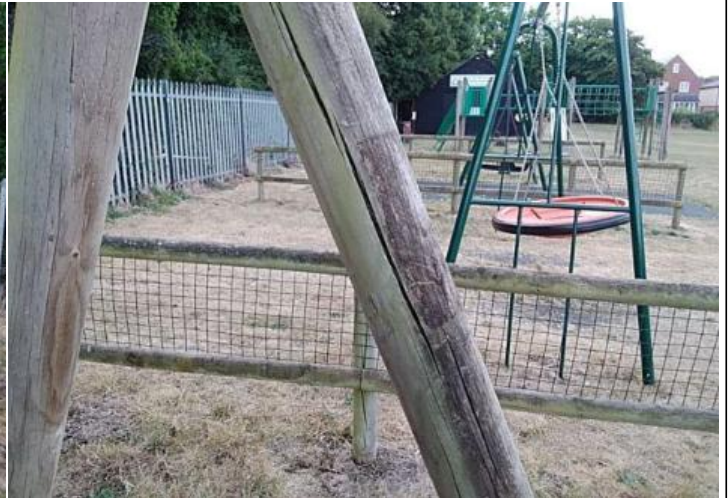
Finding: The timber has a number of splits/shakes or air cracks and this may affect the stability or allow water ingress fixing points of the structure and/or cause any instability which will accelerate the rotting process

Action: Monitor to ensure the splits do not cross through

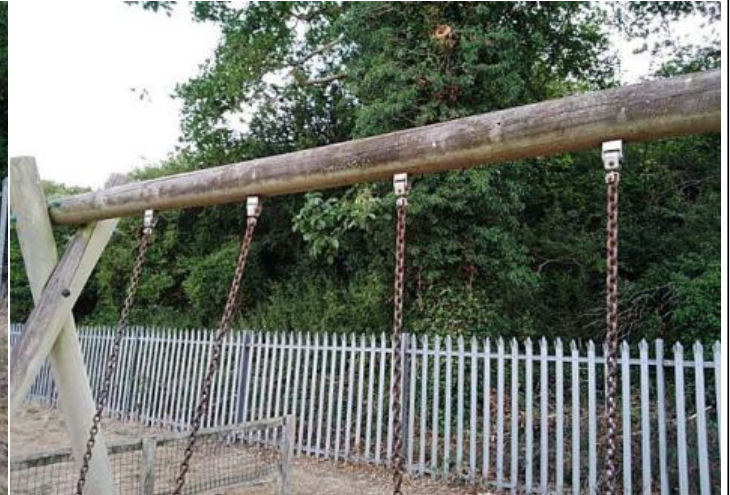
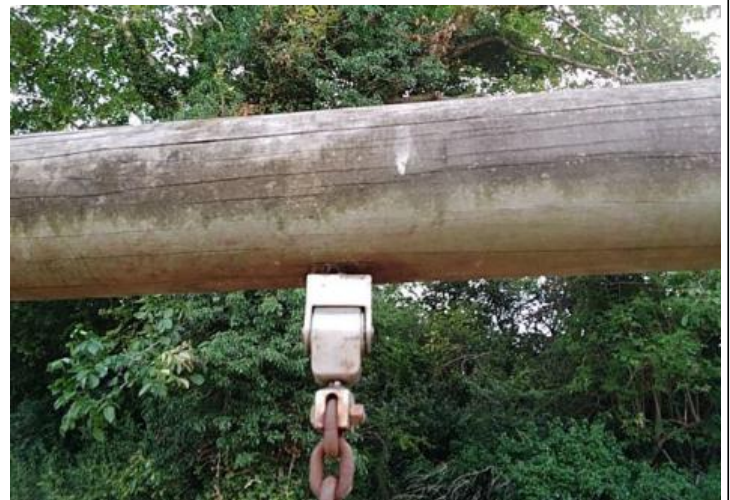
A number of suspension fixing(s) have worked loose - Secure all loose fixings

Risk Level: M - Moderate Risk
Surface: Grass Matrix Tiles

Finding: A number of suspension fixing(s) have worked loose

Action: Secure all loose fixings

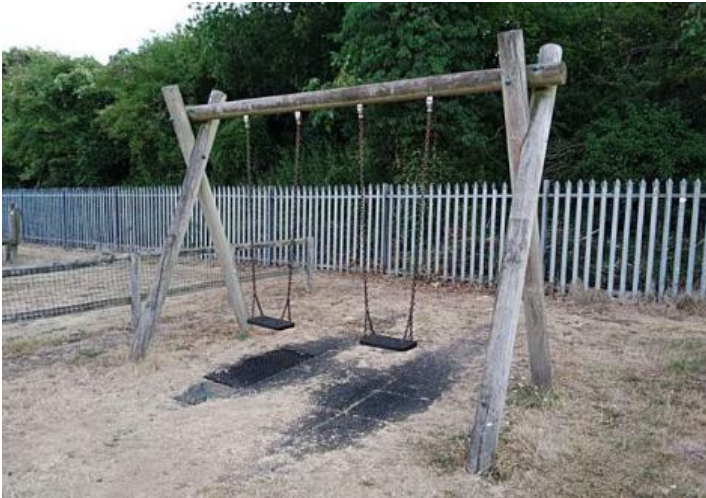
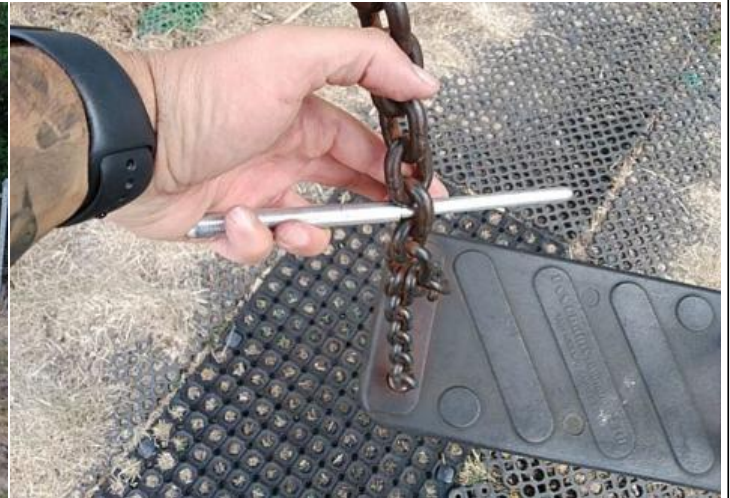
The chain openings are in excess of the 8.6mm as recommended by BS EN 1176 - Monitor - No remedial work recommended

Finding: The chain openings are in excess of the 8.6mm as recommended by BS EN 1176 **Action:** Monitor - No remedial work recommended

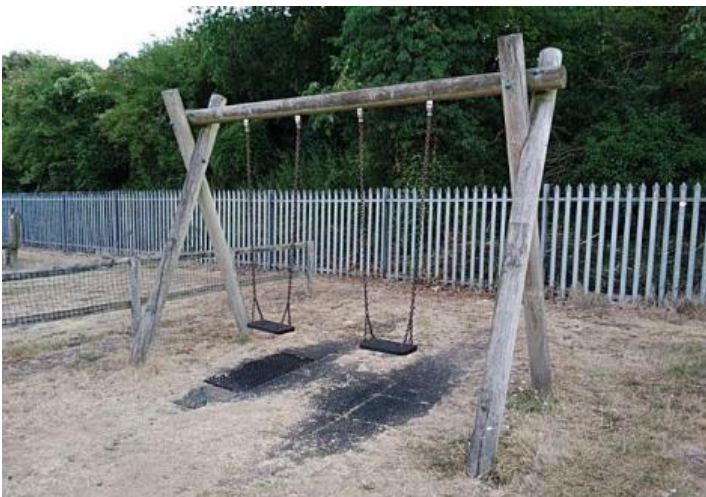
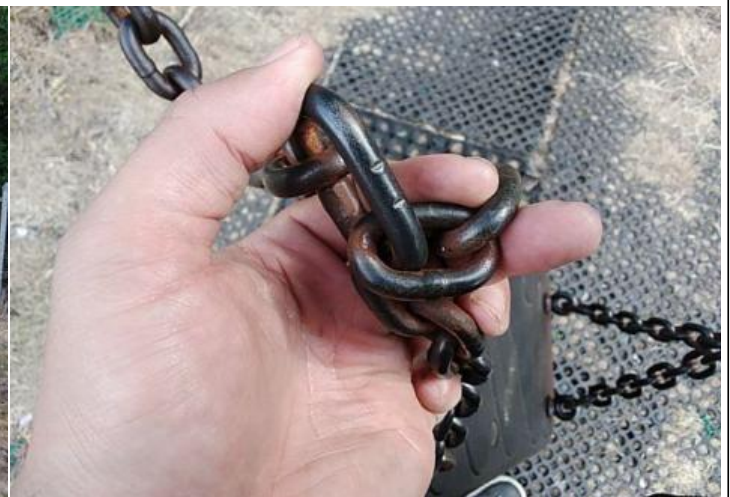
Finding: There is some notable evidence of chain wear **Action:** Monitor for any further deterioration and replace when 40% worn

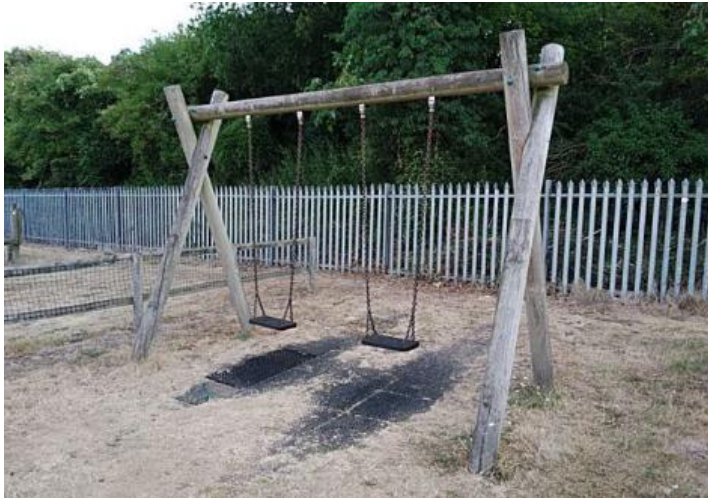
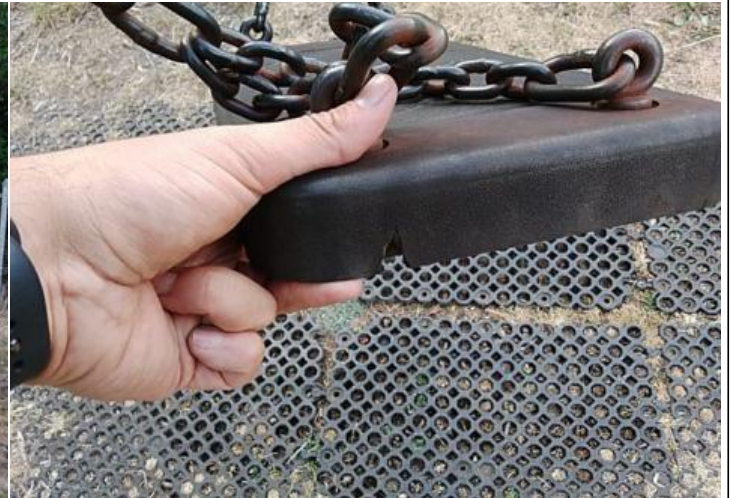
The seat has minor damage or wear - Monitor for any further deterioration and replace as required

Finding: The seat has minor damage or wear

Action: Monitor for any further deterioration and replace as required

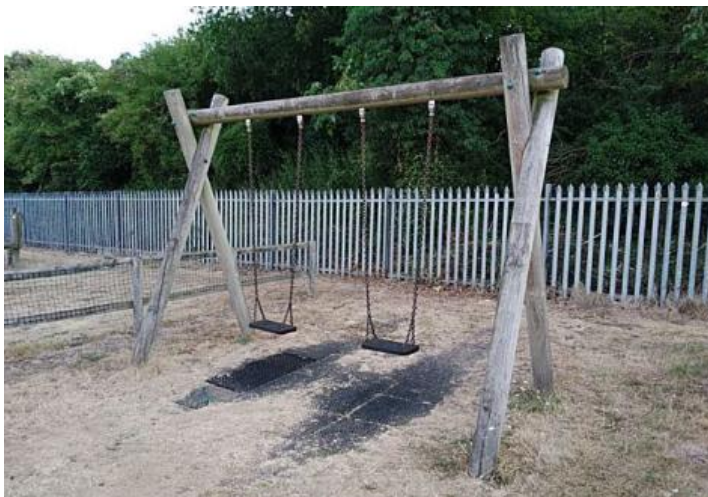
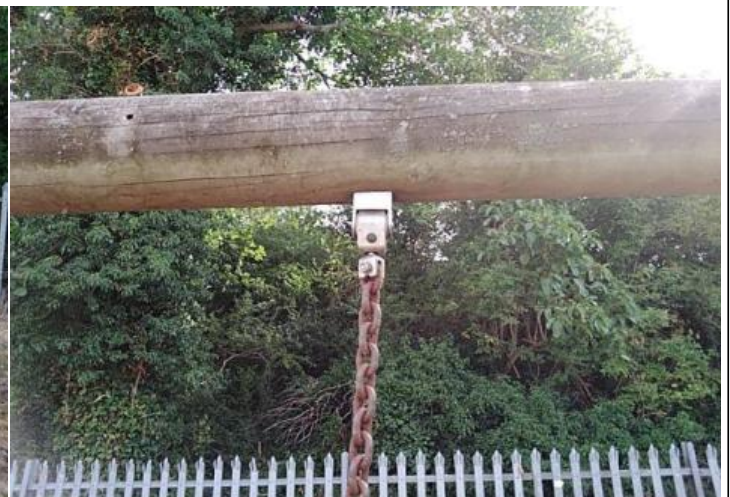
This design of swing joint has been known to fail on the weld connecting the joint to the threaded stud - We would recommend that the joint be dismantled and checked on a regular basis or consulting with manufacturer on whether a Secondary Safety Device can be fitted

Finding: This design of swing joint has been known to fail on the weld connecting the joint to the threaded stud

Action: We would recommend that the joint be dismantled and checked on a regular basis or consulting with manufacturer on whether a Secondary Safety Device can be fitted

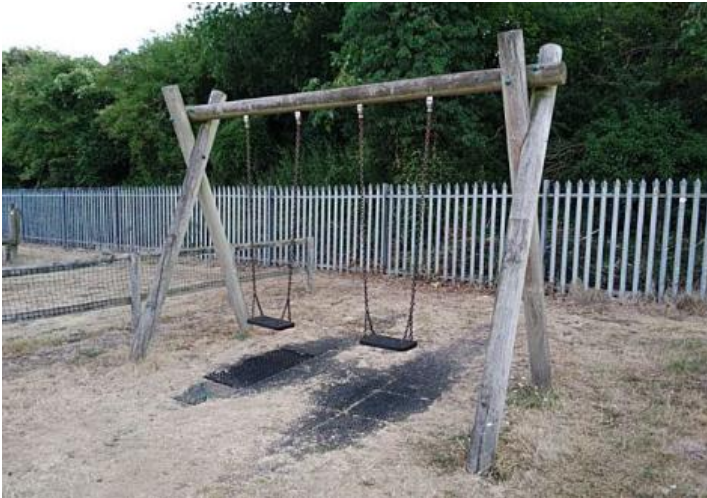
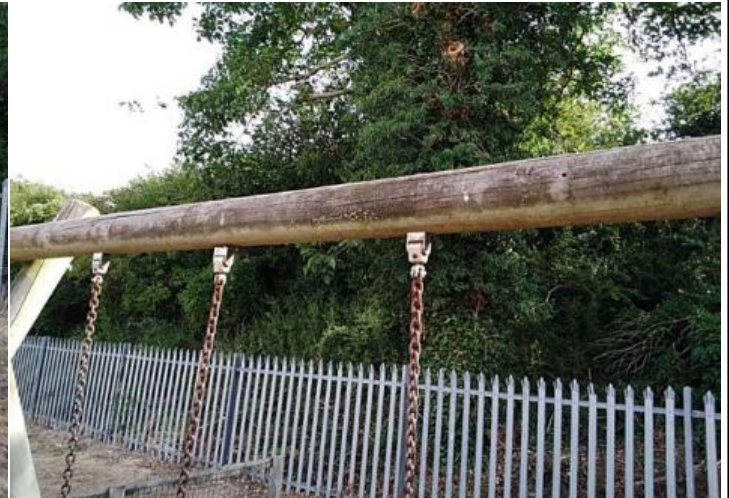
The inspector has some concerns about the internal condition of the timber crossbeam due to discolouration and was unable to verify the structural integrity without further testing. We recommend a Resi-PD survey to establish the condition of the timber at it's core. - Contact the Play Inspection Company office for further information

Finding: The inspector has some concerns about the internal condition of the timber crossbeam due to discolouration and was unable to verify the structural integrity without further testing. We recommend a Resi-PD survey to establish the condition of the timber at it's core.

Action: Contact the Play Inspection Company office for further information

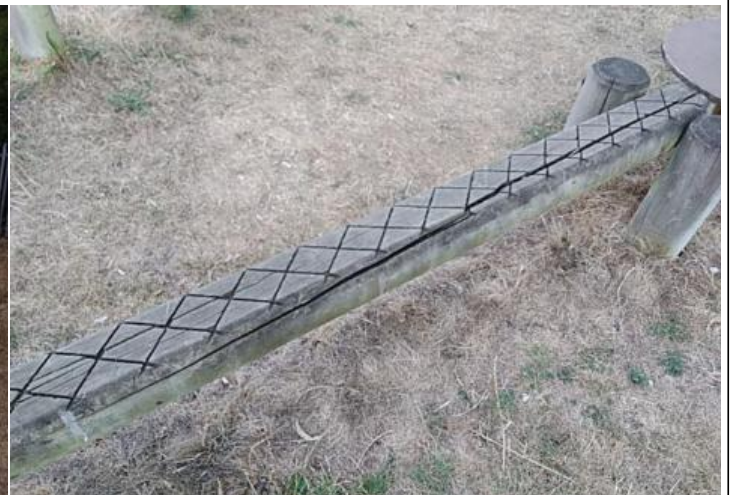
Finding: The timber has a number of splits/shakes or air cracks and this may affect the stability or allow water ingress which will accelerate the rotting process

Action: Monitor to ensure the splits do not cross through fixing points of the structure and/or cause any instability

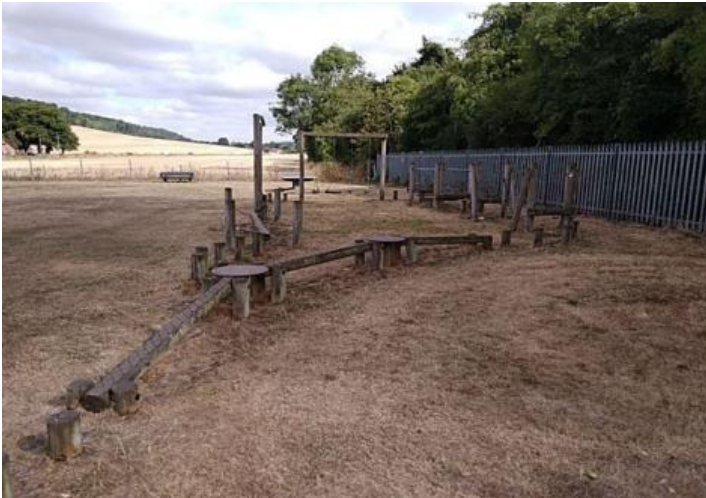
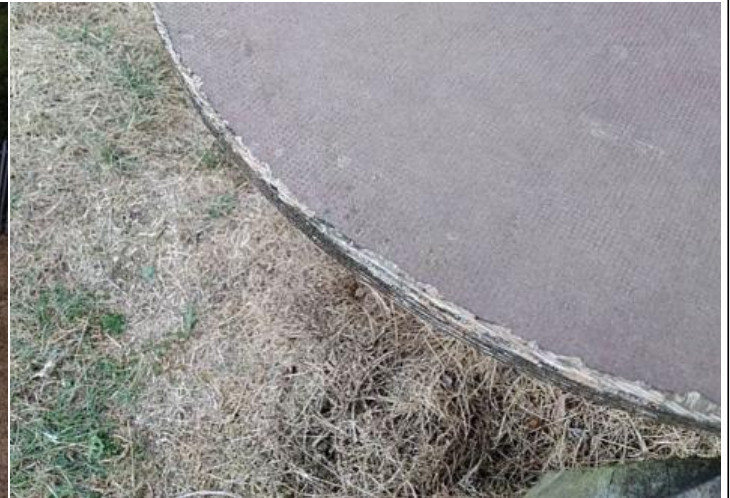
The timber is rough and worn - Sand down and treat affected areas

Finding: The timber is rough and worn

Action: Sand down and treat affected areas

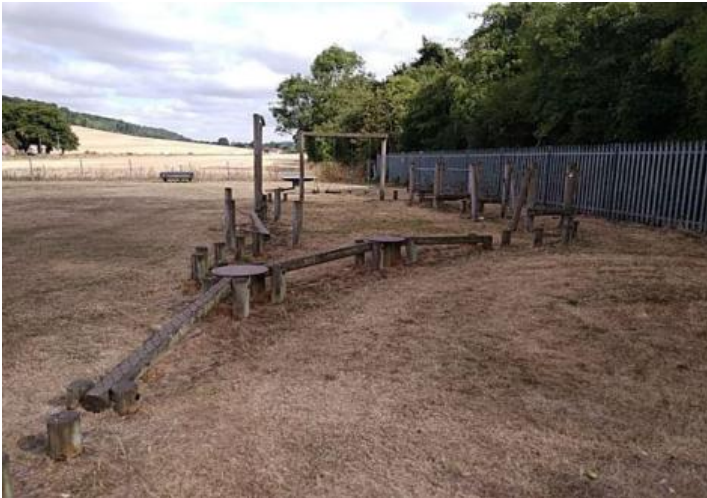
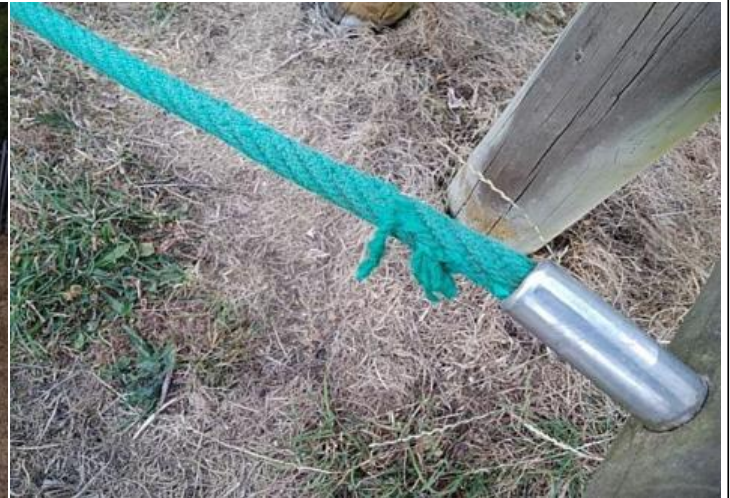
The ropes/nets are worn/damaged in places - Monitor for any further deterioration and repair or replace as required

Finding: The ropes/nets are worn/damaged in places

Action: Monitor for any further deterioration and repair or replace as required

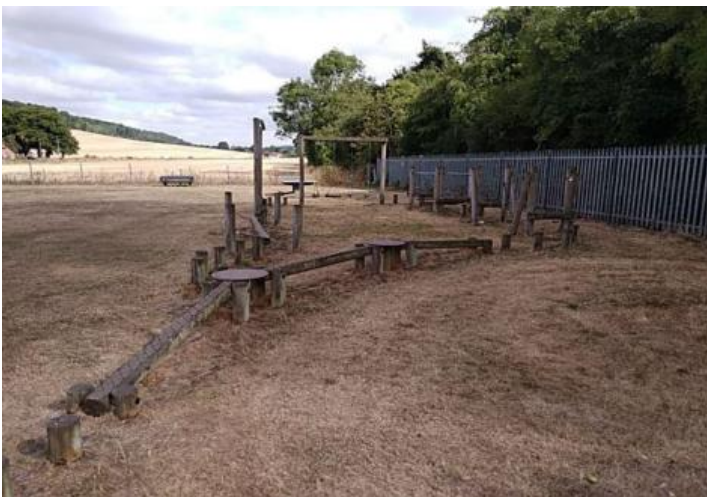
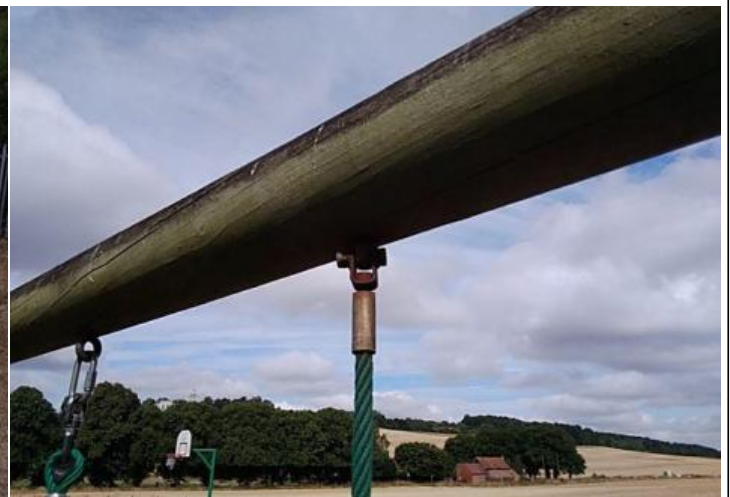
A number of fixing(s) have worked loose on the swinging steps - Secure all loose fixings

Finding: A number of fixing(s) have worked loose on the swinging steps

Action: Secure all loose fixings

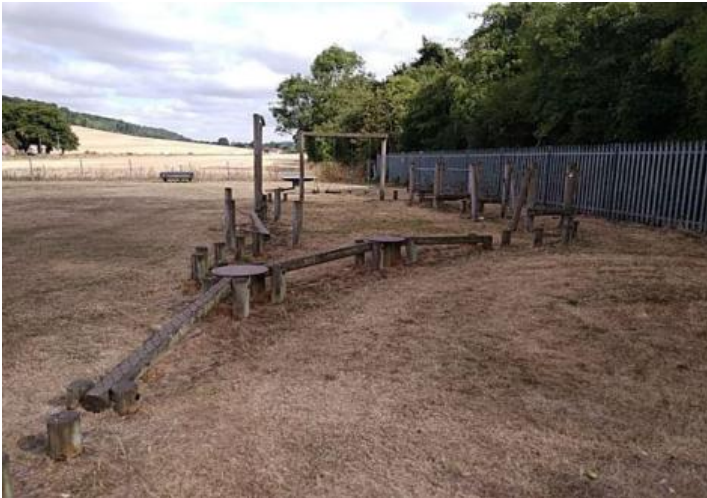
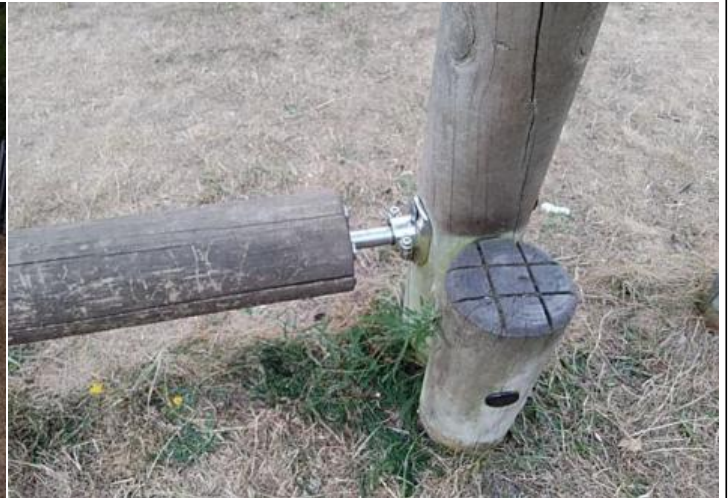
A number of fixing(s) have worked loose on the rotating beam brackets - Secure all loose fixings

Finding: A number of fixing(s) have worked loose on the rotating beam brackets

Action: Secure all loose fixings
