West Wycombe Parish Council

**YOU ARE SUMMONED TO ATTEND A MEETING OF THE PARISH COUNCIL
TO BE HELD ON THURSDAY 10th NOVEMBER 2022 IN THE CHURCH ROOM, WEST WYCOMBE**

AGENDA

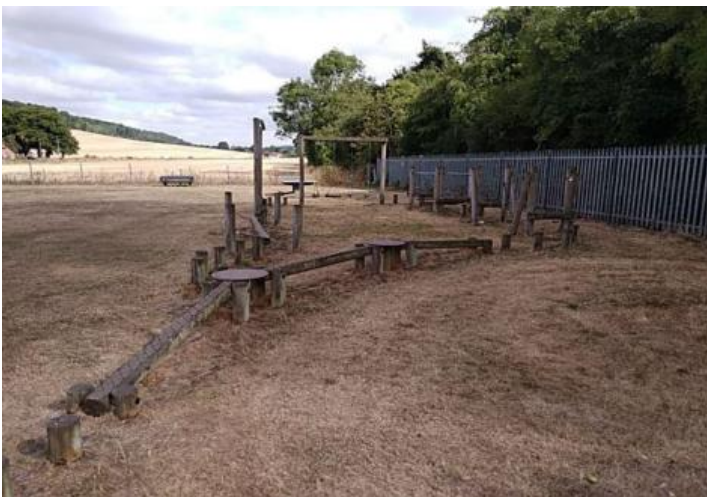
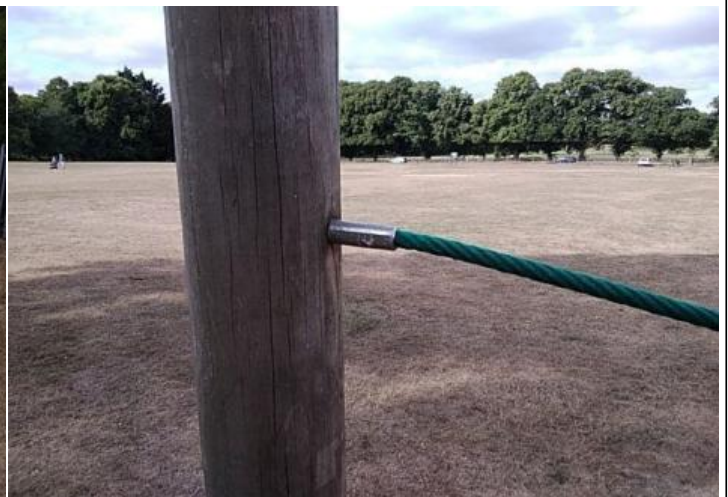
Finding: A number of fixing(s) have worked loose on the rotating beam rope grip

Action: Secure all loose fixings

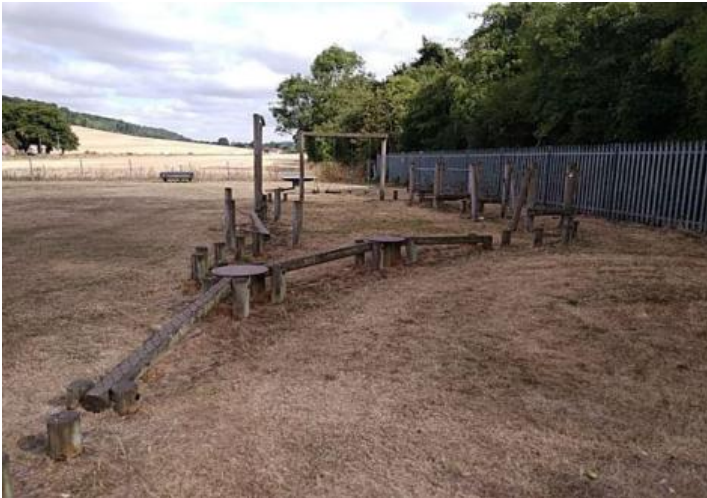
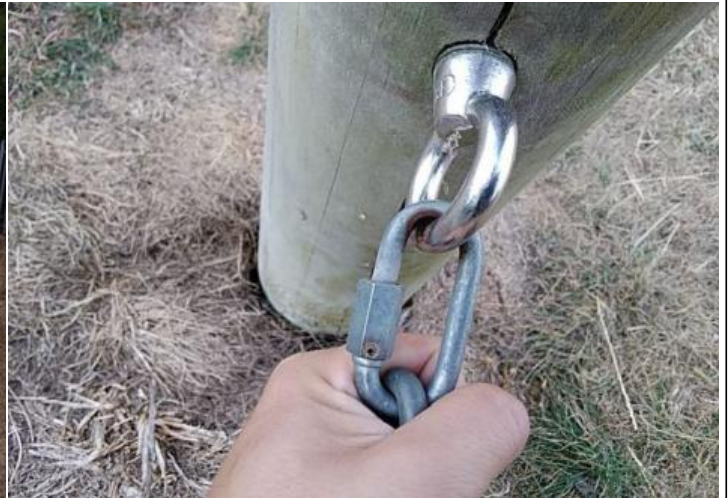
There is some wear to the shackles. - Monitor for any further deterioration and replace when 40% worn

Finding: There is some wear to the shackles.

Action: Monitor for any further deterioration and replace when 40% worn

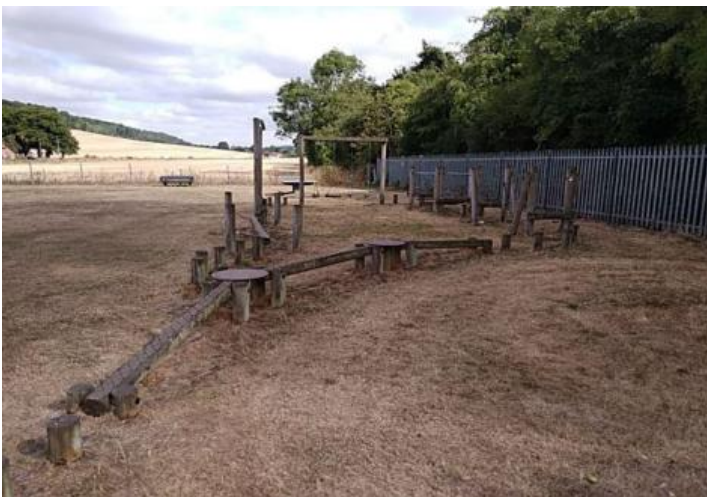
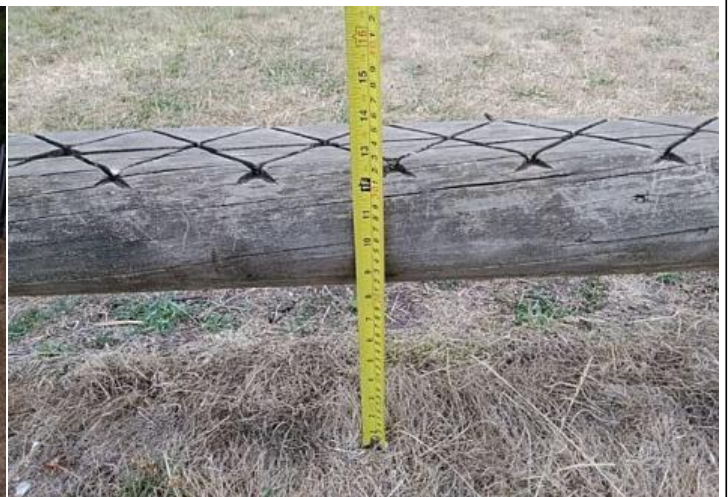
Finding: The clearance to the underside of the beam is less than 400mm and fails the requirements of BS EN 1176 Part 1

Action: Monitor - no remedial action recommended

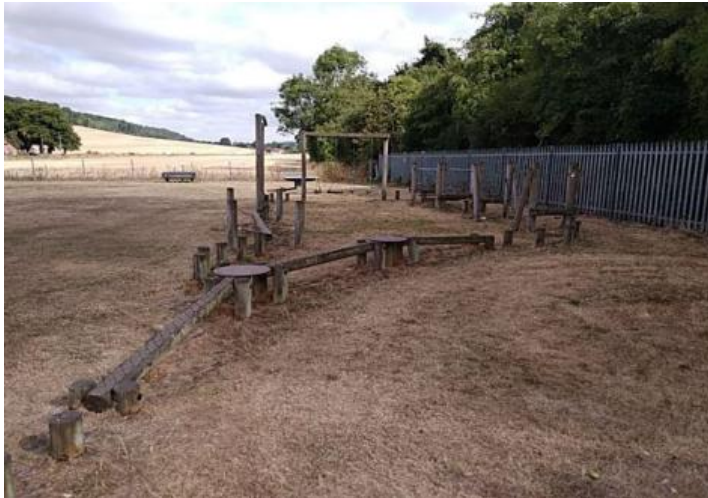
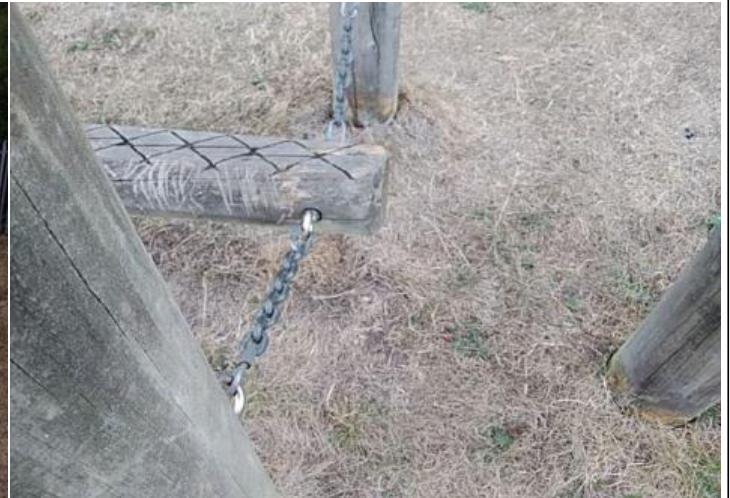
The ends of the beams do not have a minimum radius of 50mm as recommended in BS EN 1176 Part 1 - Monitor - no remedial action recommended

Finding: The ends of the beams do not have a minimum radius of 50mm as recommended in BS EN 1176 Part 1

Action: Monitor - no remedial action recommended

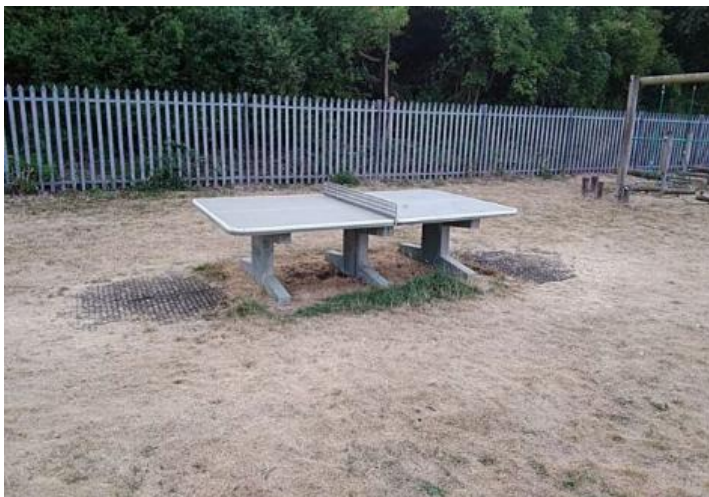
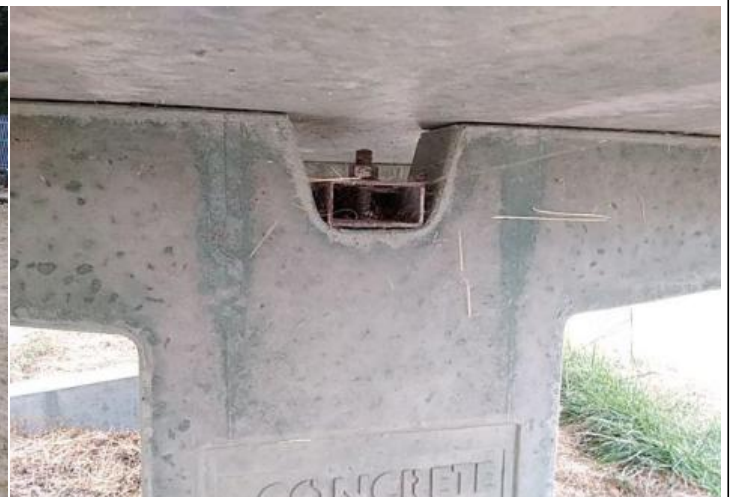
Finding: There are post / end caps missing from the item **Action:** Replace missing post caps

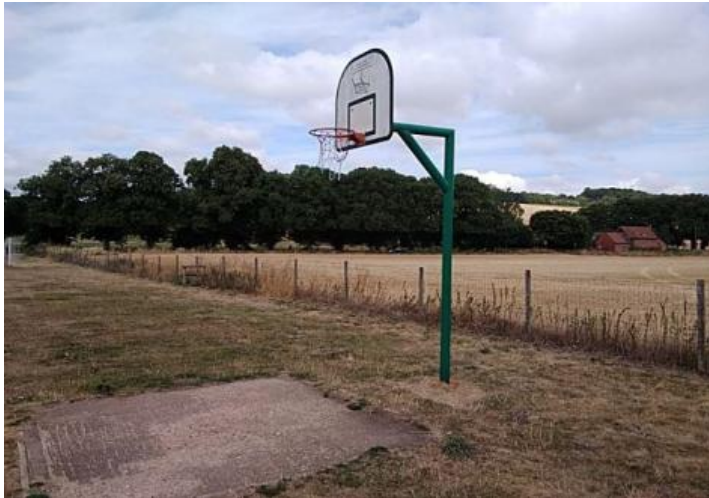
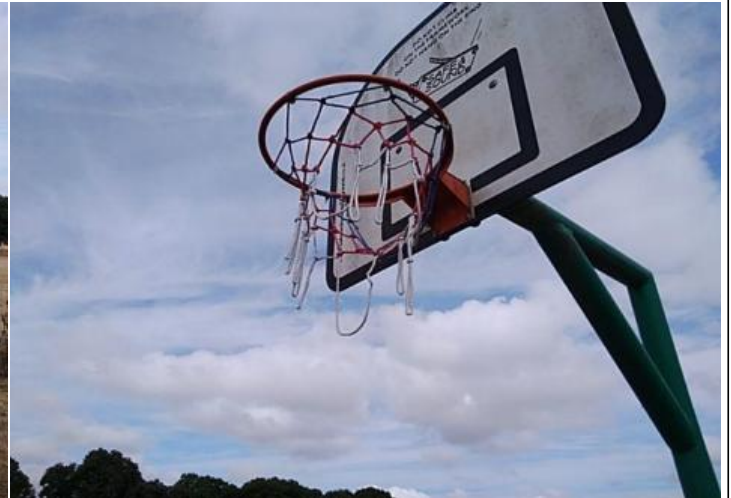
Finding: There is some damage to the net

Action: Repair or replace

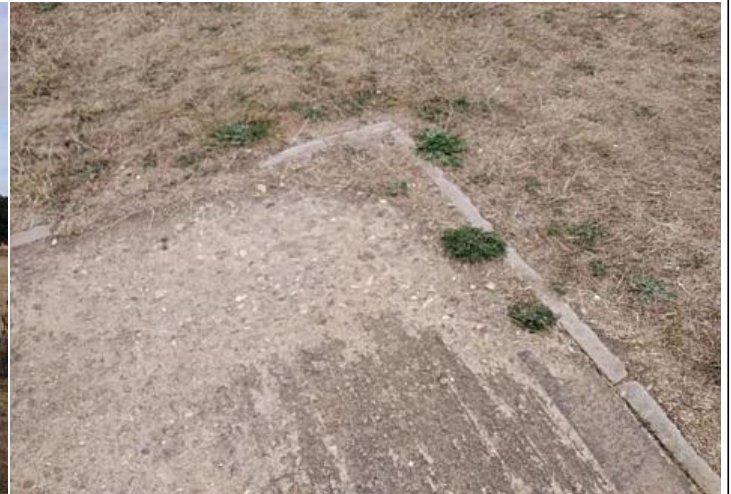
Finding: There is some minor damage to the surface

Action: Monitor for any further deterioration and repair as required
