Annual Inspection

Wycombe District Council

The Pedestal Playing Field

Annual Inspection - 12 July 2017 at 13:48 Inspector: Martin Lawrence (RPII Annual Inspector)

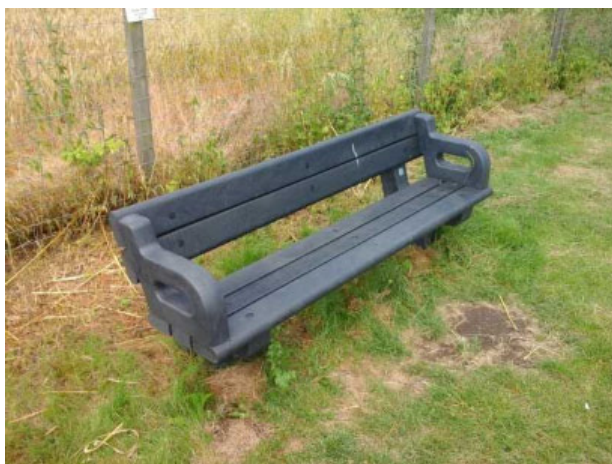
Item: Ancillary Items - Bench
Manufacturer: Owner/Operator
Surface Type: N/A
Equipment Compliance: N/A
Surface Area Compliance: N/A
Ref/Part Number:
Total Findings: 1

The bench is not securely fixed to the surface and there is some possibility of the item tipping or rolling over - Secure the bench to the ground

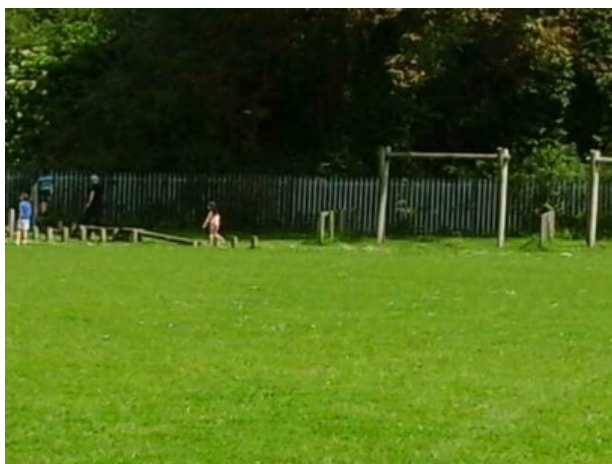
Item: Ancillary Items - Site General
Manufacturer: Owner/Operator
Surface Type: N/A
Equipment Compliance: N/A
Surface Area Compliance: N/A
Ref/Part Number:
Total Findings: 3

The timber on site has a number of splits (shakes) although these are not considered to be a problem at present - Monitor to ensure the splits do not cross through fixing points of the structure and cause any instability

There is some strimmer damage apparent on all posts, this can penetrate the preservative applied to the timber and accelerate the rotting process - Monitor for any deterioration (rot) and replace as required

The adjacent foliage is overhanging - Cut back and maintain

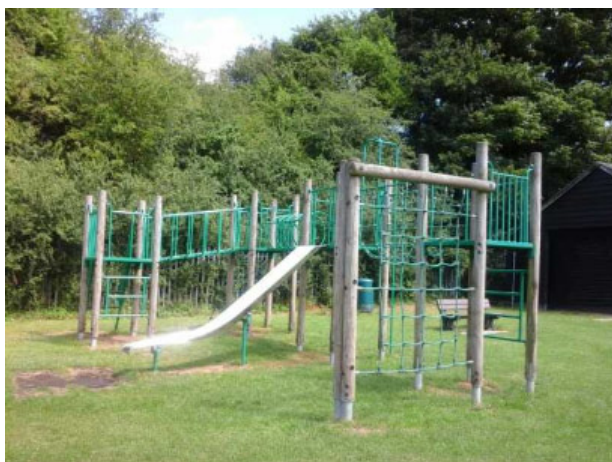
Item: Activity Equipment - Multi Play (Junior)
Manufacturer: A.E.Evans
Surface Type: Grass Matrix Tiles
Equipment Compliance: No
Surface Area Compliance: Yes
Ref/Part Number:
Total Findings: 7

The height of the slide runout is in excess of 350mm and fails the requirements of BS EN 1176: Part 3 - Monitor use

There is no side guard barrier to the slide start section and therefore does not conform to BS EN Standards - Monitor use

The grass mats are silted up and the soil is compacted; this may have an effect on the impact absorbing properties of the surface - Lift and relay mats or test impact absorbing properties to ensure the correct surface qualities are maintained for the equipment

The connecting links are in excess of 8.6mm and less than 12mm and fail the requirements of BS EN 1176:2008 Part 1; clause 4.2.13, Chains - Monitor use and replace with compliant links at the next maintenance cycle

The shackles are showing signs of corrosion - Consider replacing the shackles

The platforms are showing signs of wear - Monitor for any further deterioration and replace as required

Parts of the timber are rough or splintered - Remove all rough or sharp edges

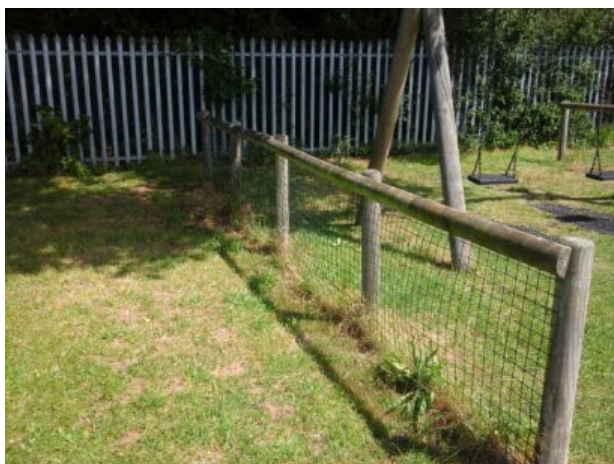
Item: Swings - Swing Barrier
Manufacturer: Not Identified
Surface Type: Grass
Equipment Compliance: N/A
Surface Area Compliance: N/A
Ref/Part Number:
Total Findings: 1

A number of fixing(s) have worked loose - Secure all loose fixings

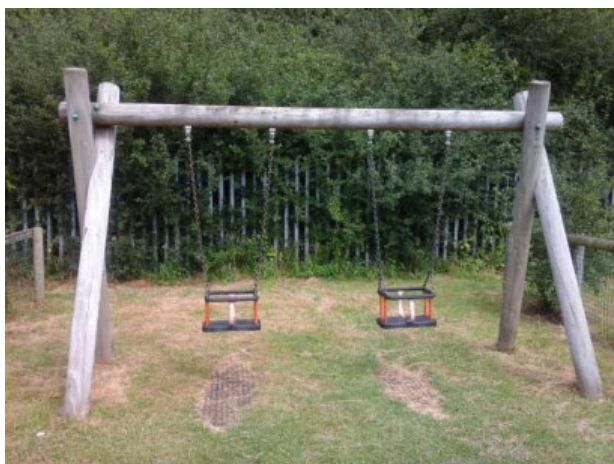
Item: Swings - 1 Bay 2 Seat (Cradle)
Manufacturer: Setter Play
Surface Type: Grass Matrix Tiles
Equipment Compliance: Yes
Surface Area Compliance: Yes
Ref/Part Number:
Total Findings: 3

The grass mats are silted up and the soil is compacted; this may have an effect on the impact absorbing properties of the surface - Lift and relay mats or test impact absorbing properties to ensure the correct surface qualities are maintained for the equipment

This design of swing joint has been known to fail on the weld connecting the joint to the threaded stud - We would recommend that the joint be dismantled and checked on a regular basis or a Secondary Safety Device be fitted

There are caps missing from the underside of the seats - Replace missing caps under the seats

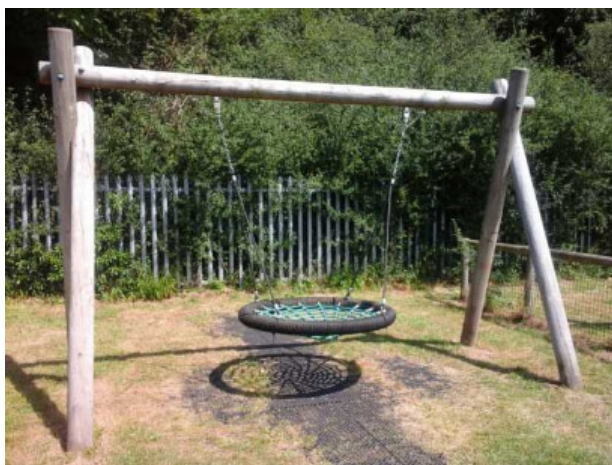
Item: Swings - Basket Swing - Type 1
Manufacturer: Setter Play
Surface Type: Grass Matrix Tiles
Equipment Compliance: No
Surface Area Compliance: Yes
Ref/Part Number:
Total Findings: 4

The connecting links are in excess of 8.6mm and less than 12mm and fail the requirements of BS EN 1176: 2008 Part 1; clause 4.2.13, Chains - Monitor use and replace with compliant connectors at the next maintenance cycle

The seat is severely damaged and requires replacing - Replace damaged seat

The bushes are showing signs of wear - Monitor for any further deterioration and replace as required

The suspension connection is loose - Tighten loose fixings to secure

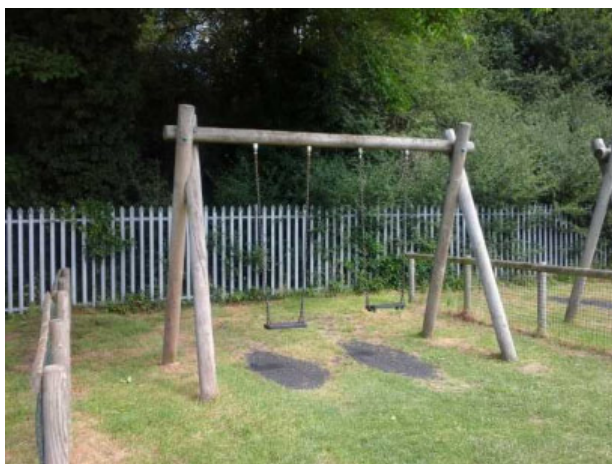
Item: Swings - 1 Bay 2 Seat (Flat)
Manufacturer: Setter Play
Surface Type: Grass Matrix Tiles
Equipment Compliance: No
Surface Area Compliance: Yes
Ref/Part Number:
Total Findings: 2

The chain openings are in excess of the 8.6mm as recommended by BS EN 1176 - Monitor use

This design of swing joint has been known to fail on the weld connecting the joint to the threaded stud - We would recommend that the joint be dismantled and checked on a regular basis or a Secondary Safety Device be fitted

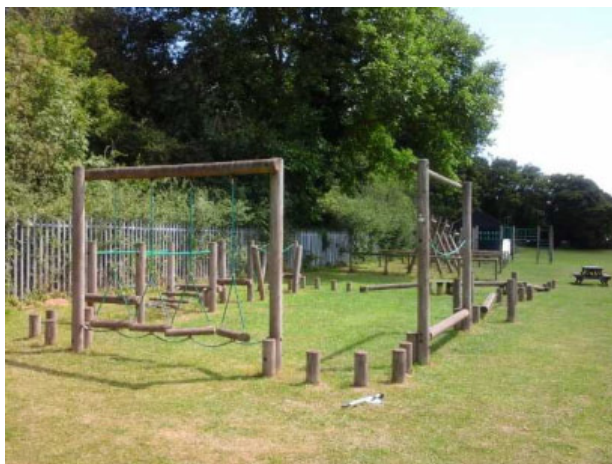
Item: Activity Equipment - Activity Trail
Manufacturer: A.E.Evans
Surface Type: Grass Matrix Tiles
Equipment Compliance: No
Surface Area Compliance: Yes
Ref/Part Number:
Total Findings: 3

Parts of the timber are rough or splintered - Remove all rough or sharp edges

The clearance to the underside of the beam is less than 400mm and fails the requirements of BS EN 1176 Part 1 - Rectify the installation

There is or are fixings missing on the rotating beam. There is only one screw in the one end - Replace all missing fixings

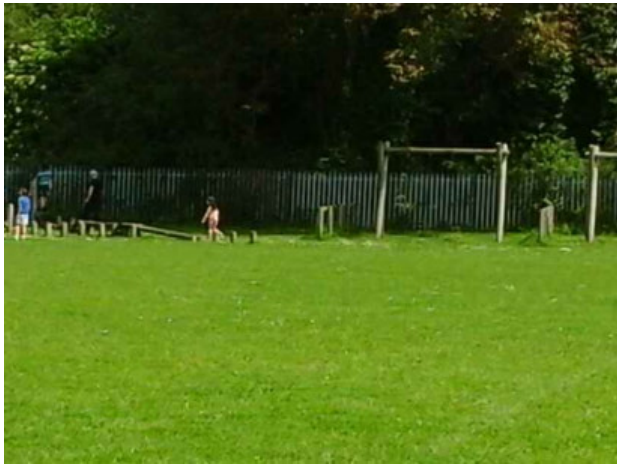
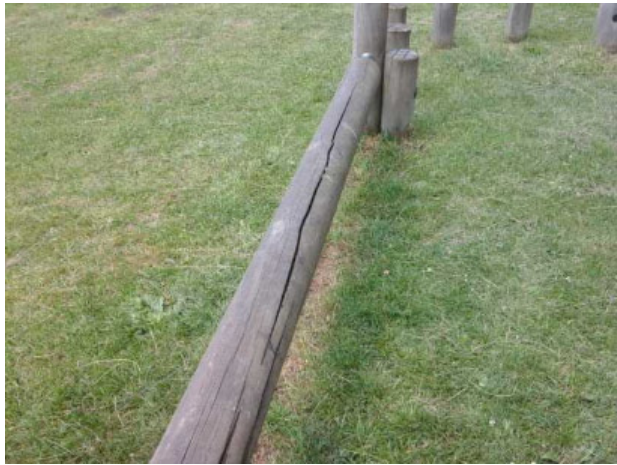
6 - Low Risk (Finding 1)			
Item:	Ancillary Items - Site General	Risk Level:	L - Low Risk
Manufacturer:	Owner/Operator	Surface:	N/A

Finding:	The timber on site has a number of splits (shakes) although these are not considered to be a problem at present		Action: Monitor to ensure the splits do not cross through fixing points of the structure and cause any instability

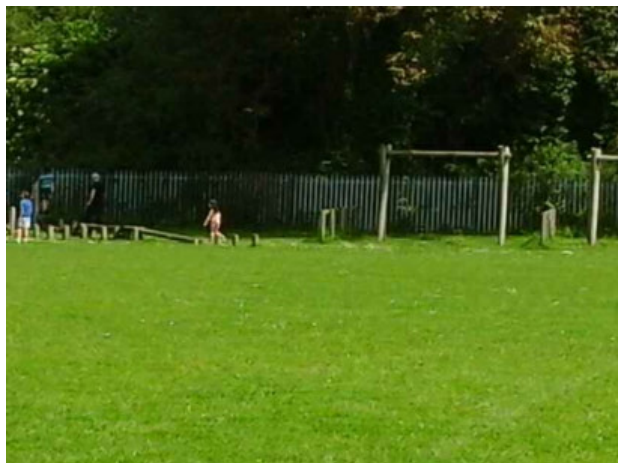
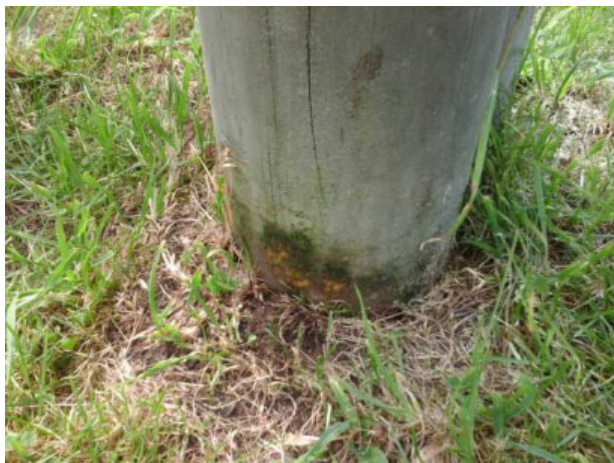
6 - Low Risk (Finding 2)

Finding: There is some strimmer damage apparent on all posts, this can penetrate the preservative applied to the timber and accelerate the rotting process

Action: Monitor for any deterioration (rot) and replace as required

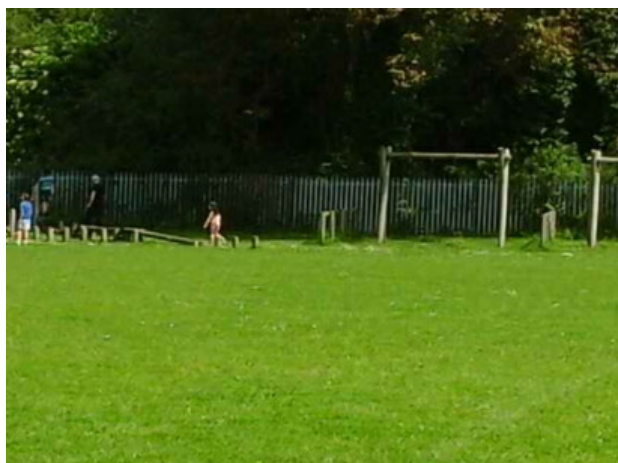
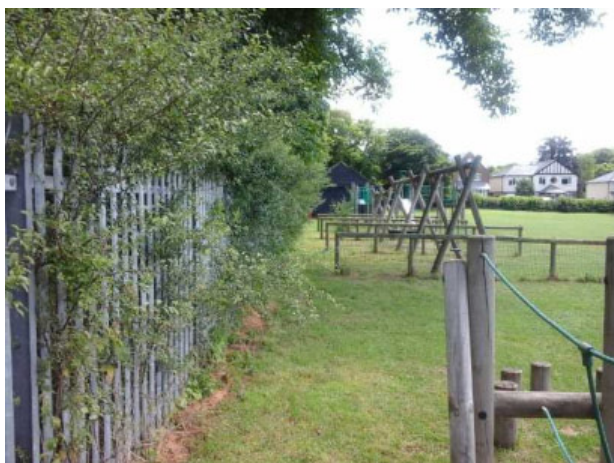
6 - Low Risk (Finding 3)

Finding: The adjacent foliage is overhanging

Action: Cut back and maintain

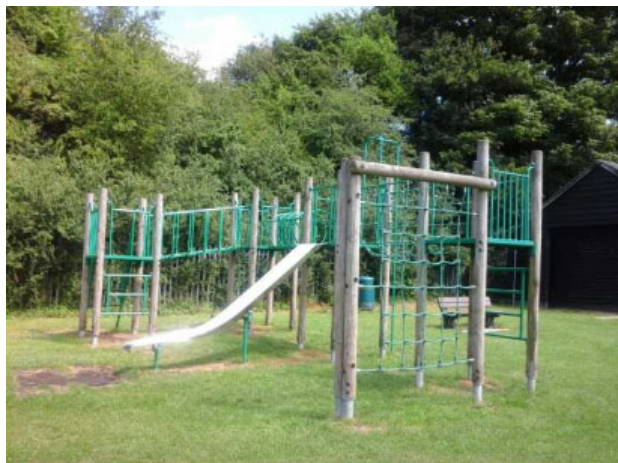
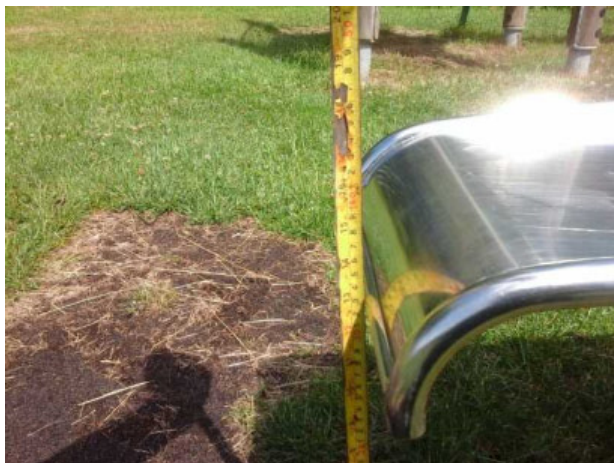
8 - Low Risk (Finding 1)

Finding: The height of the slide runout is in excess of 350mm and fails the requirements of BS EN 1176: Part 3

Action: Monitor use

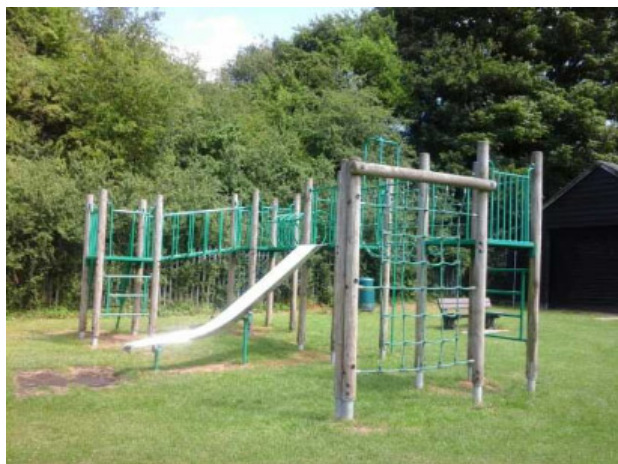
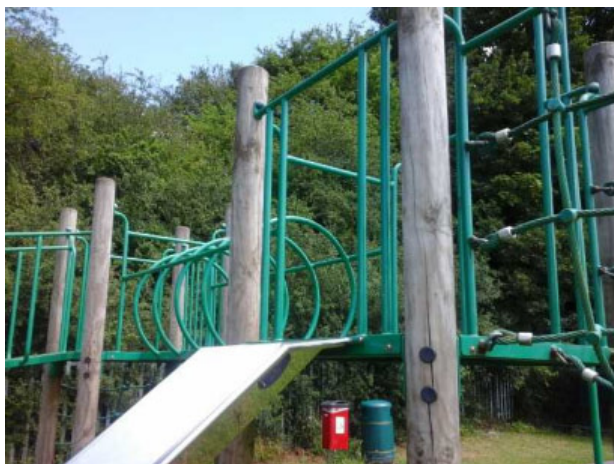
5 - Very Low Risk (Finding 2)

Finding: There is no side guard barrier to the slide start section and therefore does not conform to BS EN Standards

Action: Monitor use

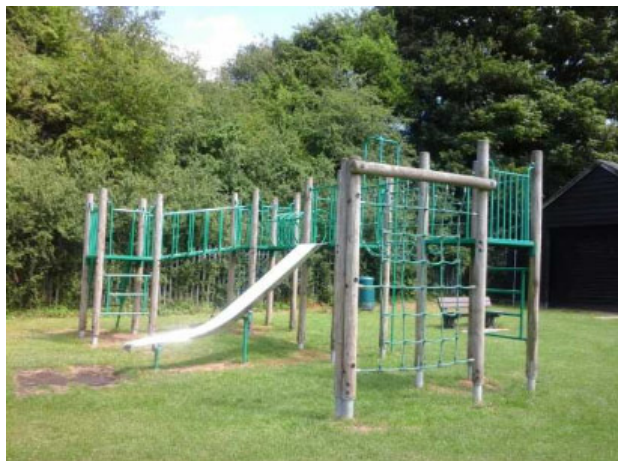
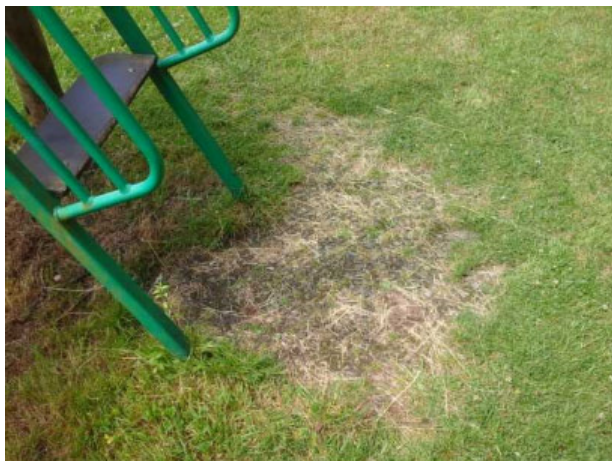
8 - Low Risk (Finding 3)

Finding: The grass mats are silted up and the soil is compacted; this may have an effect on the impact absorbing properties of the surface

Action: Lift and relay mats or test impact absorbing properties to ensure the correct surface qualities are maintained for the equipment

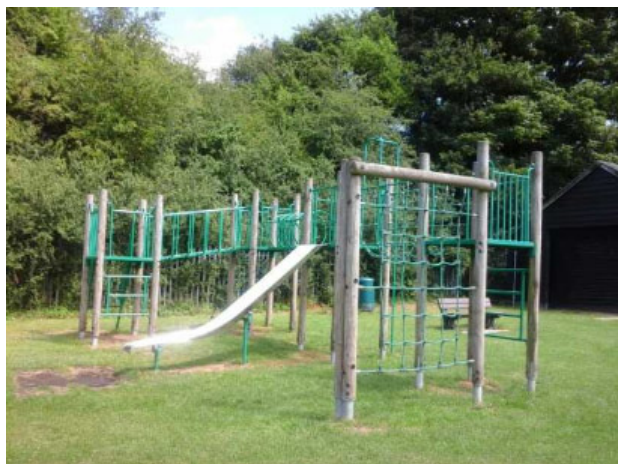
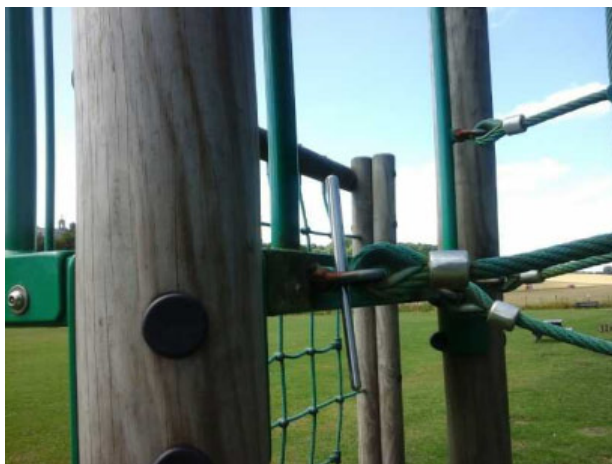
5 - Very Low Risk (Finding 4)

Finding: The connecting links are in excess of 8.6mm and less than 12mm and fail the requirements of BS EN 1176:2008 Part 1; clause 4.2.13, Chains

Action: Monitor use and replace with compliant links at the next maintenance cycle

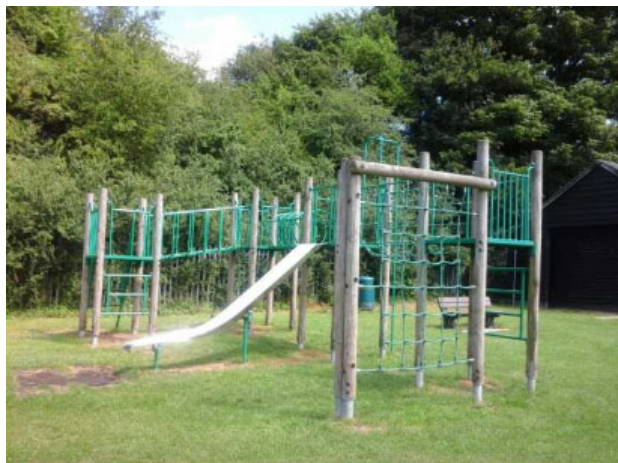
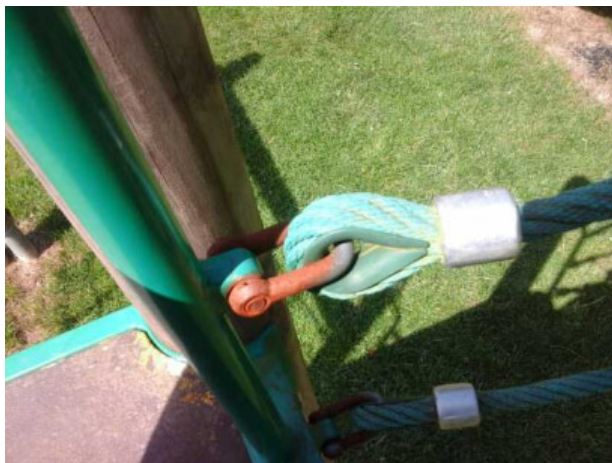
6 - Low Risk (Finding 5)

Finding: The shackles are showing signs of corrosion

Action: Consider replacing the shackles

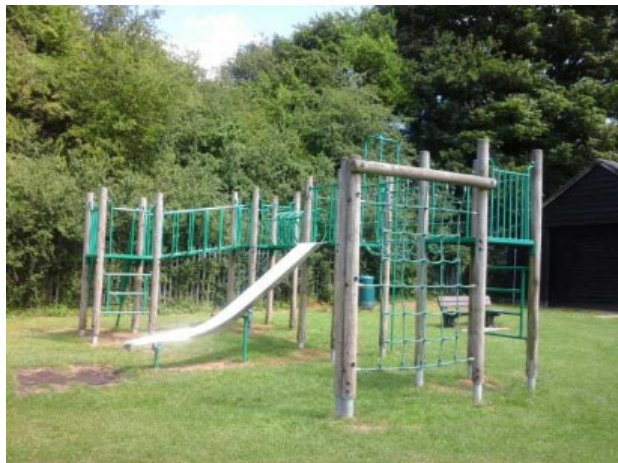
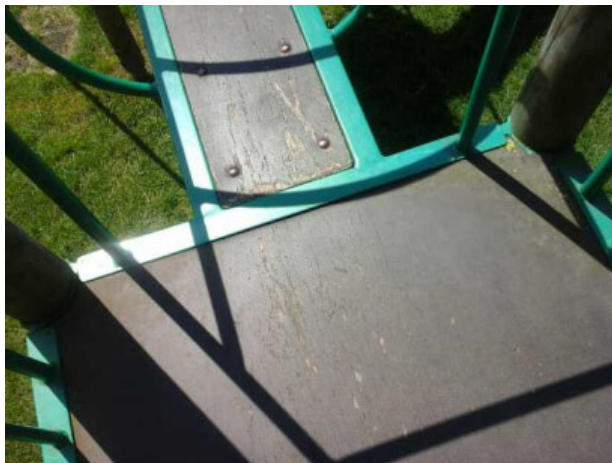
6 - Low Risk (Finding 6)

Finding: The platforms are showing signs of wear

Action: Monitor for any further deterioration and replace as required

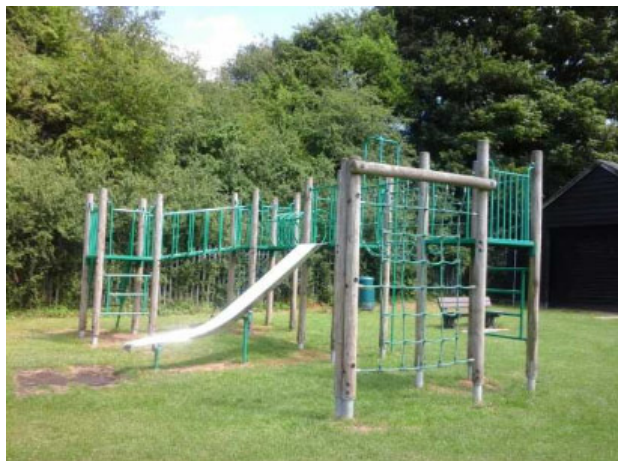
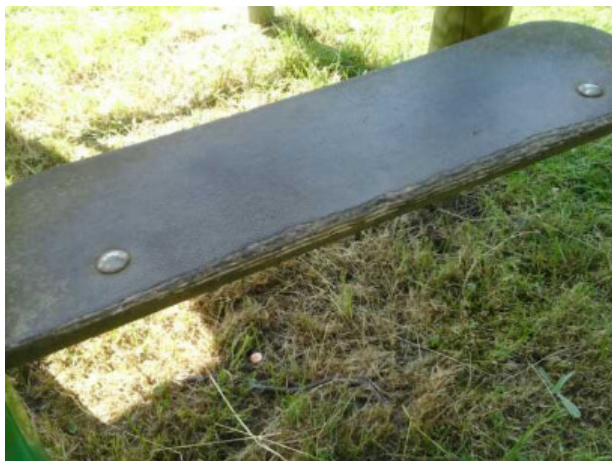
6 - Low Risk (Finding 7)

Finding: Parts of the timber are rough or splintered

Action: Remove all rough or sharp edges

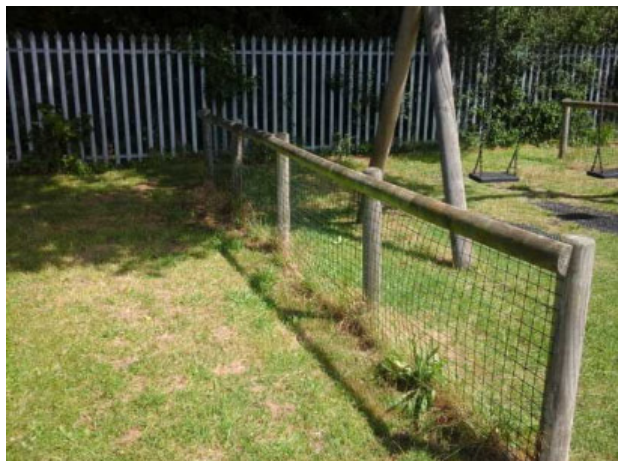
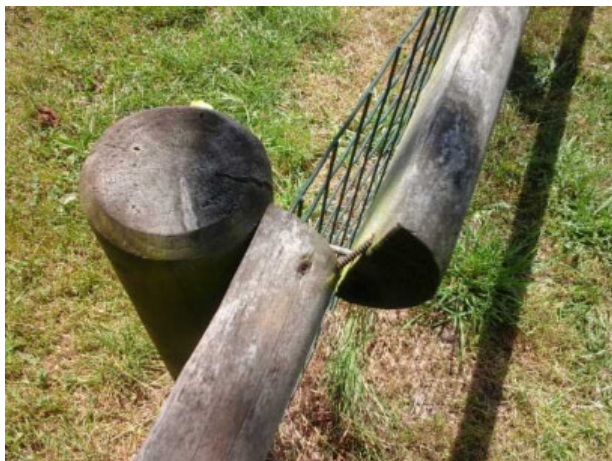
6 - Low Risk (Finding 1)

Finding: A number of fixing(s) have worked loose

Action: Secure all loose fixings

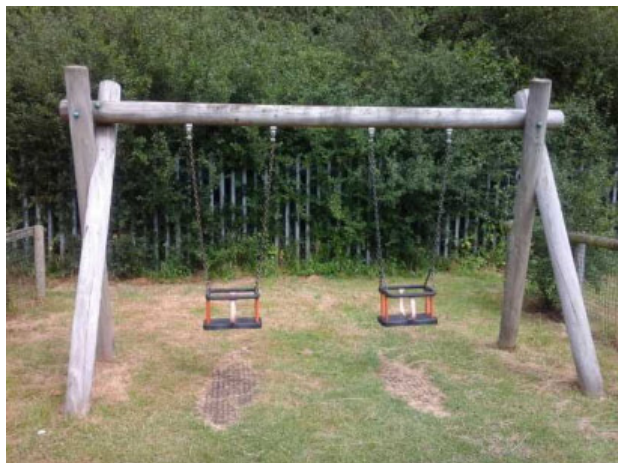
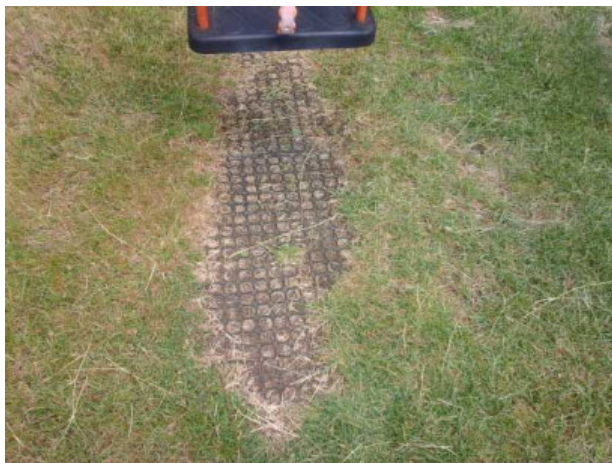
8 - Low Risk (Finding 1)

Finding: The grass mats are silted up and the soil is compacted; this may have an effect on the impact absorbing properties of the surface

Action: Lift and relay mats or test impact absorbing properties to ensure the correct surface qualities are maintained for the equipment

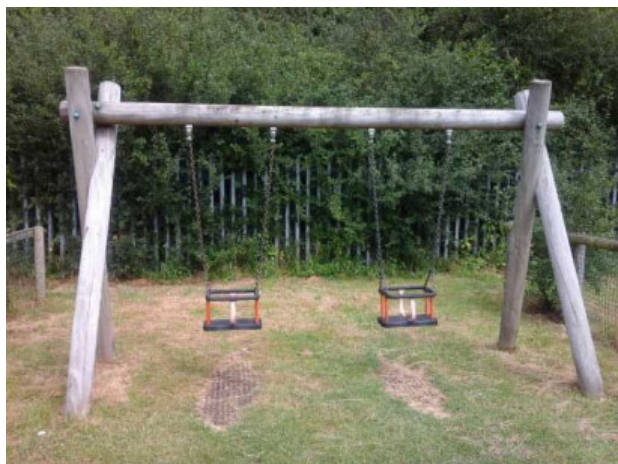
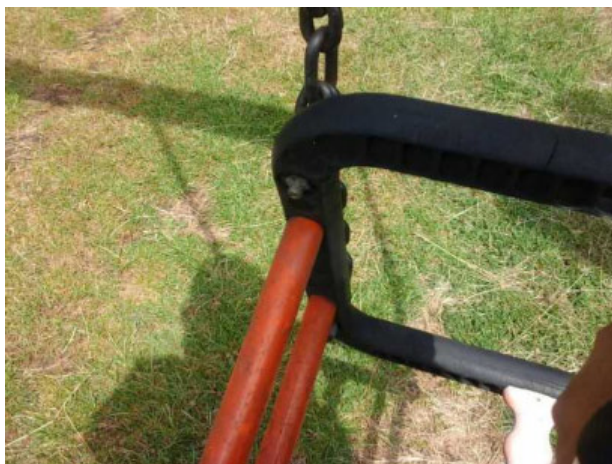
6 - Low Risk (Finding 2)

Finding: There are caps missing from the underside of the seats

Action: Replace missing caps under the seats

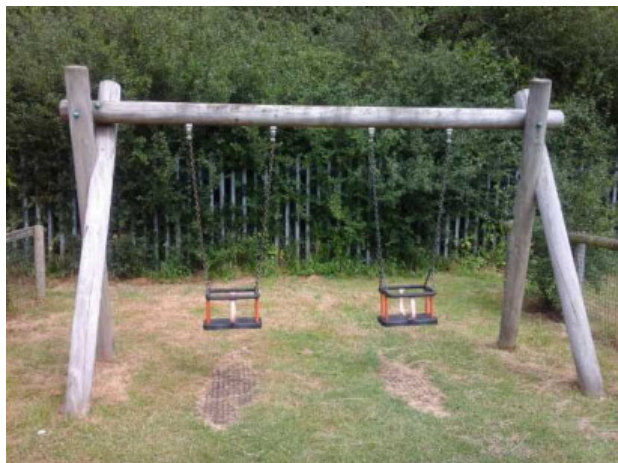
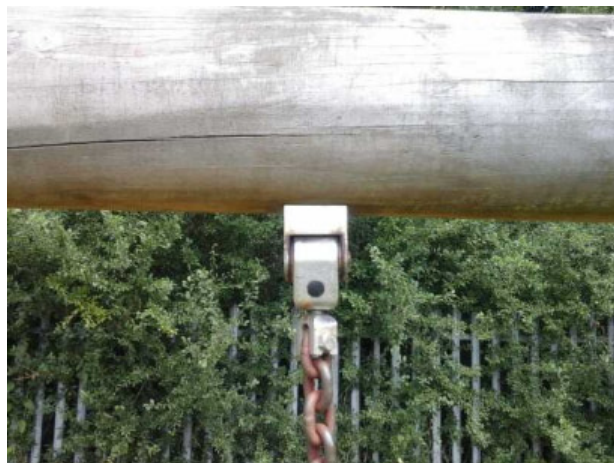
10 - Low Risk (Finding 3)

Finding: This design of swing joint has been known to fail on the weld connecting the joint to the threaded stud

Action: We would recommend that the joint be dismantled and checked on a regular basis or a Secondary Safety Device be fitted

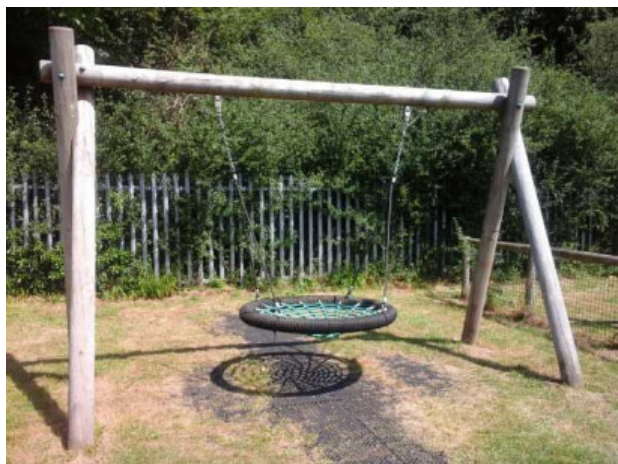
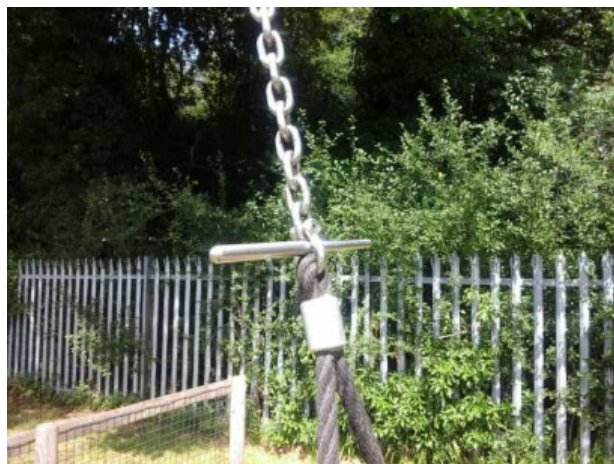
5 - Very Low Risk (Finding 1)

Finding: The connecting links are in excess of 8.6mm and less than 12mm and fail the requirements of BS EN 1176: 2008 Part 1; clause 4.2.13, Chains

Action: Monitor use and replace with compliant connectors at the next maintenance cycle

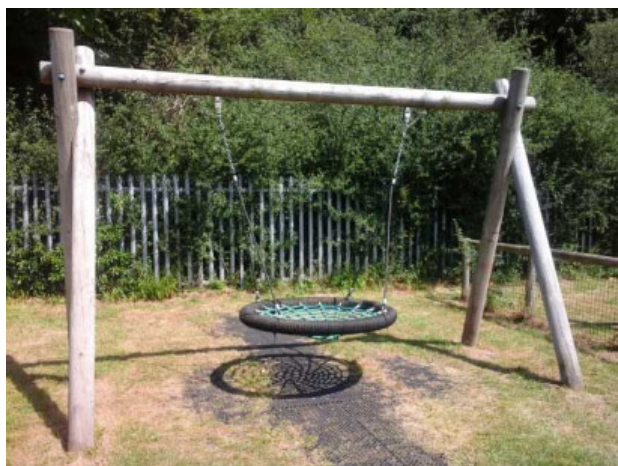
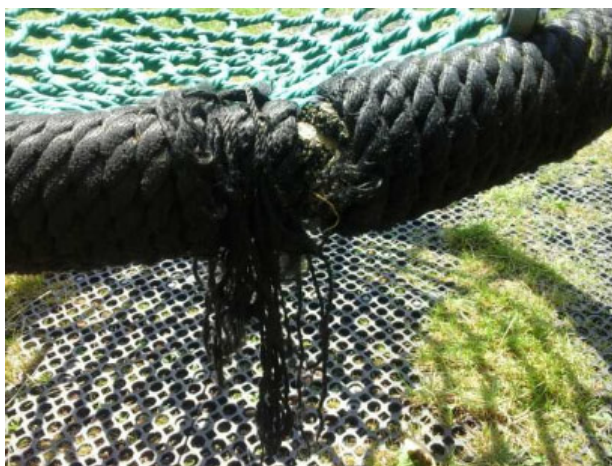
12 - Moderate Risk (Finding 2)

Finding: The seat is severely damaged and requires replacing

Action: Replace damaged seat

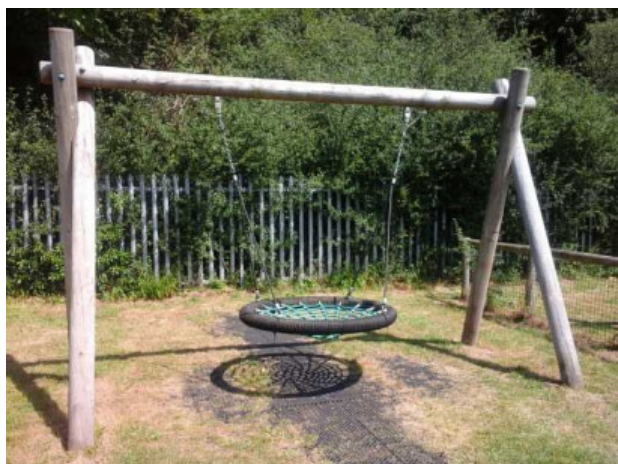
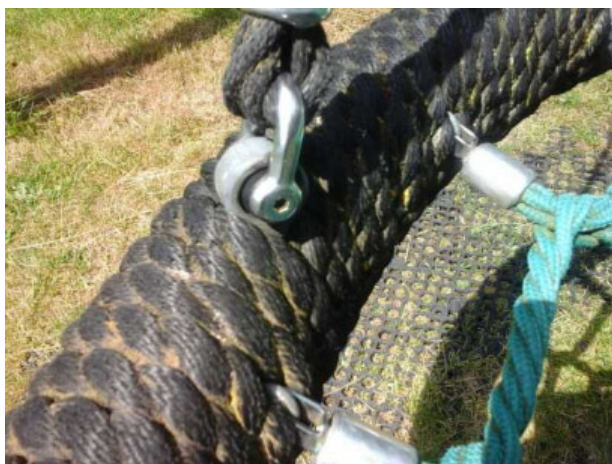
4 - Very Low Risk (Finding 3)

Finding: The bushes are showing signs of wear

Action: Monitor for any further deterioration and replace as required

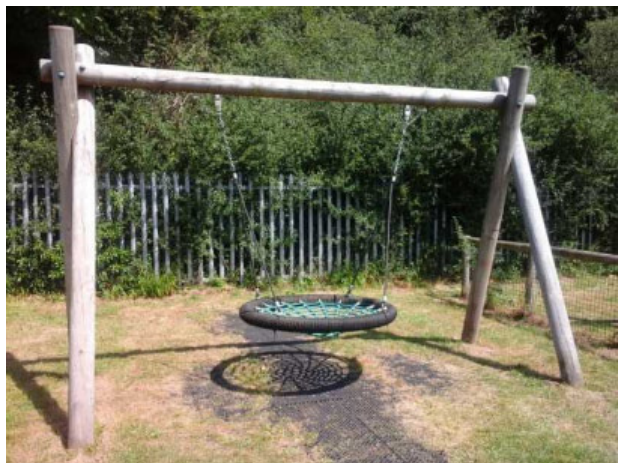
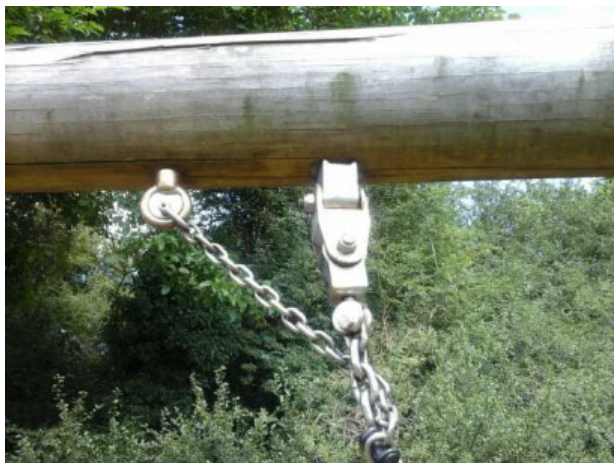
8 - Low Risk (Finding 4)

Finding: The suspension connection is loose

Action: Tighten loose fixings to secure

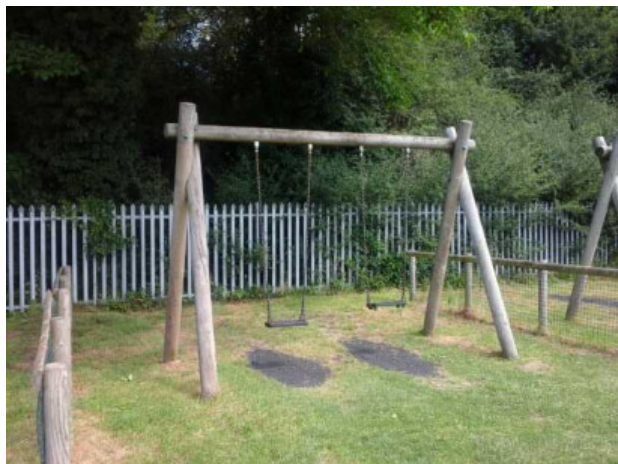
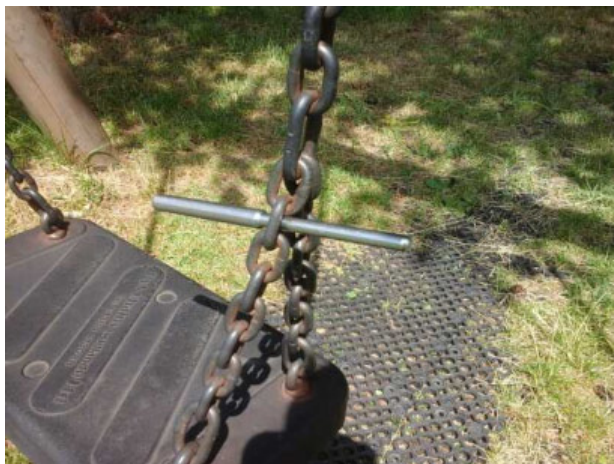
5 - Very Low Risk (Finding 1)

Finding: The chain openings are in excess of the 8.6mm as recommended by BS EN 1176

Action: Monitor use

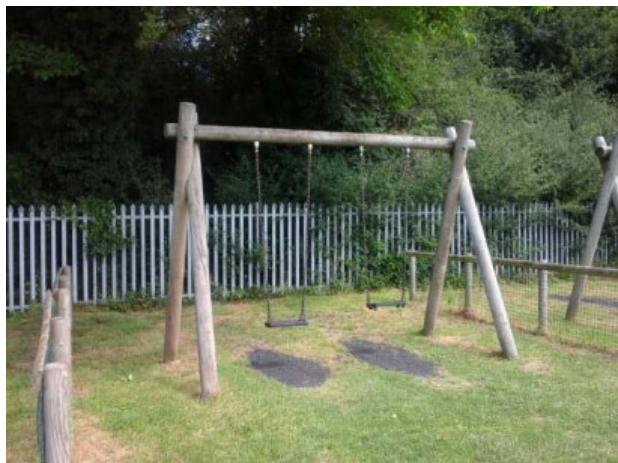
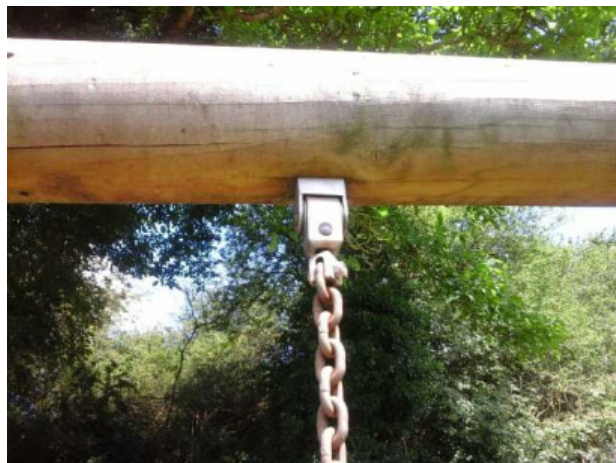
10 - Low Risk (Finding 2)

Finding: This design of swing joint has been known to fail on the weld connecting the joint to the threaded stud

Action: We would recommend that the joint be dismantled and checked on a regular basis or a Secondary Safety Device be fitted

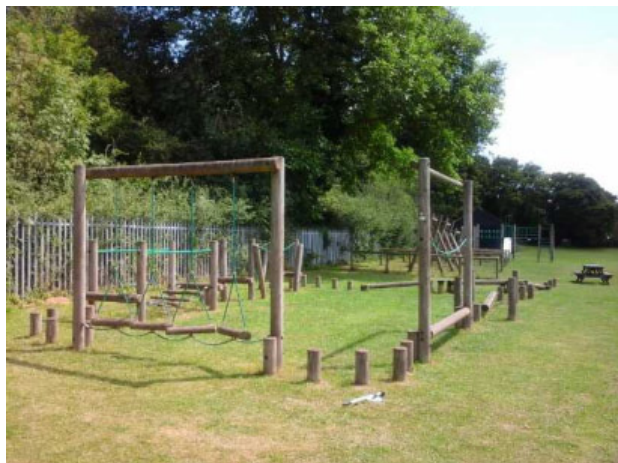
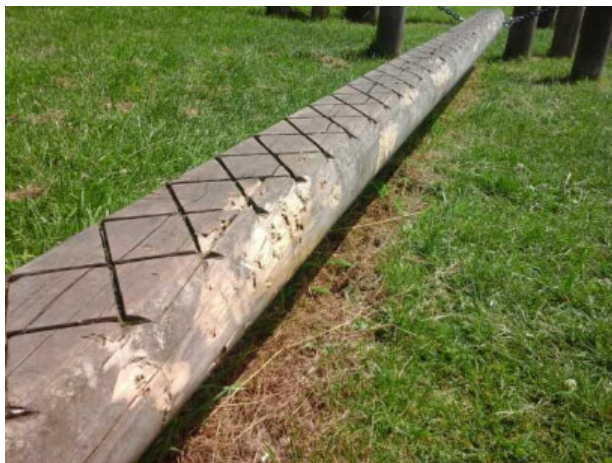
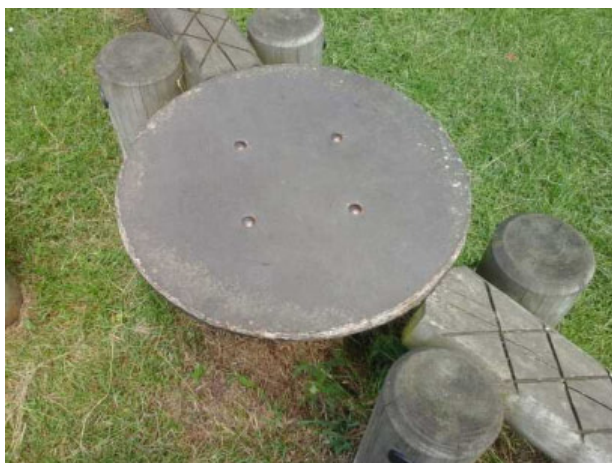
6 - Low Risk (Finding 1)

Finding: Parts of the timber are rough or splintered

Action: Remove all rough or sharp edges

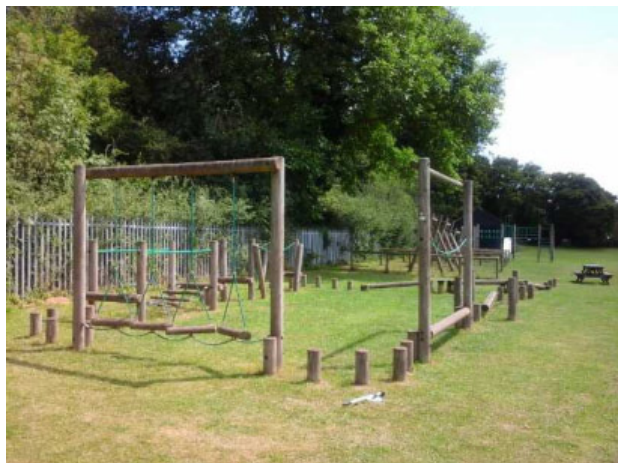
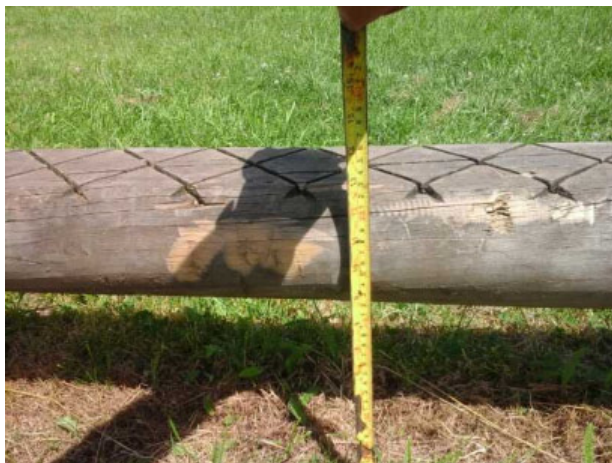
8 - Low Risk (Finding 2)

Finding: The clearance to the underside of the beam is less than 400mm and fails the requirements of BS EN 1176 Part 1
Action: Rectify the installation

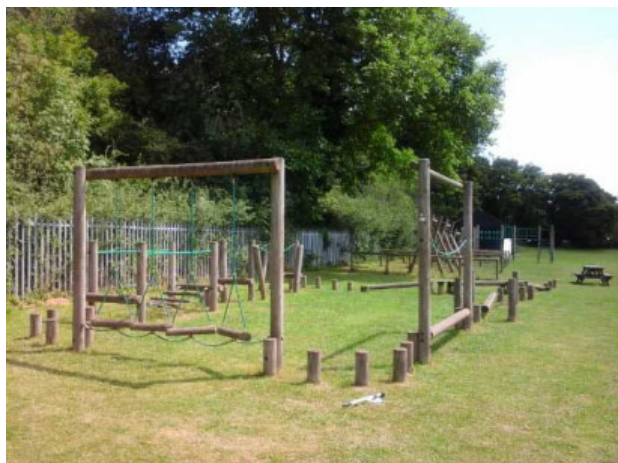
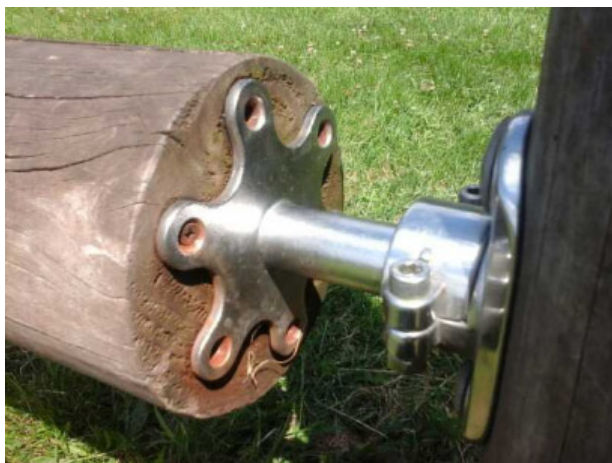
12 - Moderate Risk (Finding 3)

Finding: There is or are fixings missing on the rotating beam. There is only one screw in the one end
Action: Replace all missing fixings
