the **play inspection** company

Annual Inspection

Buckinghamshire Council High Wycombe

The Pedestal Playing Field

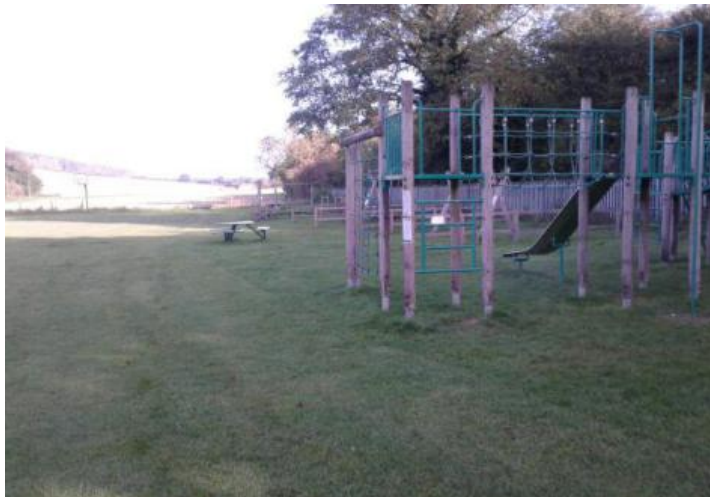
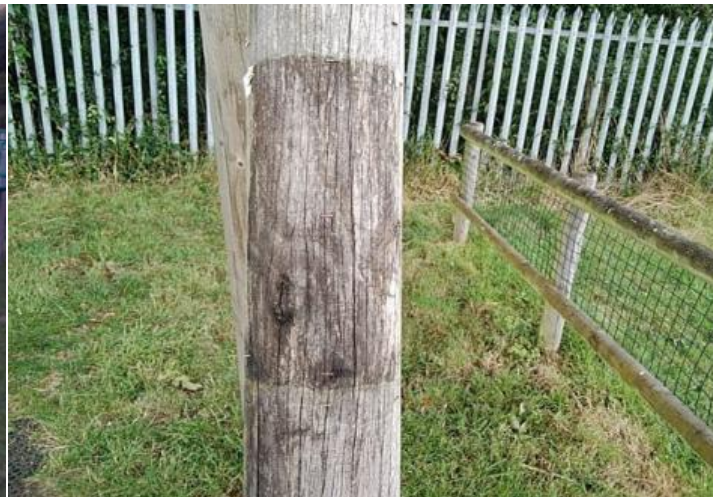
Finding: There are staples present

Action: Remove the staples

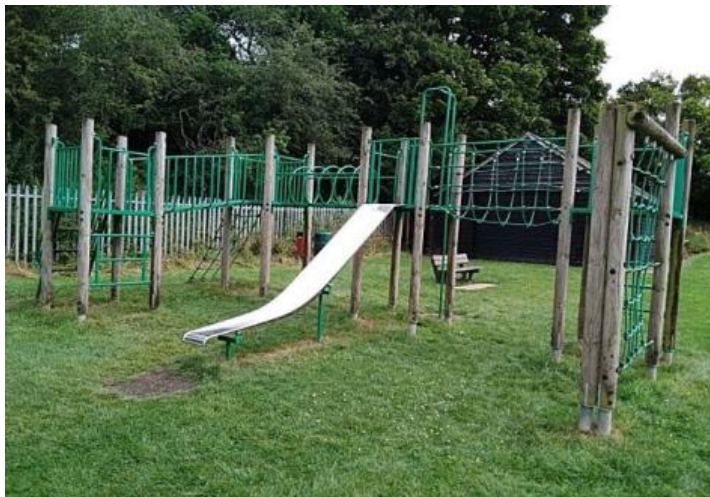
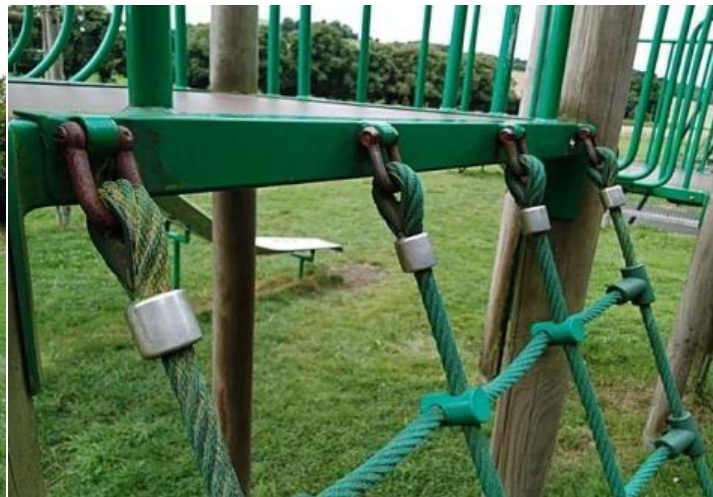
There is surface corrosion present on the item - Consider treating the item

Finding: There is surface corrosion present on the item

Action: Consider treating the item

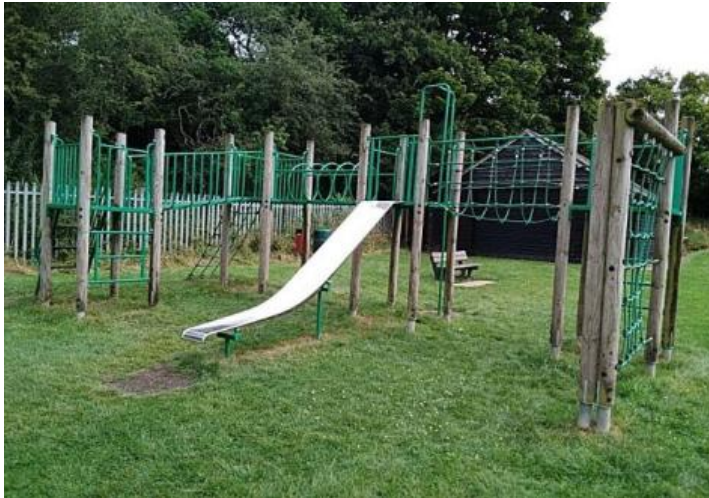
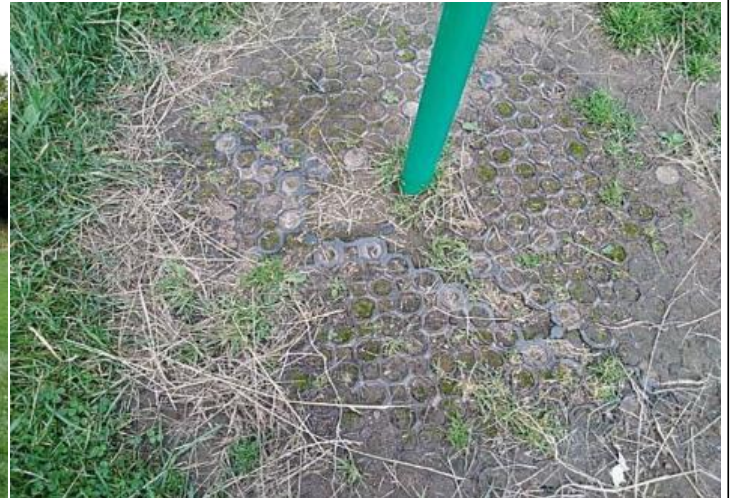
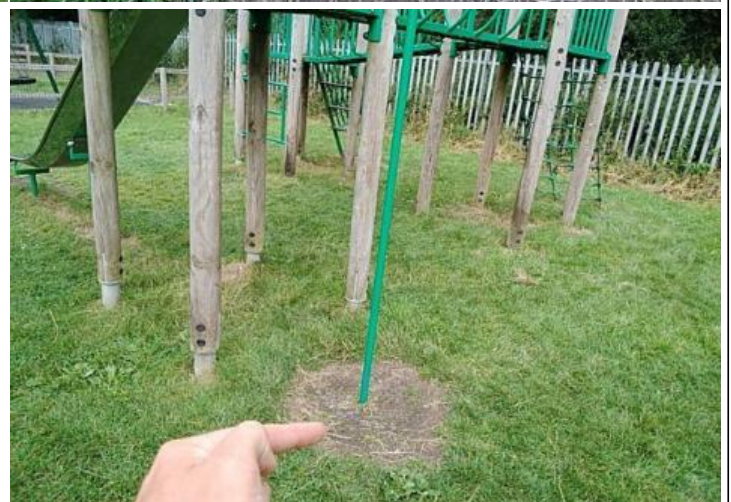
Finding: There are gaps opening between the grass mat tiles

Action: Reinstate surface

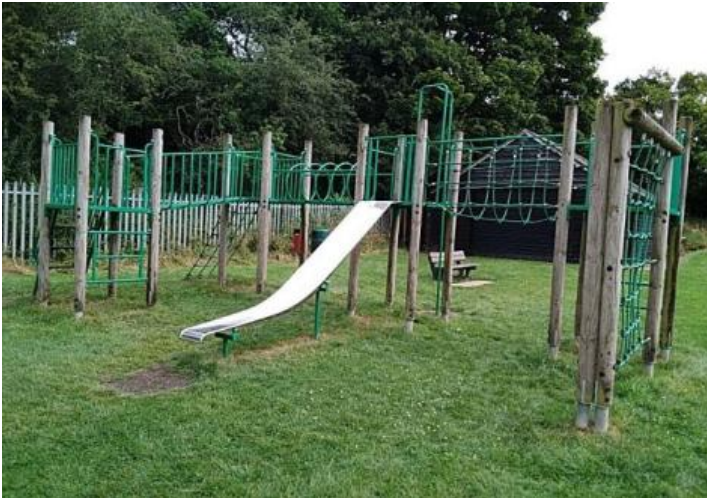
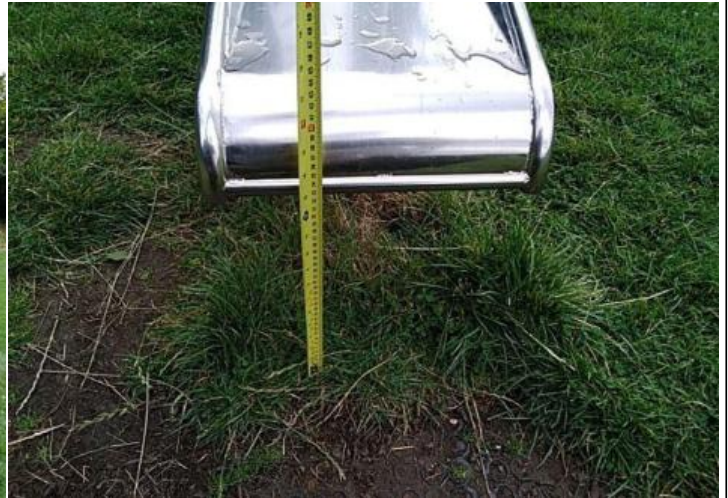
The height of the slide runout is in excess of 350mm and fails the requirements of BS EN 1176: Part 3 - Monitor - No remedial work recommended

Finding: The height of the slide runout is in excess of 350mm and fails the requirements of BS EN 1176: Part 3

Action: Monitor - No remedial work recommended

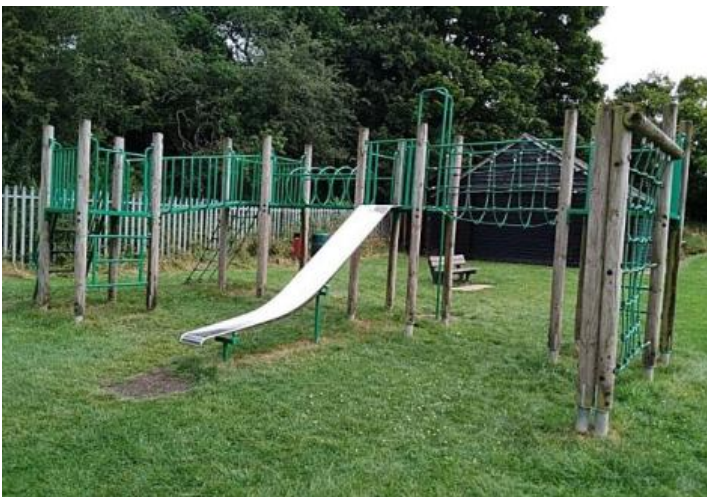
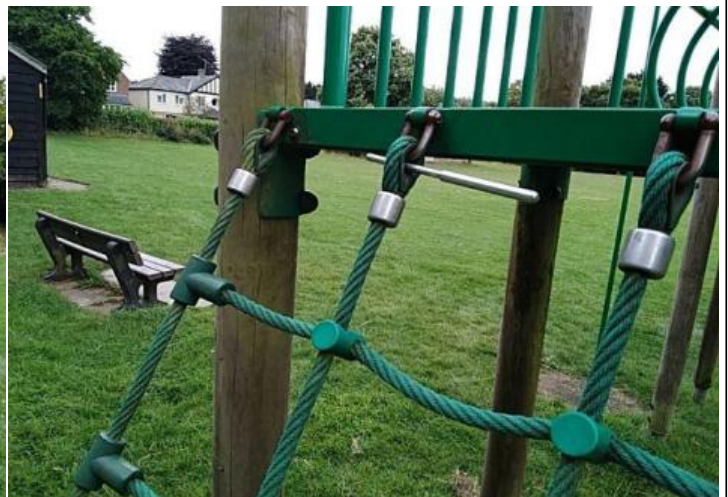
There is/are finger entrapment/s in the net and the item fails to meet the requirements of BS EN 1176 Part 1 4.2.7.6 Entrapment of fingers - Monitor - No remedial work recommended

Finding: There is/are finger entrapment/s in the net and the item fails to meet the requirements of BS EN 1176 Part 1 4.2.7.6 Entrapment of fingers

Action: Monitor - No remedial work recommended

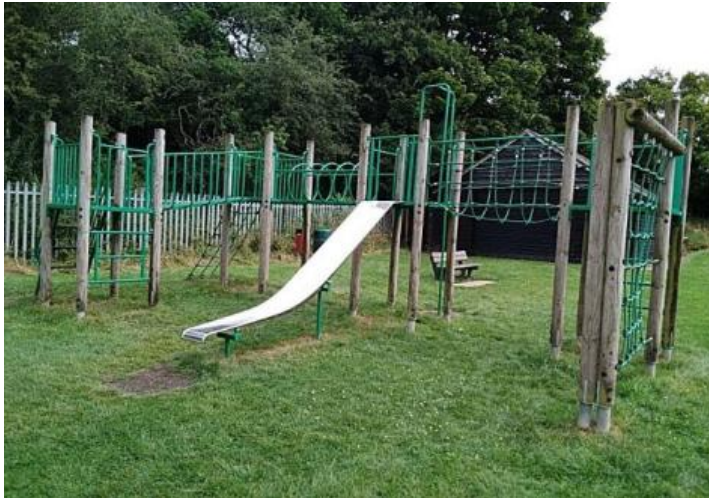
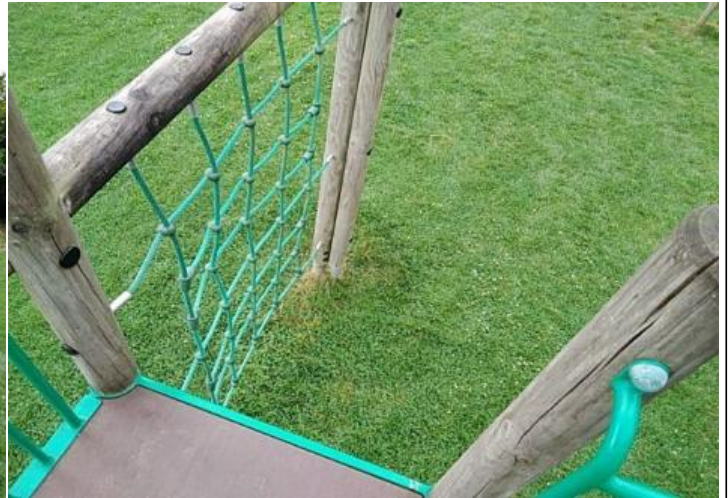
There is an opening in the barriers exceeding the width allowed (500mm) in BS EN 1176, and no guardrail has been provided; this is a low risk failure and no remedial action is required - Monitor - No remedial work recommended

Finding: There is an opening in the barriers exceeding the width allowed (500mm) in BS EN 1176, and no guardrail has been provided; this is a low risk failure and no remedial action is required

Action: Monitor - No remedial work recommended

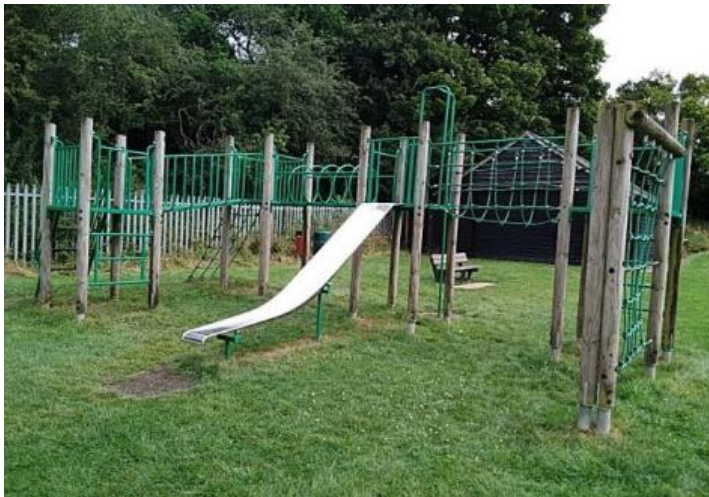
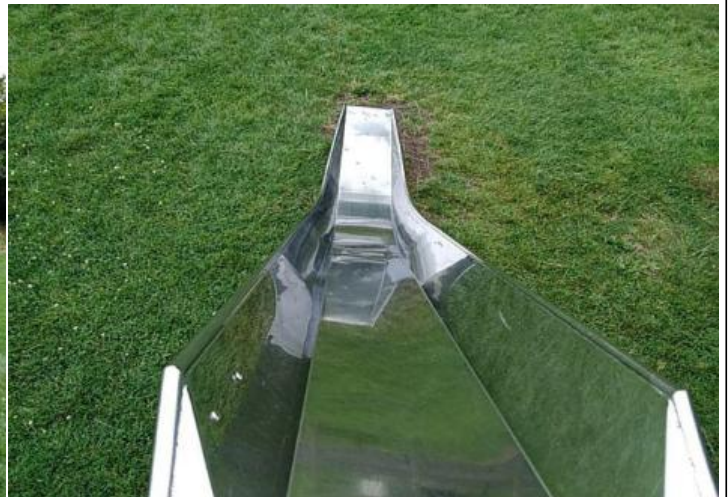
There are a number of dents in the slide surface - Monitor for any further deterioration and repair as required

Finding: There are a number of dents in the slide surface

Action: Monitor for any further deterioration and repair as required

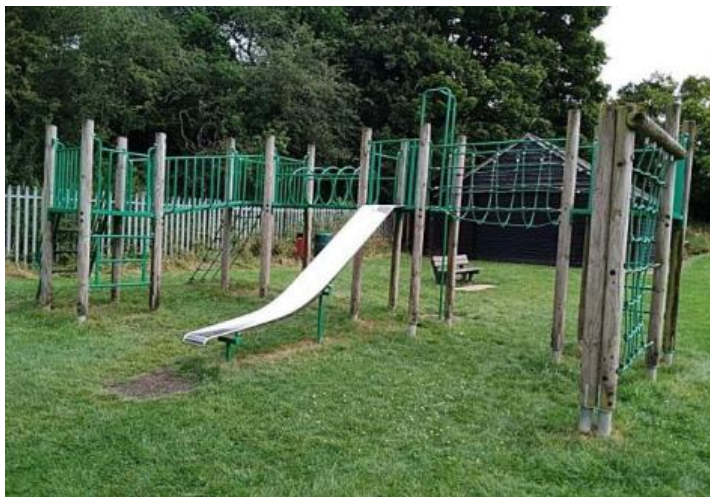
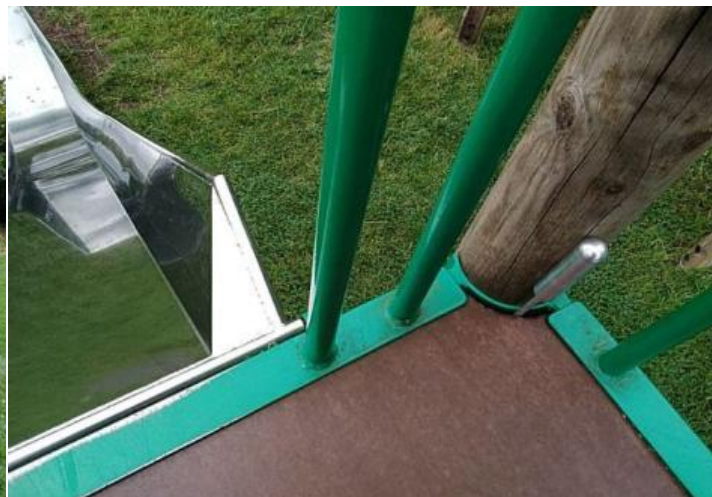
There is/are finger entrapment/s in the platform and the item fails to meet the requirements of BS EN 1176 Part 1 4.2.7.6 Entrapment of fingers - Monitor - No remedial work recommended

Finding: There is/are finger entrapment/s in the platform and the item fails to meet the requirements of BS EN 1176 Part 1 4.2.7.6 Entrapment of fingers

Action: Monitor - No remedial work recommended

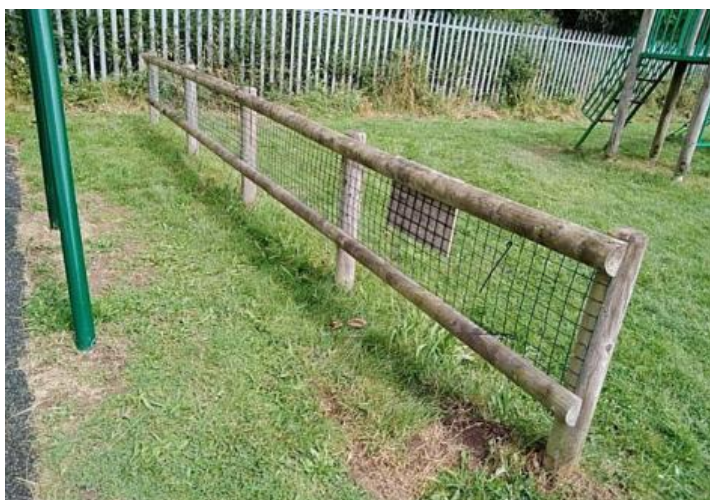
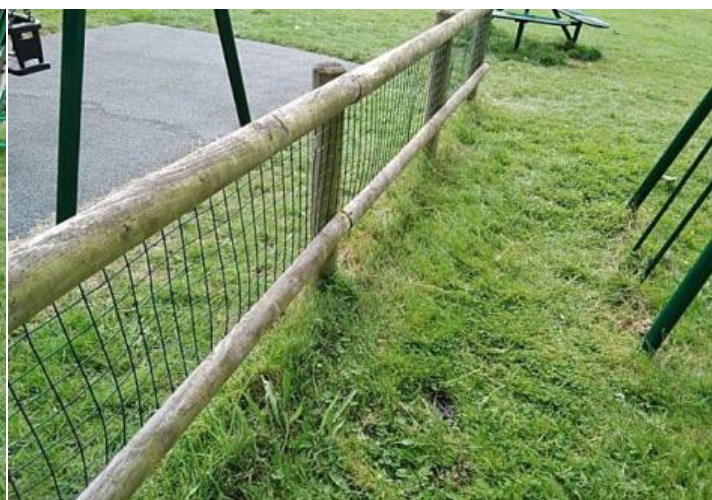
The item is slightly loose in its foundations - Monitor for any further deterioration and repair as required

Finding: The item is slightly loose in its foundations

Action: Monitor for any further deterioration and repair as required

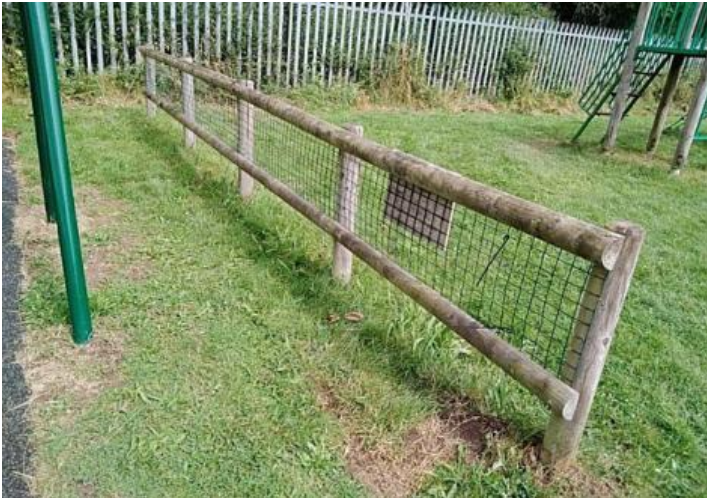
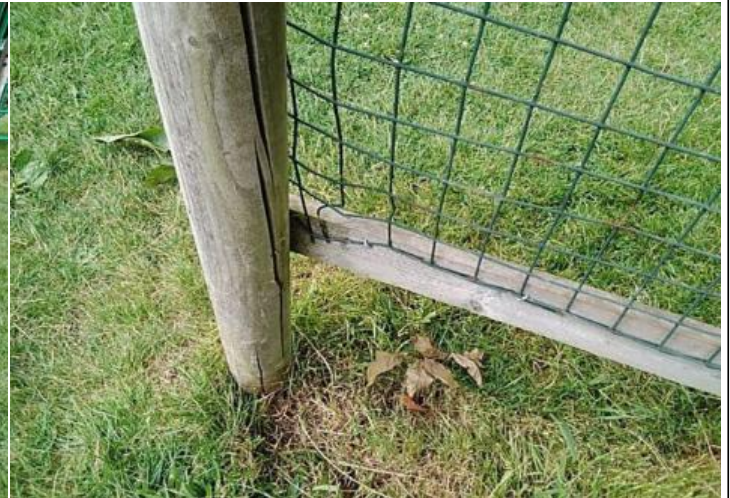
There is some damage to the item - Monitor for any further deterioration and repair as required

Finding: There is some damage to the item

Action: Monitor for any further deterioration and repair as required

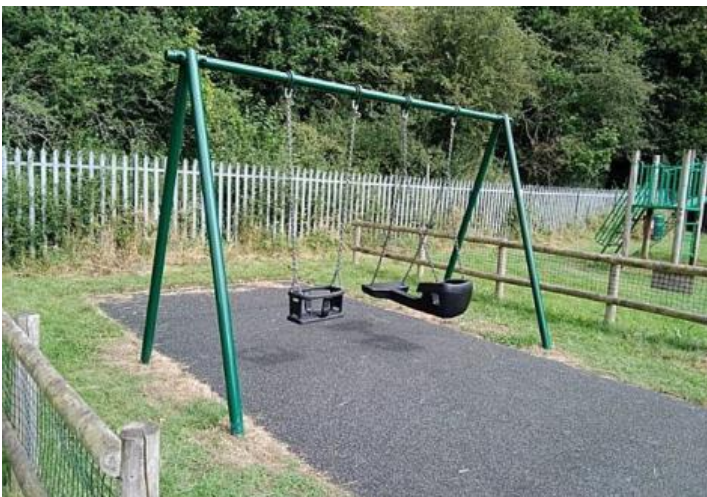
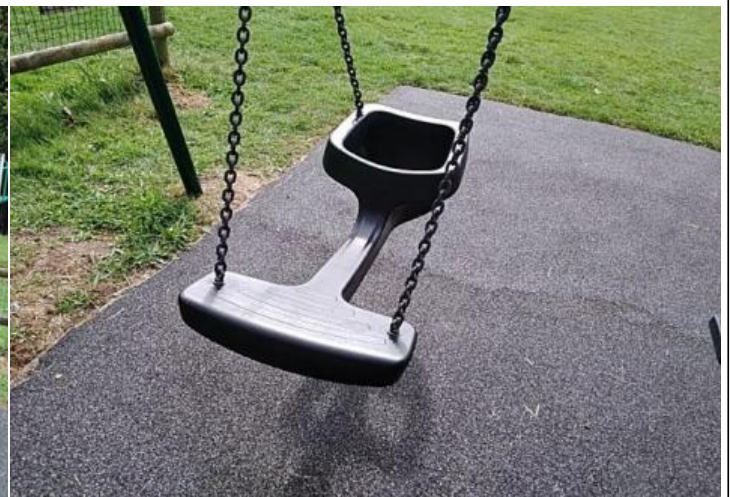
The swing seat connectors are loose - Tighten to secure

Finding: The swing seat connectors are loose

Action: Tighten to secure

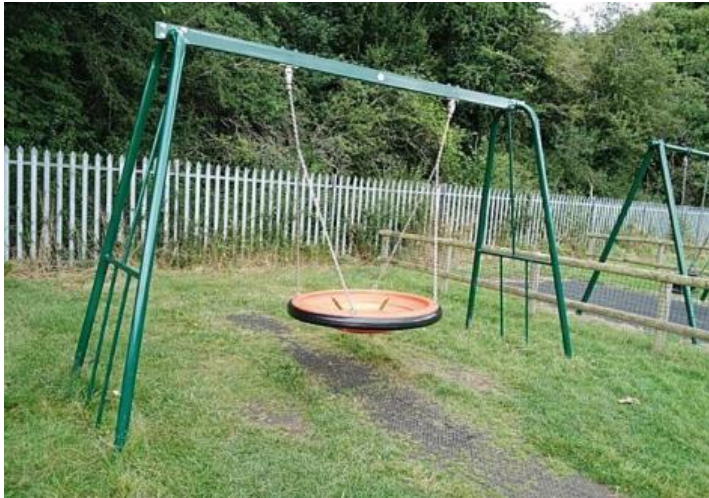
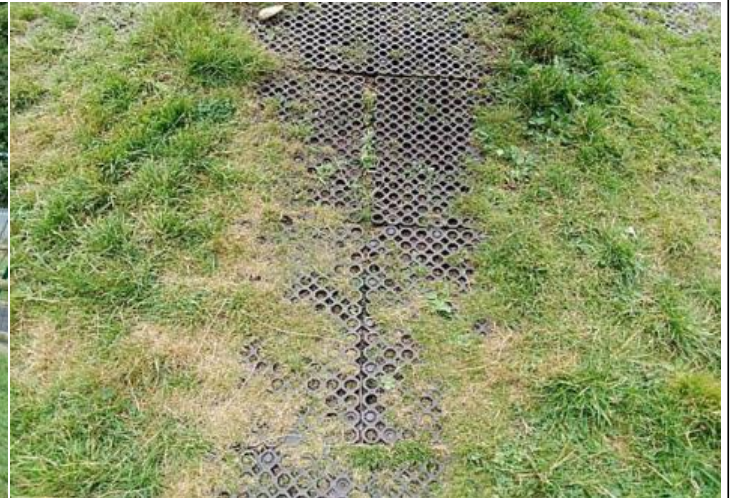
Finding: There are gaps opening between the grass mat tiles

Action: Reinstate surface

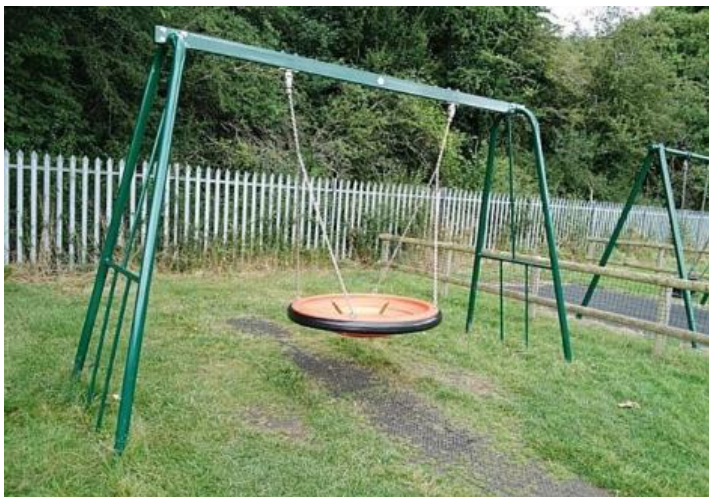
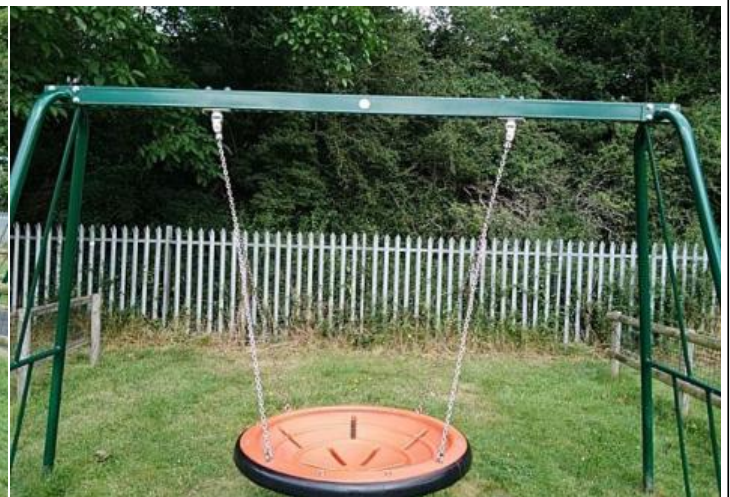
Swings of this design should have a secondary safety device fitted to prevent collapse of the seat in the event of a joint failure to meet the requirements of BS EN 1176 Part 2 - Consider providing a secondary safety device where possible

Finding: Swings of this design should have a secondary safety device fitted to prevent collapse of the seat in the event of a joint failure to meet the requirements of BS EN 1176 Part 2

Action: Consider providing a secondary safety device where possible

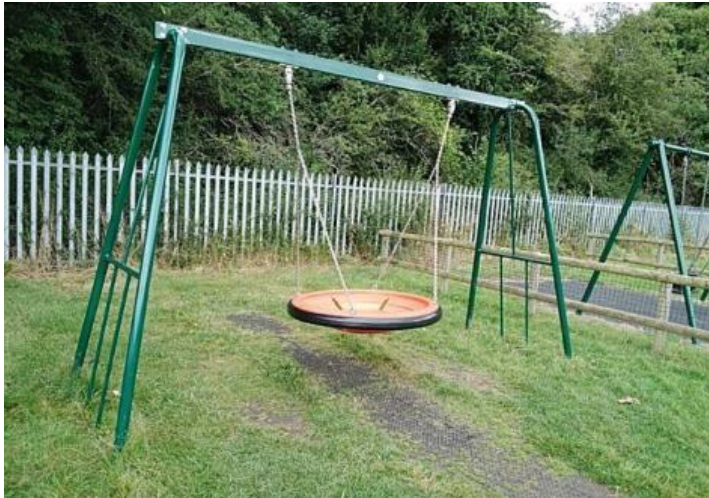
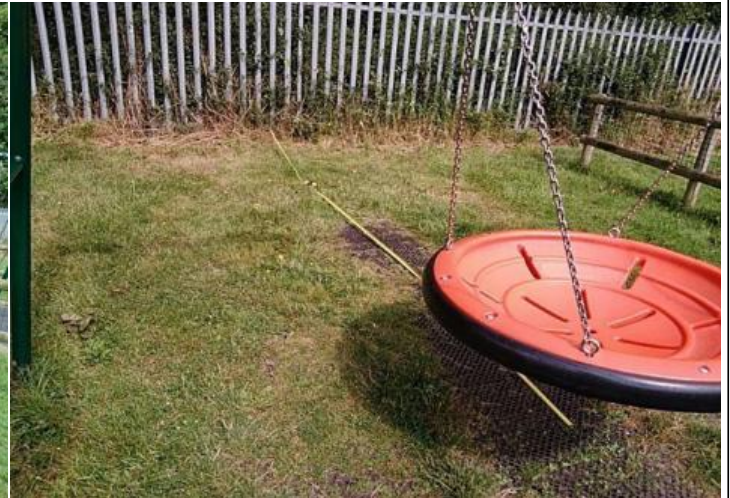
BS EN 1176 Part 2: Annex A makes a recommendation that fences or enclosures should be upto 1.50m from the edges of the swing seat to the sides, and subject to risk assessment, from the edge of the impact area. This is however, a low risk finding and no remedial action is recommended. - Monitor - No remedial work recommended

Finding: BS EN 1176 Part 2: Annex A makes a recommendation that fences or enclosures should be upto 1.50m from the edges of the swing seat to the sides, and subject to risk assessment, from the edge of the impact area. This is however, a low risk finding and no remedial action is recommended.

Action: Monitor - No remedial work recommended

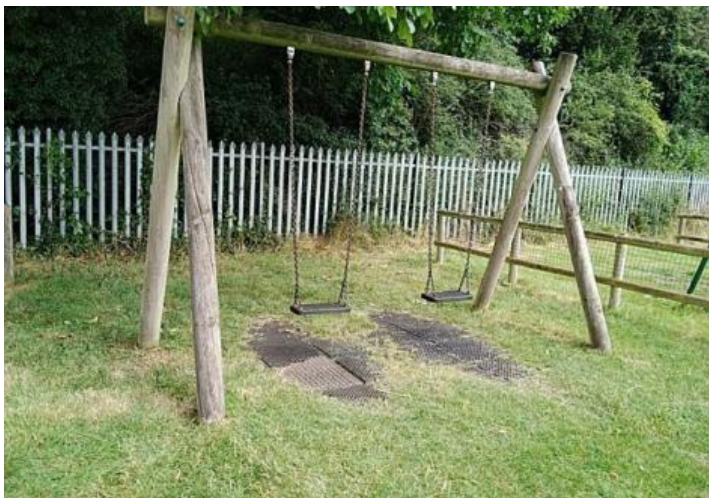
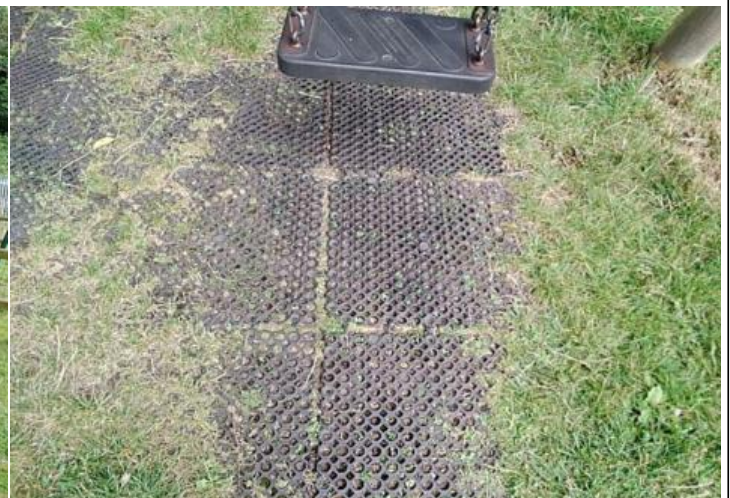
Finding: There are gaps opening between the grass mat tiles

Action: Reinstate surface

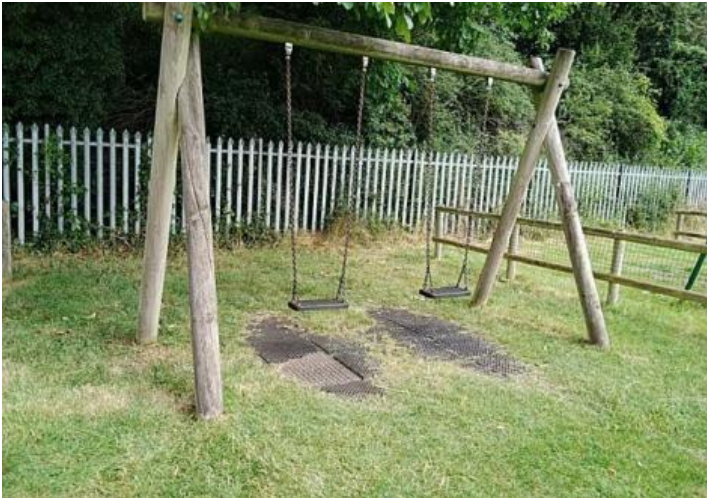
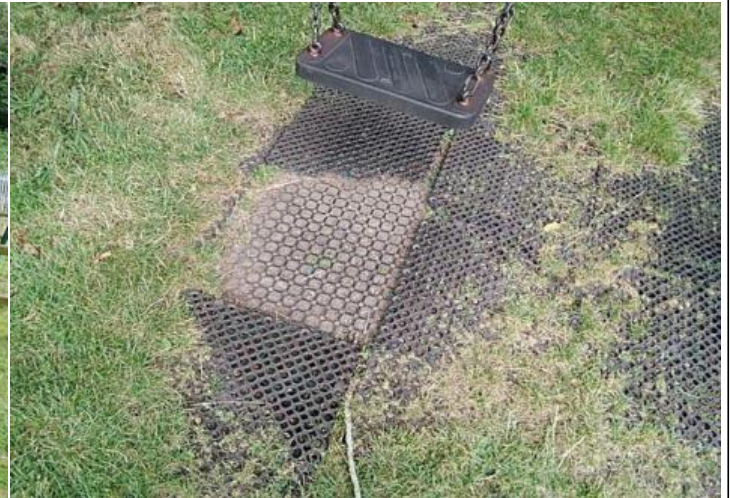
There is moderate damage to the surface - Repair the damaged areas of surfacing

Finding: There is moderate damage to the surface

Action: Repair the damaged areas of surfacing

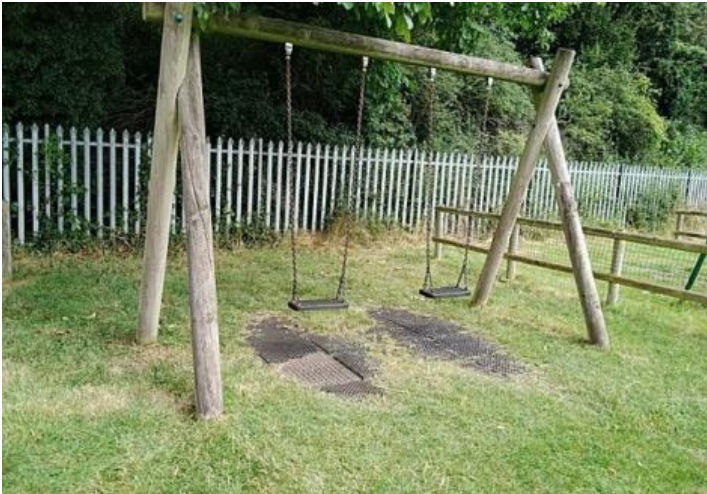
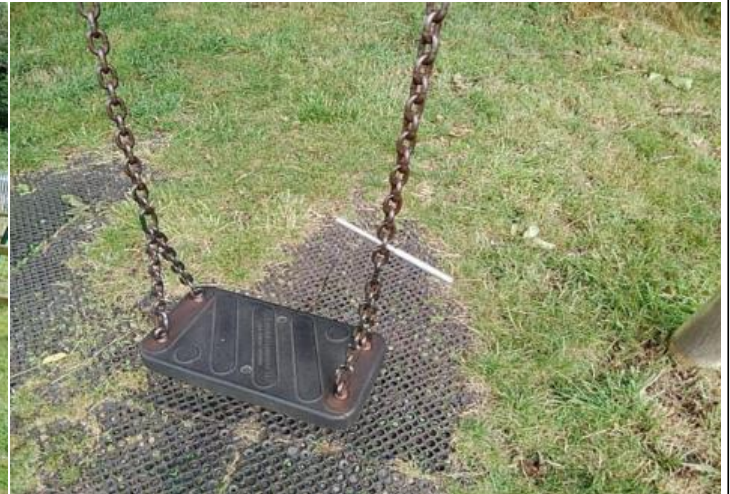
The chain openings are in excess of 8.6mm and do not meet the recommendations of BS EN 1176 Part 1 - Monitor - No remedial work recommended

Finding: The chain openings are in excess of 8.6mm and do not meet the recommendations of BS EN 1176 Part 1

Action: Monitor - No remedial work recommended

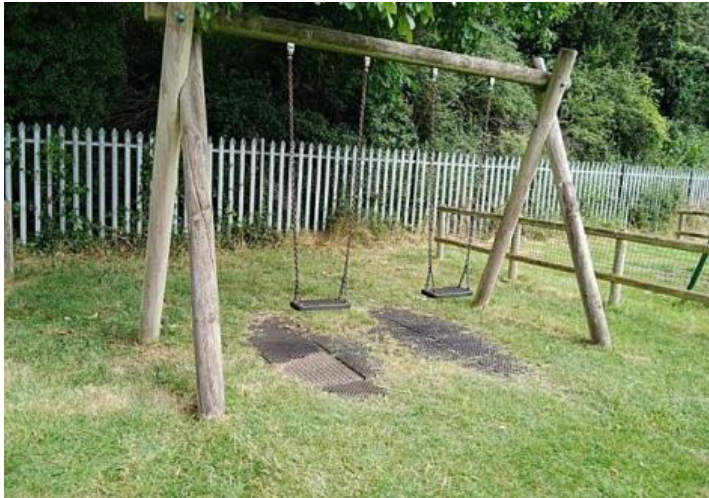
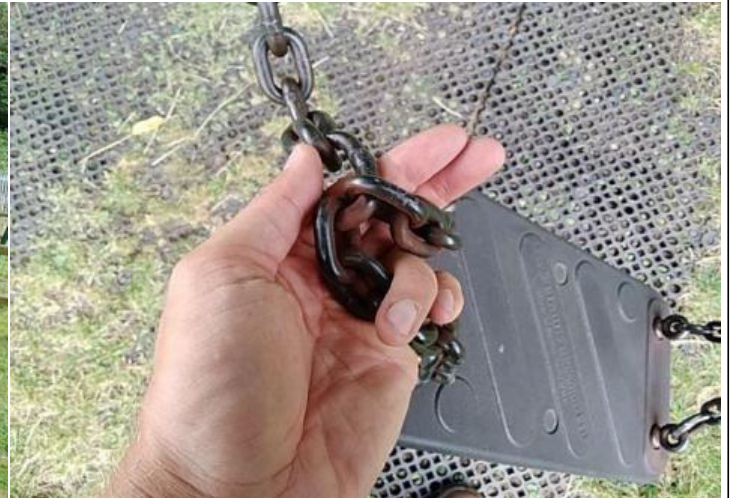
There is some notable evidence of chain wear - Monitor for any further deterioration and replace when 40% worn

Finding: There is some notable evidence of chain wear

Action: Monitor for any further deterioration and replace when 40% worn

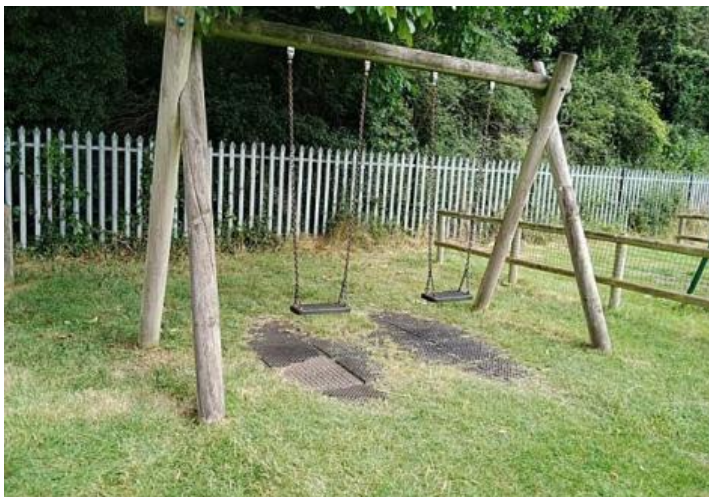
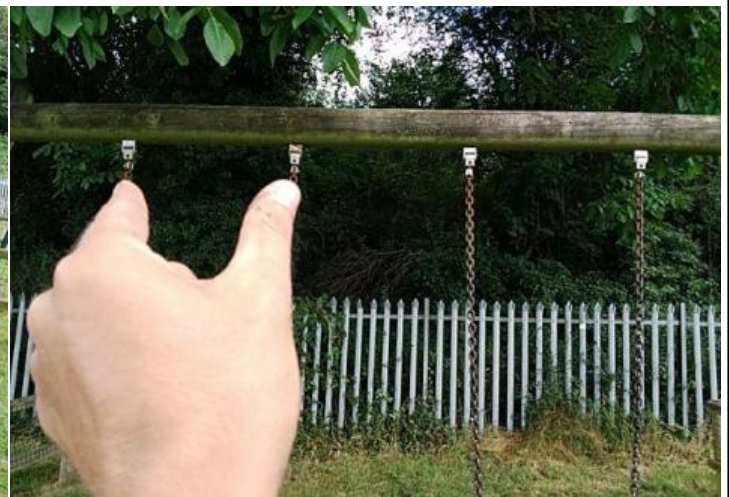
A number of fixing(s) have worked loose - Secure all loose fixings

Finding: A number of fixing(s) have worked loose

Action: Secure all loose fixings

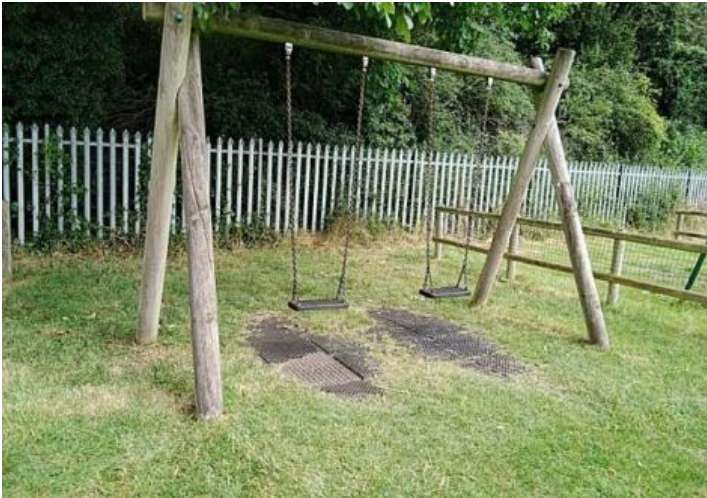
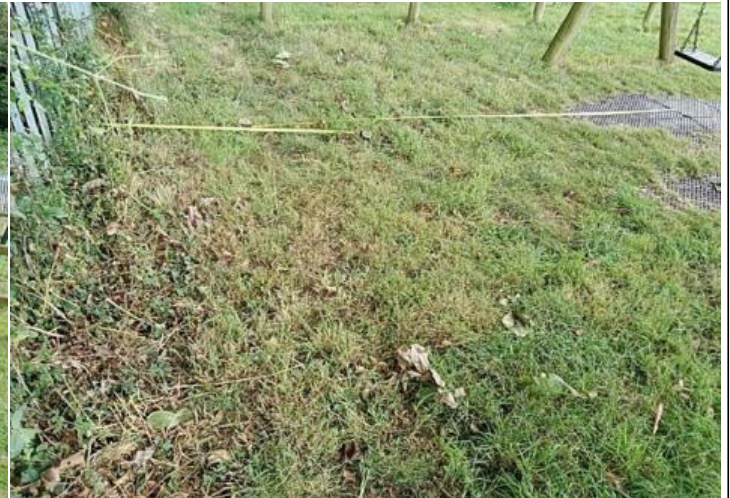
BS EN 1176 Part 2: Annex A makes a recommendation that fences or enclosures should be upto 1.50m from the edges of the swing seat to the sides, and subject to risk assessment, from the edge of the impact area. This is however, a low risk finding and no remedial action is recommended. - Monitor - No remedial work recommended

Finding: BS EN 1176 Part 2: Annex A makes a recommendation that fences or enclosures should be up to 1.50m from the edges of the swing seat to the sides, and subject to risk assessment, from the edge of the impact area. This is however, a low risk finding and no remedial action is recommended.

Action: Monitor - No remedial work recommended

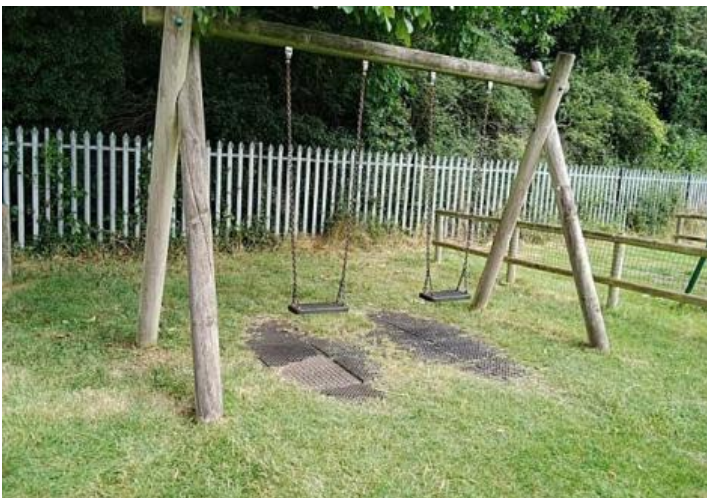
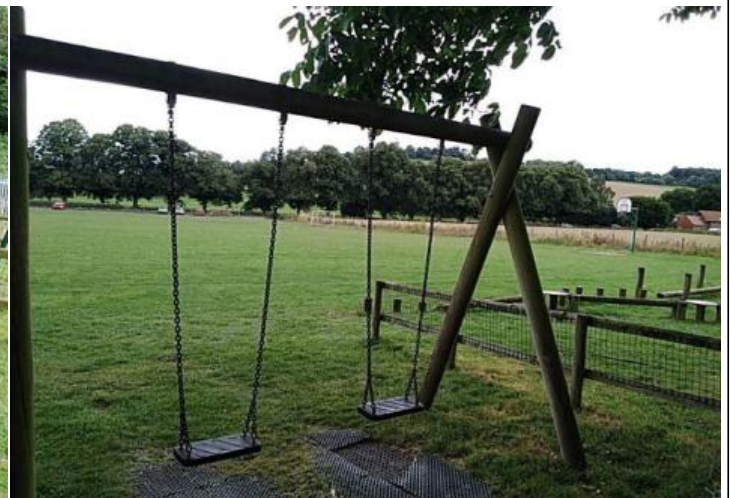
Finding: The tree canopy overhangs the equipment and is less than 2.0m away

Action: Lift tree canopy to ensure a minimum clearance of 2.0m from the equipment

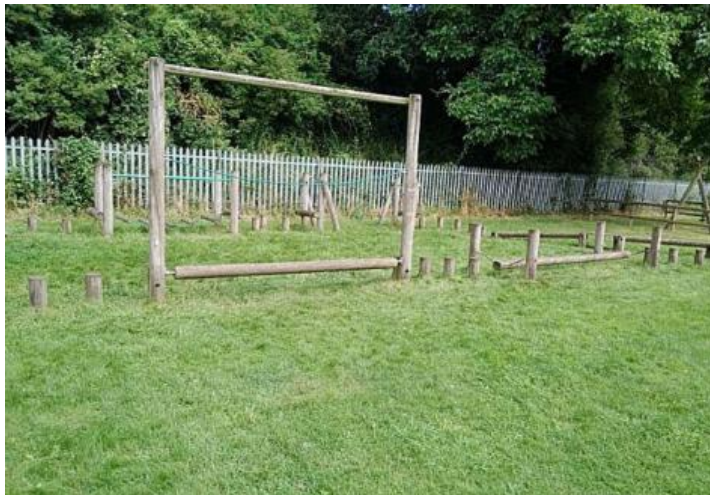
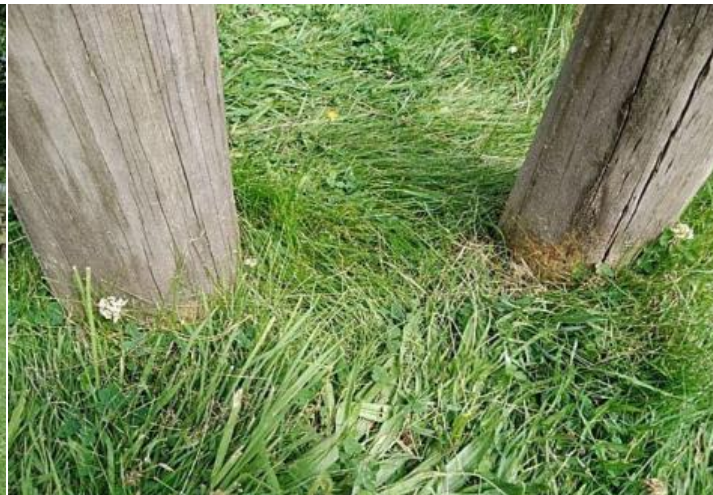
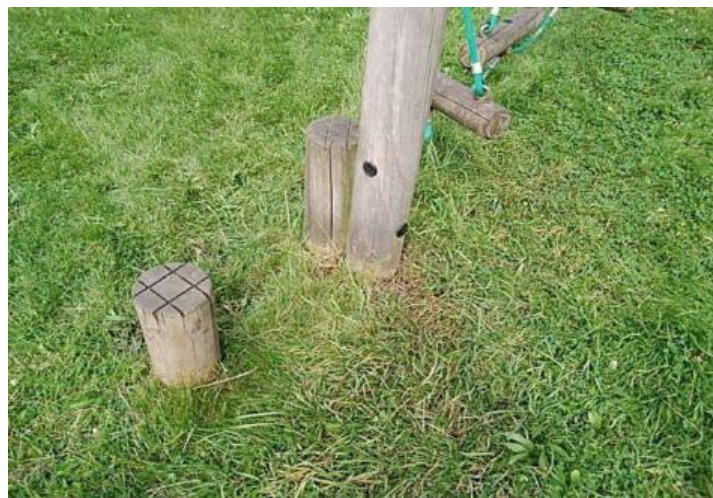
There is some strimmer / machinery damage apparent on the posts, this can penetrate the preservative applied to the timber and accelerate the rotting process - Monitor for any deterioration (rot) and replace as required

Finding: There is some strimmer / machinery damage apparent on the posts, this can penetrate the preservative applied to the timber and accelerate the rotting process

Action: Monitor for any deterioration (rot) and replace as required

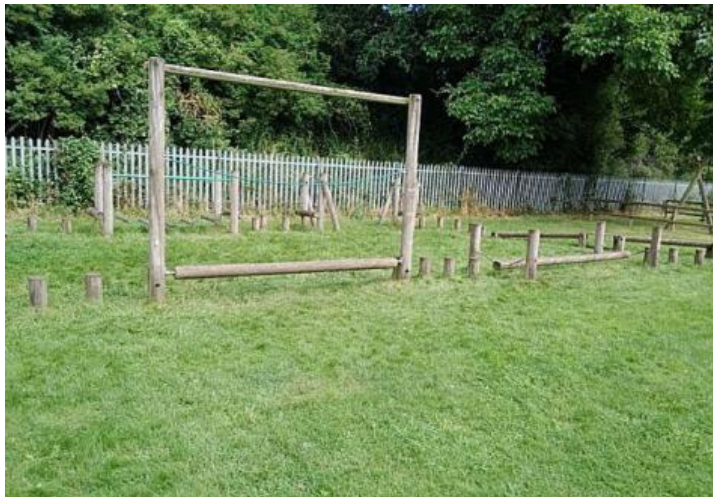
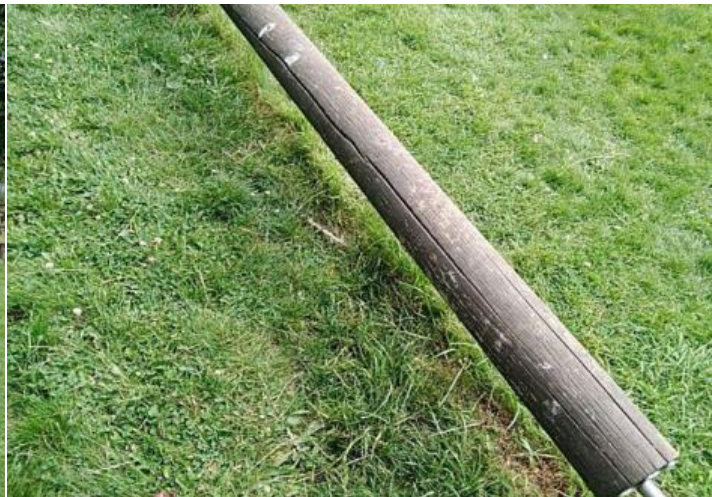
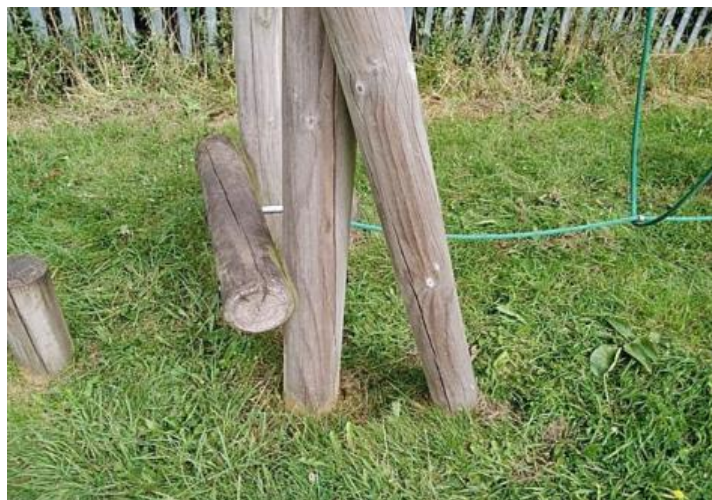
The timber has a number of splits/shakes or air cracks and this may affect the stability or allow water ingress which will accelerate the rotting process - Monitor to ensure the splits do not cross through fixing points of the structure and/or cause any instability

Finding: The timber has a number of splits/shakes or air cracks and this may affect the stability or allow water ingress which will accelerate the rotting process

Action: Monitor to ensure the splits do not cross through fixing points of the structure and/or cause any instability

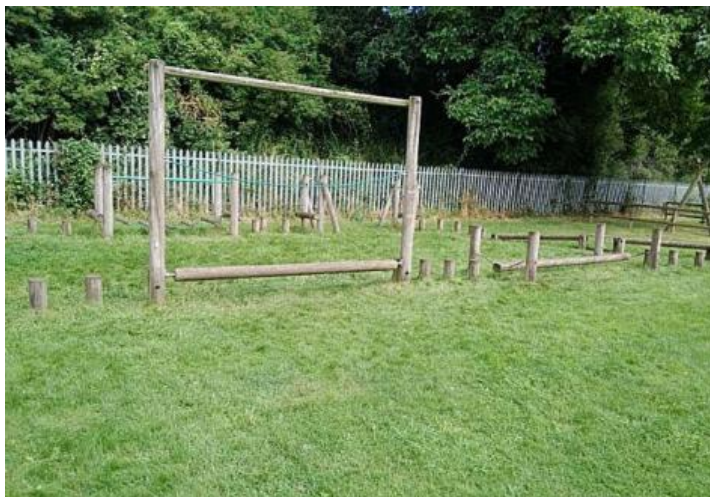
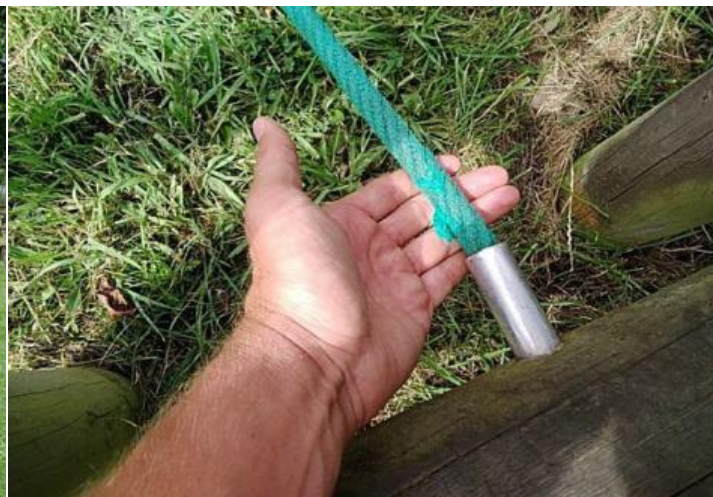
The ropes/nets are worn/damaged in places - Monitor for any further deterioration and repair or replace as required

Finding: The ropes/nets are worn/damaged in places

Action: Monitor for any further deterioration and repair or replace as required

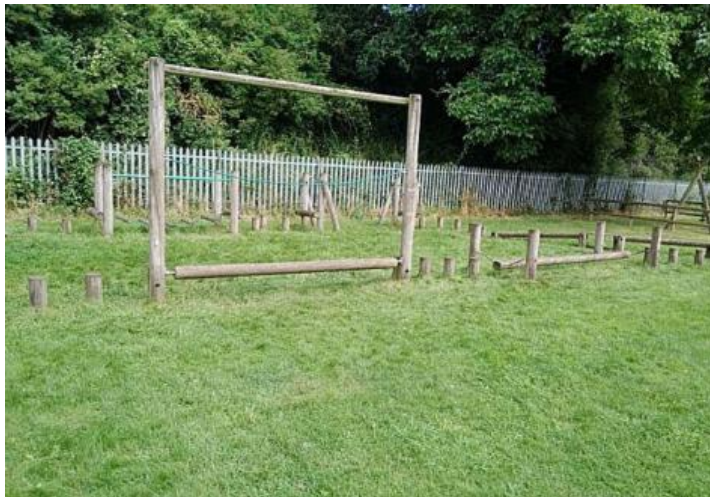
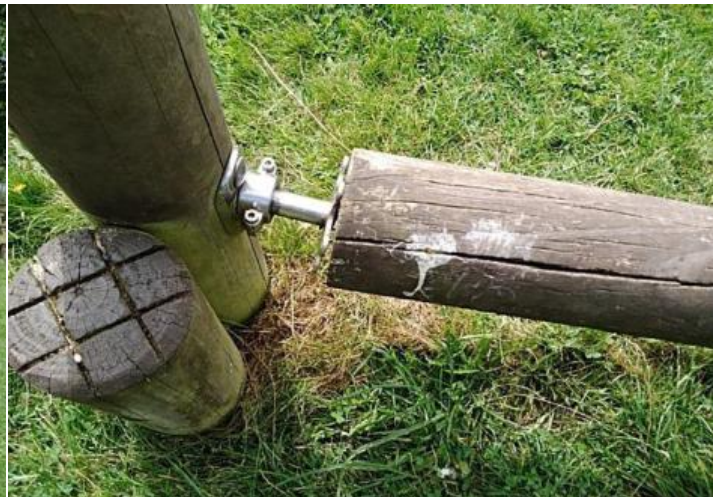
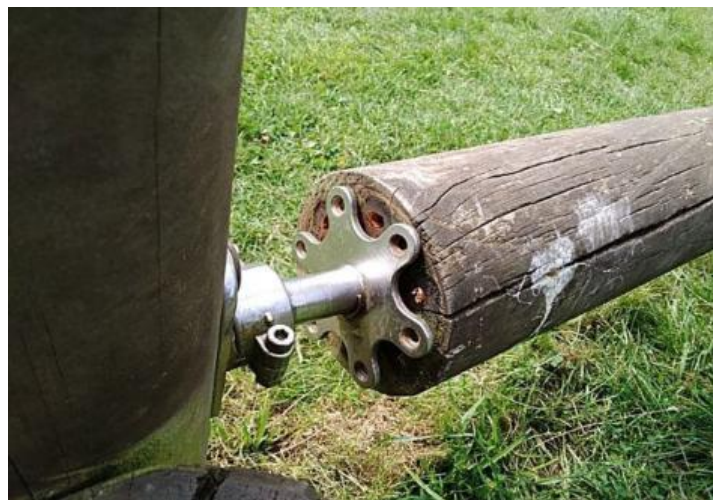
A number of fixing(s) have worked loose - Secure all loose fixings

Finding: A number of fixing(s) have worked loose

Action: Secure all loose fixings

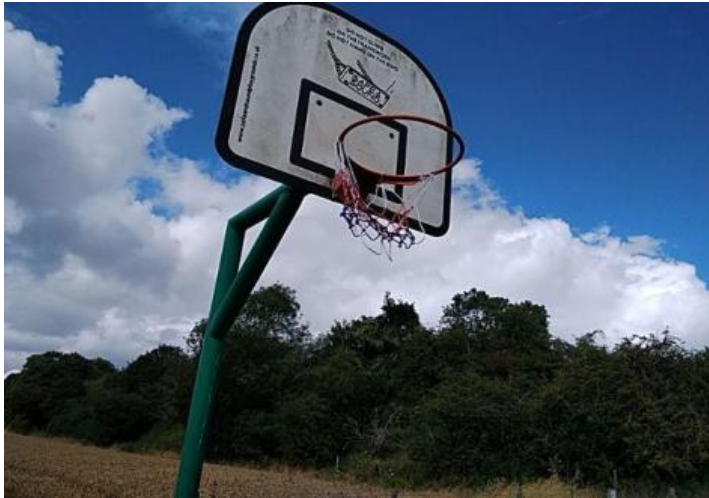
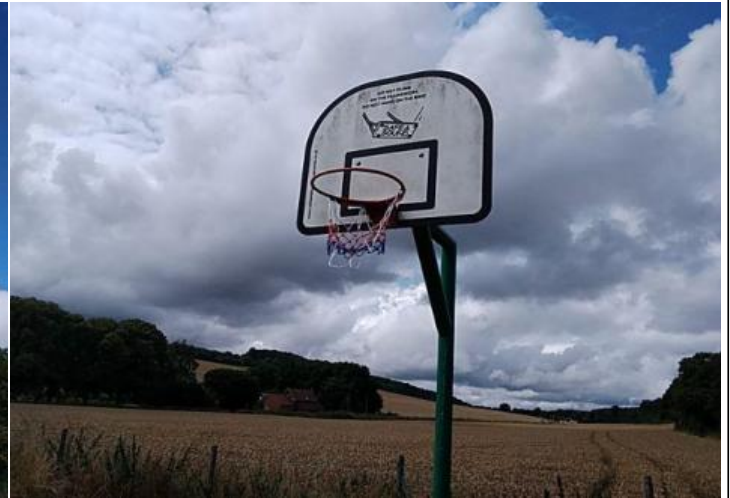
There is some damage to the net - Repair or replace

Finding: There is some damage to the net

Action: Repair or replace

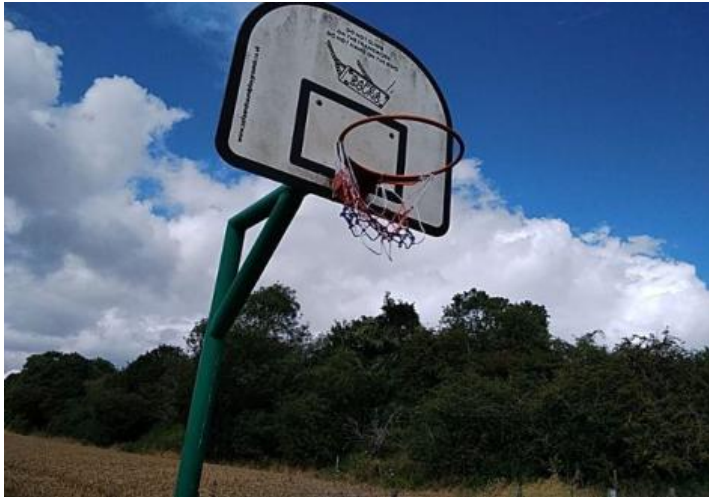
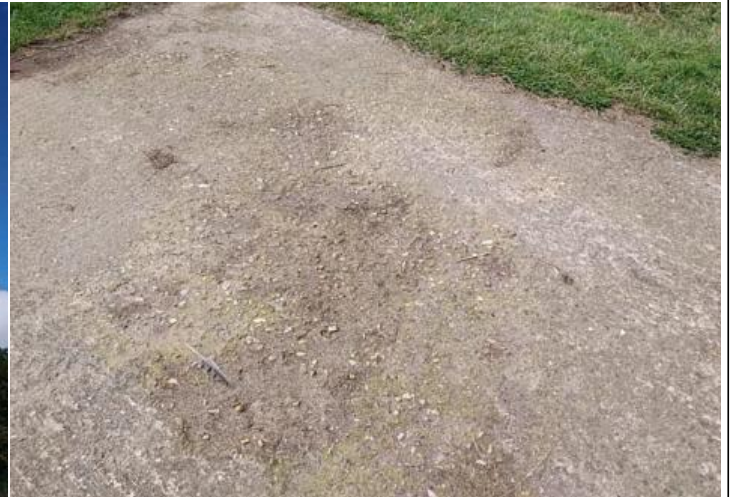
There is some minor damage to the surface - Monitor for any further deterioration and repair as required

Finding: There is some minor damage to the surface

Action: Monitor for any further deterioration and repair as required
