the play inspection company

Annual Inspection

Buckinghamshire Council High Wycombe

The Pedestal Playing Field

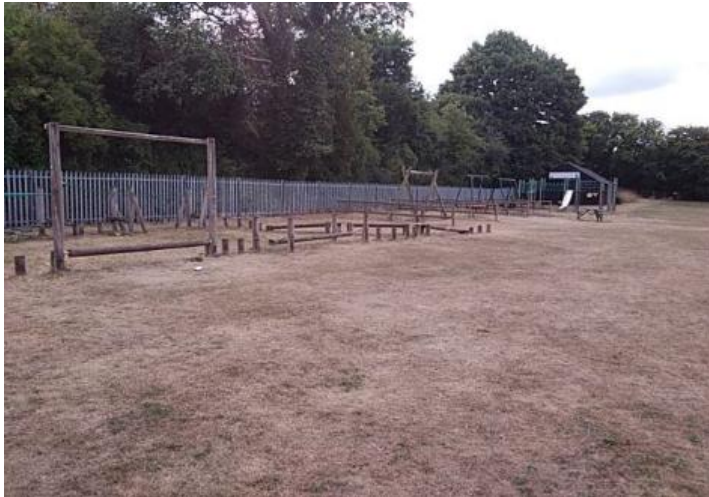
Item: Ancillary Items - Site General
Manufacturer: Owner/Operator

There is some strimmer / machinery damage apparent on the posts, this can penetrate the preservative applied to the timber and accelerate the rotting process - Monitor for any deterioration (rot) and replace as required

Finding: There is some strimmer / machinery damage apparent on the posts, this can penetrate the preservative applied to the timber and accelerate the rotting process

Action: Monitor for any deterioration (rot) and replace as required

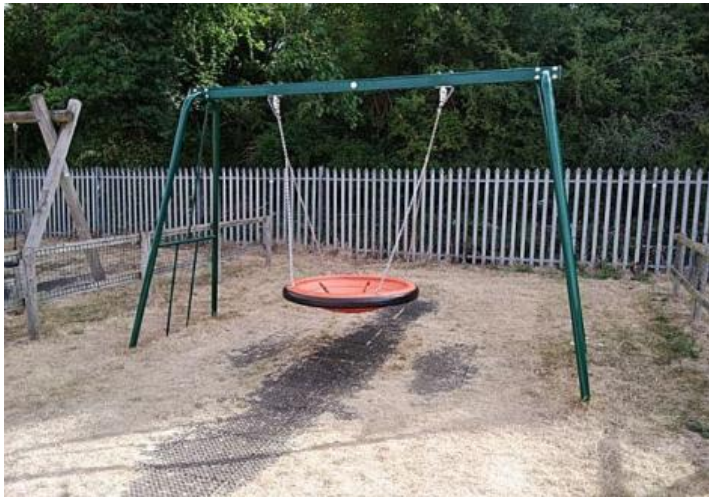
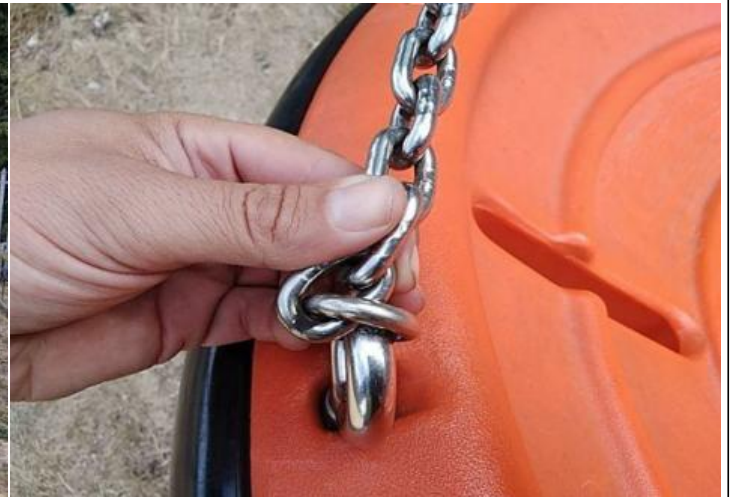
Item: Swings - Basket Swing - Type 1
Manufacturer: Sovereign Leisure

Finding: There is some notable evidence of chain wear

Action: Monitor for any further deterioration and replace when 40% worn

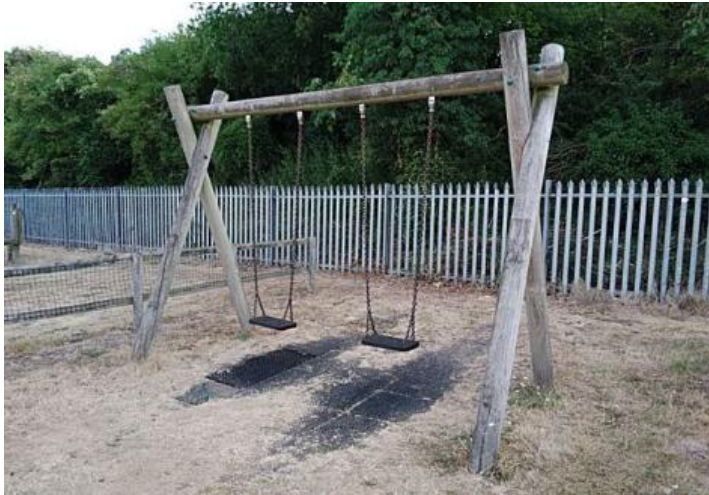
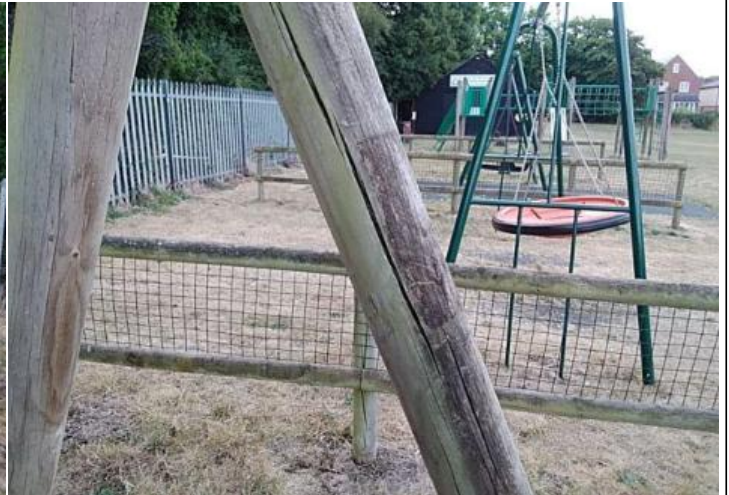
Item: Swings - 1 Bay 2 Seat (Flat)
Manufacturer: Setter Play

Finding: The timber has a number of splits/shakes or air cracks and this may affect the stability or allow water ingress which will accelerate the rotting process

Action: Monitor to ensure the splits do not cross through fixing points of the structure and/or cause any instability

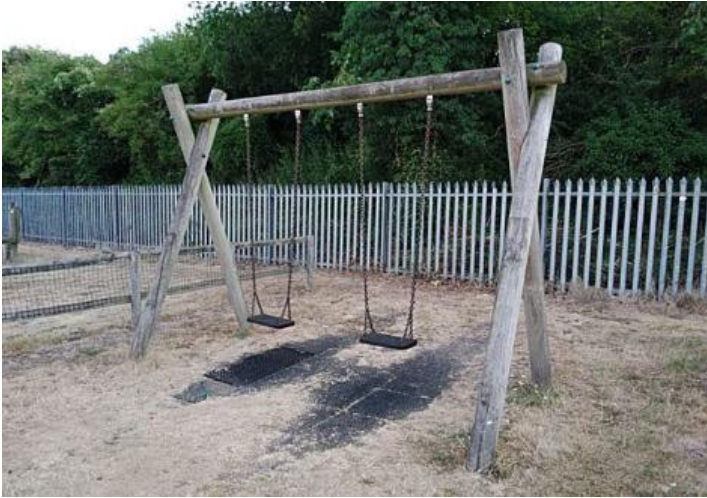
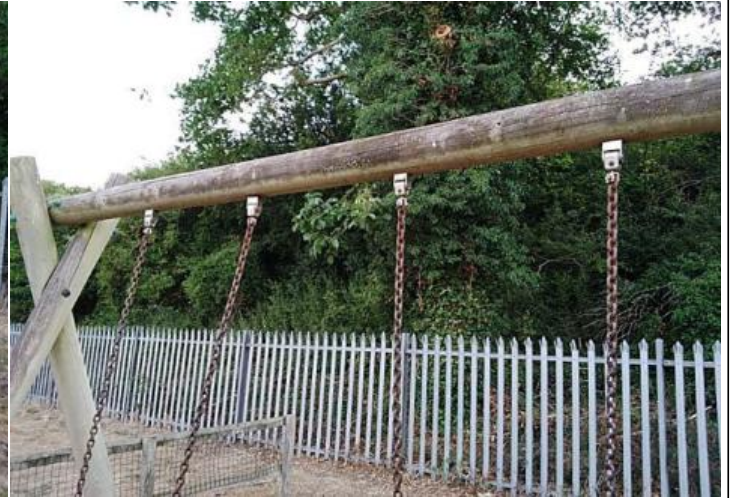
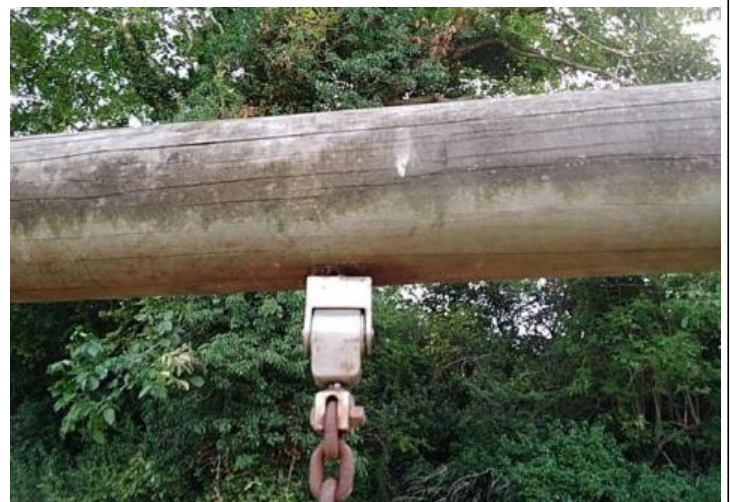
Item: Swings - 1 Bay 2 Seat (Flat)
Manufacturer: Setter Play

A number of suspension fixing(s) have worked loose - Secure all loose fixings

Finding: A number of suspension fixing(s) have worked loose

Action: Secure all loose fixings

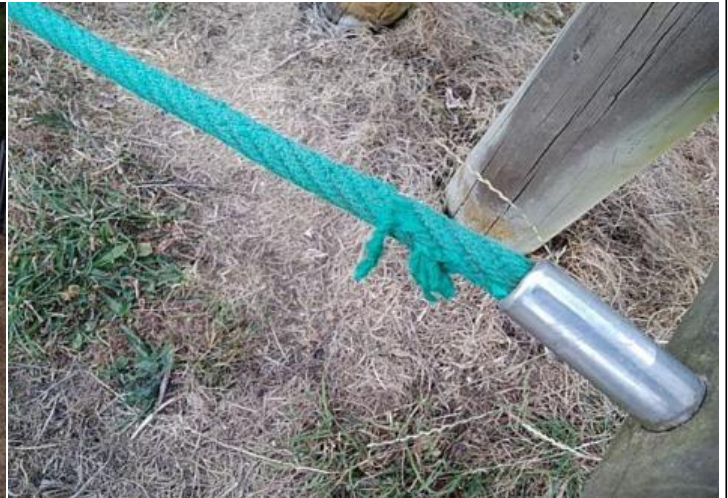
Item: Activity Equipment - Activity Trail
Manufacturer: A.E.Evans

The ropes/nets are worn/damaged in places - Monitor for any further deterioration and repair or replace as required

Finding: The ropes/nets are worn/damaged in places

Action: Monitor for any further deterioration and repair or replace as required

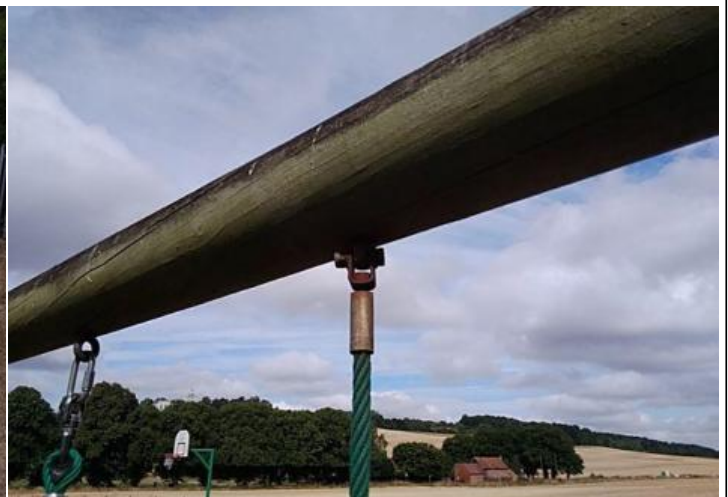
Item: Activity Equipment - Activity Trail
Manufacturer: A.E.Evans

A number of fixing(s) have worked loose on the swinging steps - Secure all loose fixings

Finding: A number of fixing(s) have worked loose on the swinging steps

Action: Secure all loose fixings

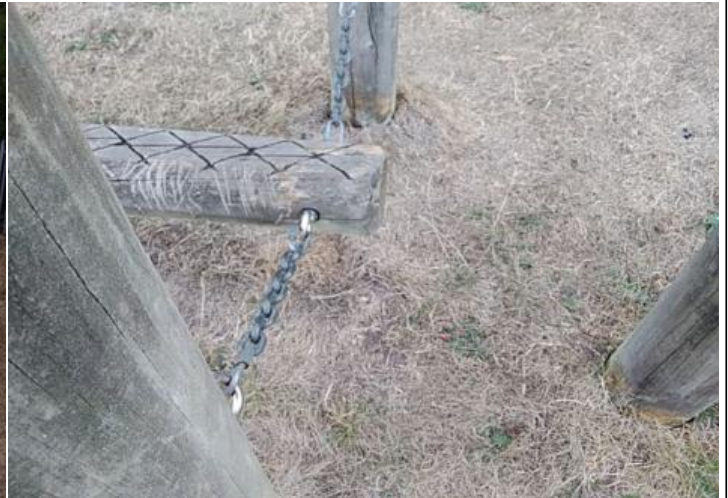
Item: Activity Equipment - Activity Trail
Manufacturer: A.E.Evans

The ends of the beams do not have a minimum radius of 50mm as recommended in BS EN 1176 Part 1 - Monitor - no remedial action recommended

Finding: The ends of the beams do not have a minimum radius of 50mm as recommended in BS EN 1176 Part 1

Action: Monitor - no remedial action recommended

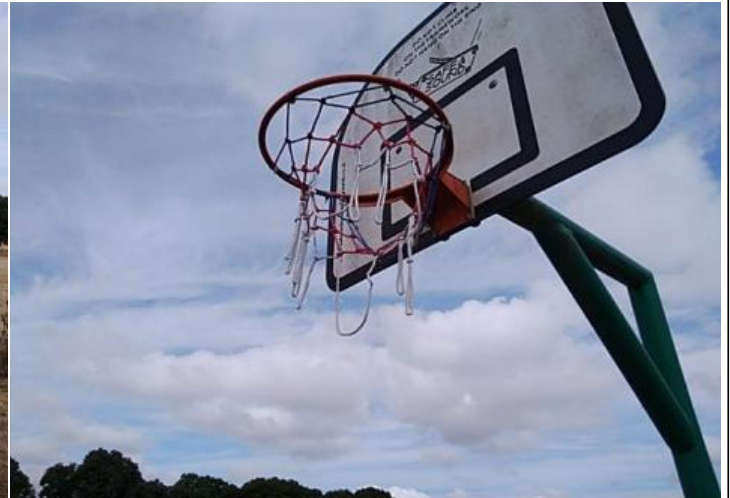
Item: Multi Use Games Area - Basketball Post
Manufacturer: Safe & Sound

There is some damage to the net - Repair or replace

Finding: There is some damage to the net

Action: Repair or replace

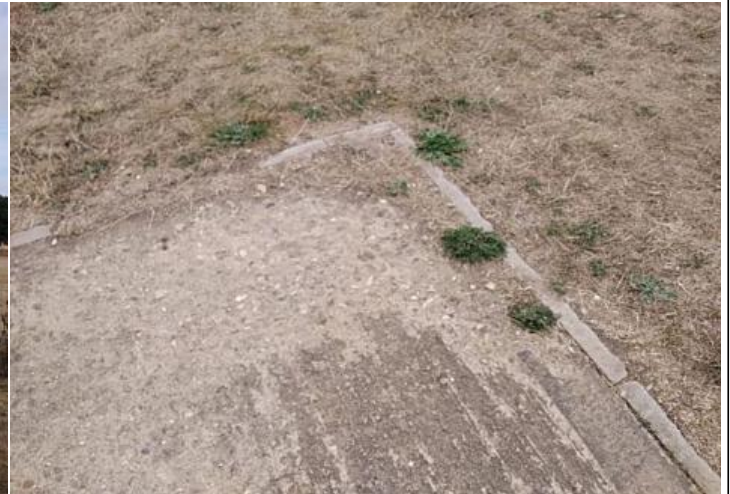
Item: Multi Use Games Area - Basketball Post
Manufacturer: Safe & Sound

There is some minor damage to the surface - Monitor for
any further deterioration and repair as required

Finding: There is some minor damage to the surface

Action: Monitor for any further deterioration and repair as required
