West Wycombe Parish Council

**YOU ARE SUMMONED TO ATTEND A MEETING OF THE PARISH COUNCIL
TO BE HELD ON THURSDAY 10th NOVEMBER 2022 IN THE CHURCH ROOM, WEST WYCOMBE**

AGENDA

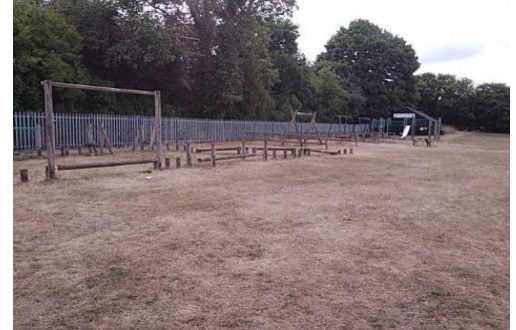
Item: Site General
Manufacturer: Owner/Operator
Surface Type: N/A
Item Quantity: 1
Equipment Compliance: N/A
Surface Area Compliance: N/A

There is some strimmer / machinery damage apparent on the posts, this can penetrate the preservative applied to the timber and accelerate the rotting process - Monitor for any deterioration (rot) and replace as required

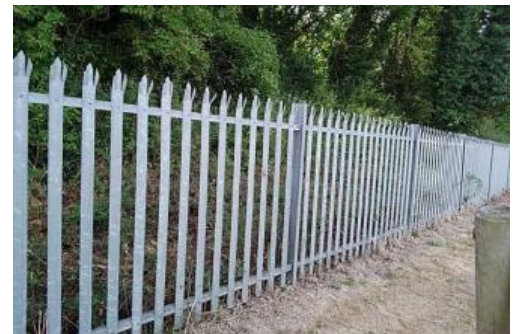
Item: Fence
Manufacturer: Not Identified
Surface Type: Grass
Item Quantity: 1
Equipment Compliance: N/A
Surface Area Compliance: N/A

This item is satisfactory - no work required -

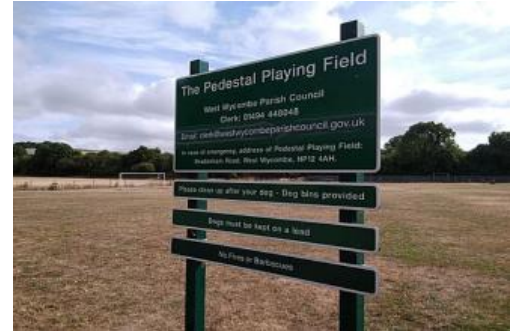
Item: Sign
Manufacturer: Owner/Operator
Surface Type: N/A
Item Quantity: 1
Equipment Compliance: N/A
Surface Area Compliance: N/A

This item is satisfactory - no work required -

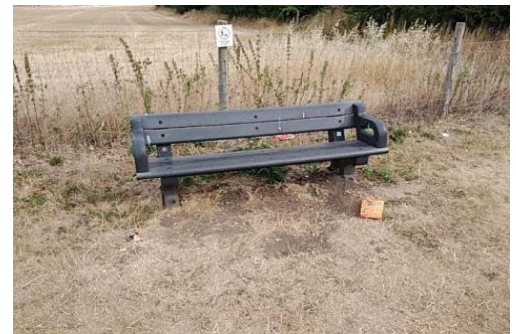
Item: Bench
Manufacturer: Owner/Operator
Surface Type: Paving Slabs
Item Quantity: 2
Equipment Compliance: N/A
Surface Area Compliance: N/A

The area around the item has eroded and may become slippery - Reinstate eroded area

There is some evidence of fire damage to the item - Monitor for any further deterioration and repair as required

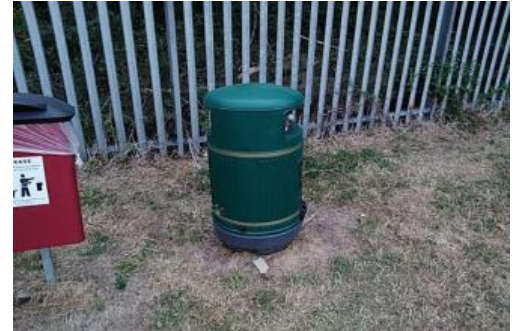
Item: Litter Bin
Manufacturer: Owner/Operator
Surface Type: Grass
Item Quantity: 1
Equipment Compliance: N/A
Surface Area Compliance: N/A

This item is satisfactory - no work required -

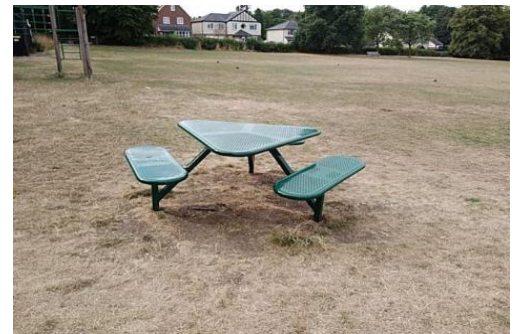
Item: Picnic Table
Manufacturer: Not Identified
Surface Type: Grass
Item Quantity: 1
Equipment Compliance: N/A
Surface Area Compliance: N/A

The area around the item has eroded and may become slippery - Reinstate eroded area

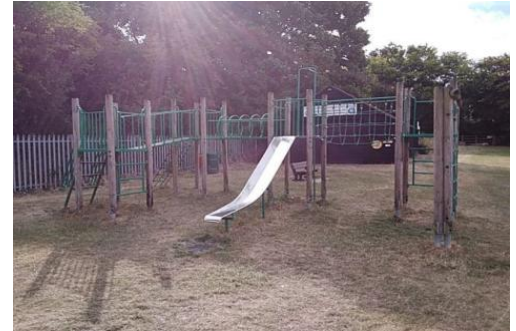
Item: Multi Play (Junior)
Manufacturer: A.E.Evans
Surface Type: Grass Matrix Tiles
Item Quantity: 1
Equipment Compliance: No
Surface Area Compliance: Yes

There are gaps opening between the grass mat tiles - Provide additional ties or secure / reinstate surface

The grass mats are silted up and the soil is compacted; this may have an effect on the impact absorbing properties of the surface - Consider HIC testing impact absorbing properties to ensure the correct surface qualities are maintained for the equipment and replace as required

The timber has a number of splits/shakes or air cracks and this may affect the stability or allow water ingress which will accelerate the rotting process - Monitor to ensure the splits do not cross through fixing points of the structure and/or cause any instability

A number of fixing(s) have worked loose on the rope net - Secure all loose fixings

A number of fixing(s) have worked loose on the access element - Secure all loose fixings

The height of the slide runout is in excess of 350mm and fails the requirements of BS EN 1176: Part 3 - Monitor - No remedial work recommended

There is/are finger entrapment/s in the slide starting section and the item fails to meet the requirements of BS EN 1176 Part 1 4.2.7.6 Entrapment of fingers - Monitor - No remedial work recommended

A number of fixing(s) have worked loose on the rope bridge - Secure all loose fixings

There are areas or parts of the timber rope net crossbeam on the structure that have rotted. Office contacted to inform client - Replace all affected timbers

There is an opening in the barriers exceeding the width allowed (500mm) in BS EN 1176, and no guardrail has been provided; this is a low risk failure and no remedial action is required - Monitor - No remedial work recommended

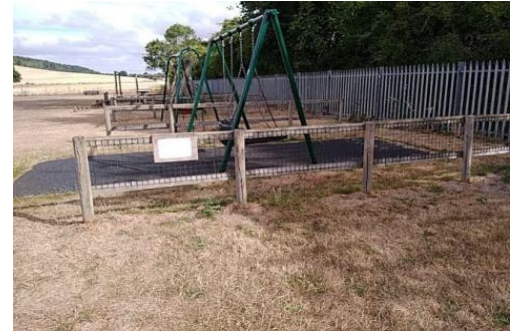
Item: Swing Barrier
Manufacturer: Not Identified
Surface Type: Grass
Item Quantity: 1
Equipment Compliance: N/A
Surface Area Compliance: N/A

The timber has a number of splits/shakes or air cracks and this may affect the stability or allow water ingress which will accelerate the rotting process - Monitor to ensure the splits do not cross through fixing points of the structure and/or cause any instability

The item is slightly loose in its foundations - Monitor for any further deterioration and repair as required

The item has been damaged - Monitor for any further deterioration and replace as required

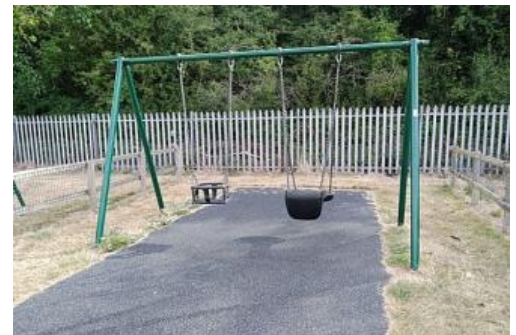
Item: 1 Bay 2 Seat Swing
Manufacturer: Wicksteed Playgrounds
Surface Type: Wet Pour
Item Quantity: 1
Equipment Compliance: Yes
Surface Area Compliance: Yes

This item is satisfactory - no work required -

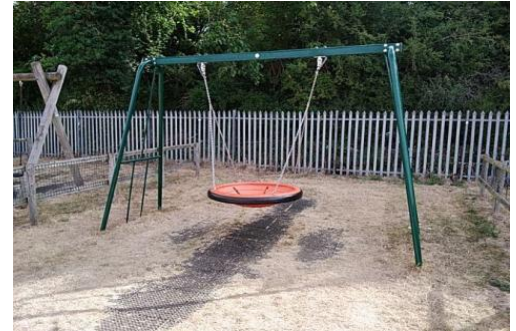
Item: Basket Swing - Type 1
Manufacturer: Sovereign Leisure
Surface Type: Grass Matrix Tiles
Item Quantity: 1
Equipment Compliance: Yes
Surface Area Compliance: Yes

There are gaps opening between the grass mat tiles -
Provide additional ties or secure / reinstate surface

There are caps missing from the underside of the seats -
Replace missing caps under the seats

There is some notable evidence of chain wear - Monitor for
any further deterioration and replace when 40% worn

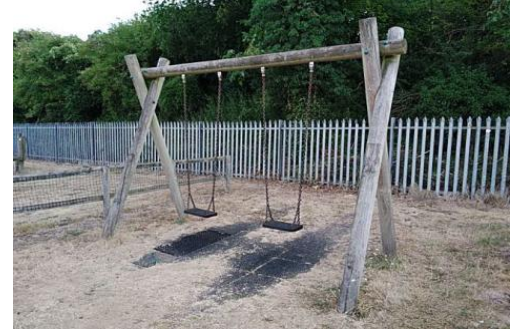
Item: 1 Bay 2 Seat (Flat)
Manufacturer: Setter Play
Surface Type: Grass Matrix Tiles
Item Quantity: 1
Equipment Compliance: No
Surface Area Compliance: Yes

There is moderate damage to the surface - Repair the damaged areas of surfacing

A number of suspension fixing(s) have worked loose - Secure all loose fixings

There is some notable evidence of chain wear - Monitor for any further deterioration and replace when 40% worn

This design of swing joint has been known to fail on the weld connecting the joint to the threaded stud - We would recommend that the joint be dismantled and checked on a regular basis or consulting with manufacturer on whether a Secondary Safety Device can be fitted

The timber has a number of splits/shakes or air cracks and this may affect the stability or allow water ingress which will accelerate the rotting process - Monitor to ensure the splits do not cross through fixing points of the structure and/or cause any instability

The chain openings are in excess of the 8.6mm as recommended by BS EN 1176 - Monitor - No remedial work recommended

The seat has minor damage or wear - Monitor for any further deterioration and replace as required

The inspector has some concerns about the internal condition of the timber crossbeam due to discolouration and was unable to verify the structural integrity without further testing. We recommend a Resi-PD survey to establish the condition of the timber at it's core. - Contact the Play Inspection Company office for further information

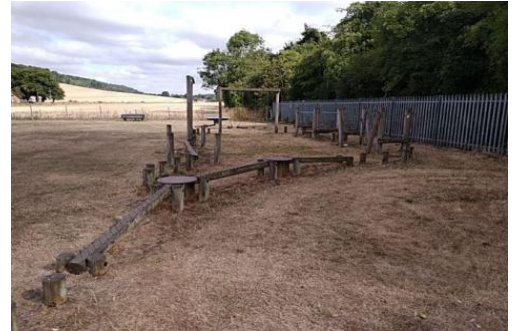
Item: Activity Trail
Manufacturer: A.E.Evans
Surface Type: Grass Matrix Tiles
Item Quantity: 1
Equipment Compliance: Yes
Surface Area Compliance: Yes

The timber has a number of splits/shakes or air cracks and this may affect the stability or allow water ingress which will accelerate the rotting process - Monitor to ensure the splits do not cross through fixing points of the structure and/or cause any instability

A number of fixing(s) have worked loose on the swinging steps - Secure all loose fixings

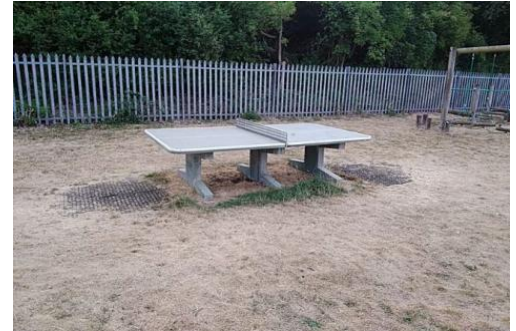
Item: Table Tennis
Manufacturer: Not Identified
Surface Type: Grass Matrix Tiles
Item Quantity: 1
Equipment Compliance: N/A
Surface Area Compliance: N/A

There are gaps opening between the grass mat tiles -
Provide additional ties or secure / reinstate surface

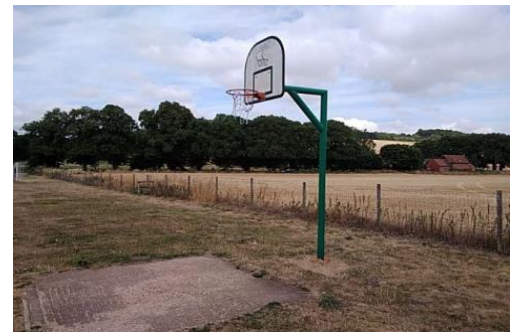
Item: Basketball Post
Manufacturer: Safe & Sound
Surface Type: Grass
Item Quantity: 1
Equipment Compliance: No
Surface Area Compliance: N/A

There is some damage to the net - Repair or replace

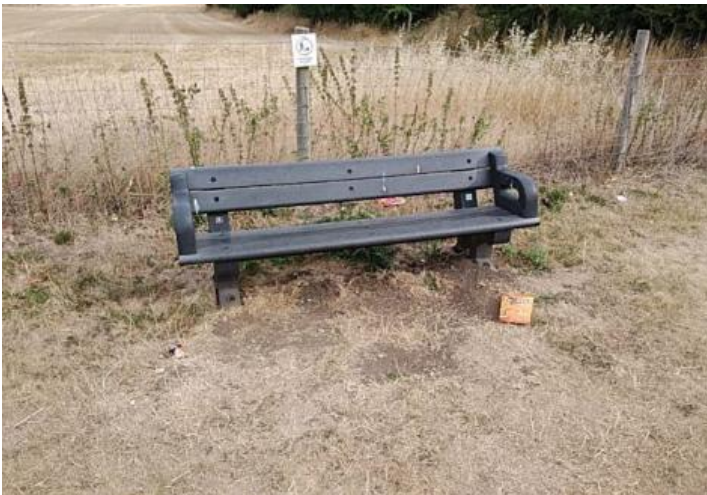
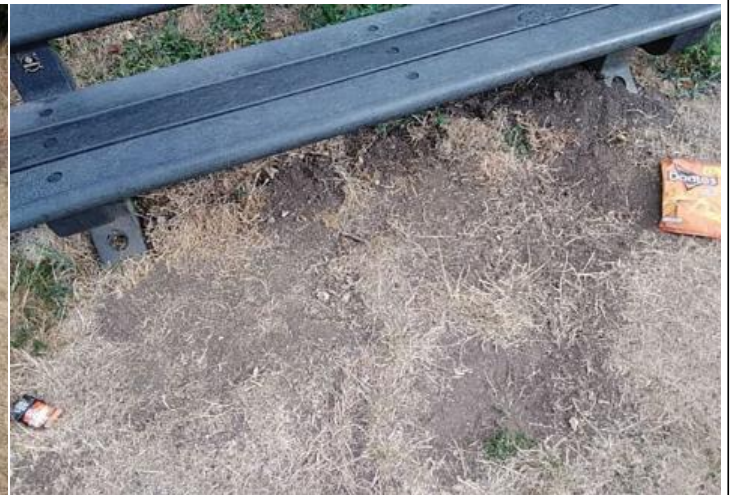
Item: Ancillary Items - Bench
Manufacturer: Owner/Operator

Finding: The area around the item has eroded and may become slippery

Action: Reinstate eroded area

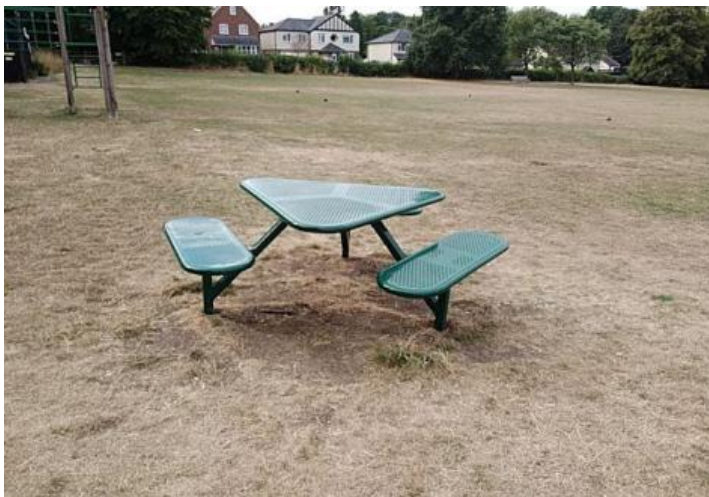
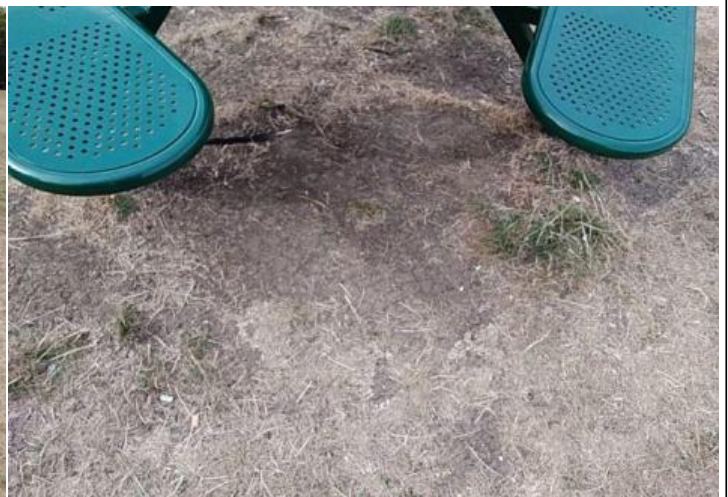
Item: Ancillary Items - Picnic Table
Manufacturer: Not Identified

Finding: The area around the item has eroded and may become slippery **Action:** Reinstate eroded area

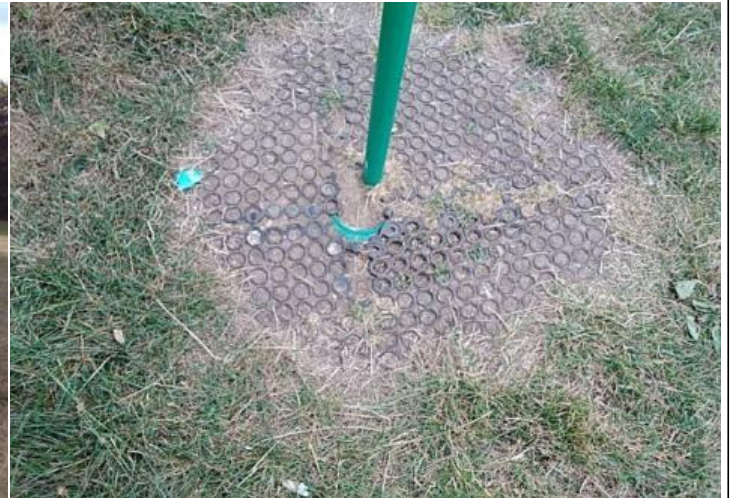
Item: Activity Equipment - Multi Play (Junior)
Manufacturer: A.E.Evans

Finding: There are gaps opening between the grass mat tiles

Action: Provide additional ties or secure / reinstate surface tiles

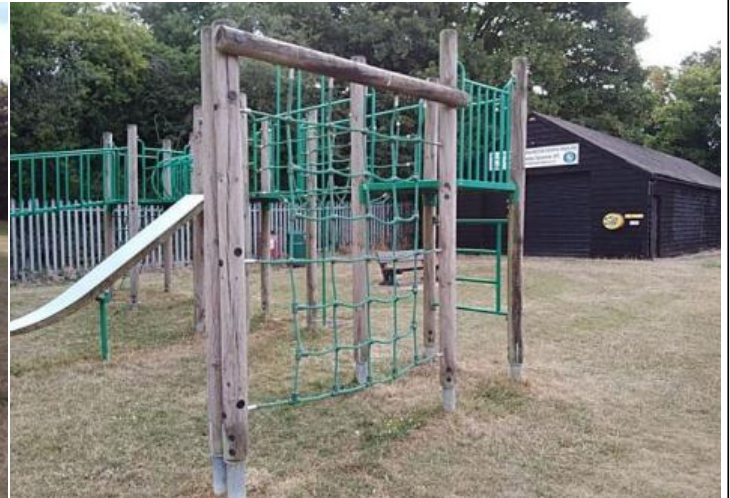
Item: Activity Equipment - Multi Play (Junior)
Manufacturer: A.E.Evans

Finding: This item of equipment has a fall height in excess of 2.5m and grass mats have been installed as an impact absorbing surface; these mats rely heavily on the underlying surface to achieve their critical fall height properties.

Action: Ensure surfacing certification is sought and consider HIC testing to ensure the surfacing is performing adequately

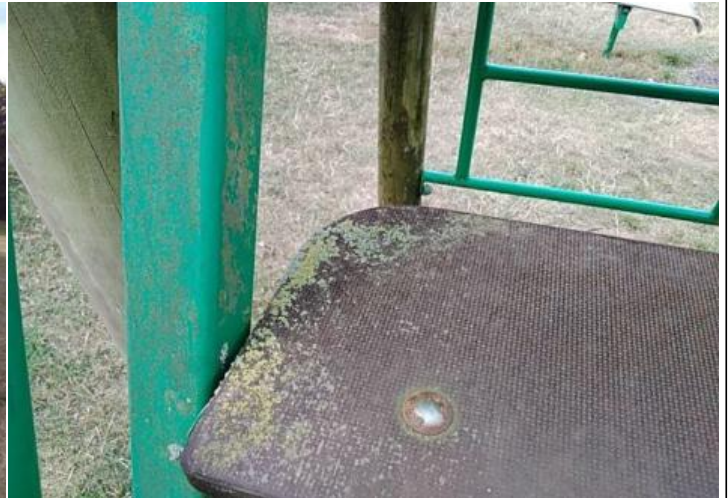
Item: Activity Equipment - Multi Play (Junior)
Manufacturer: A.E.Evans

Finding: There is algae or moss on the surface of the equipment

Action: Clean and treat appropriately

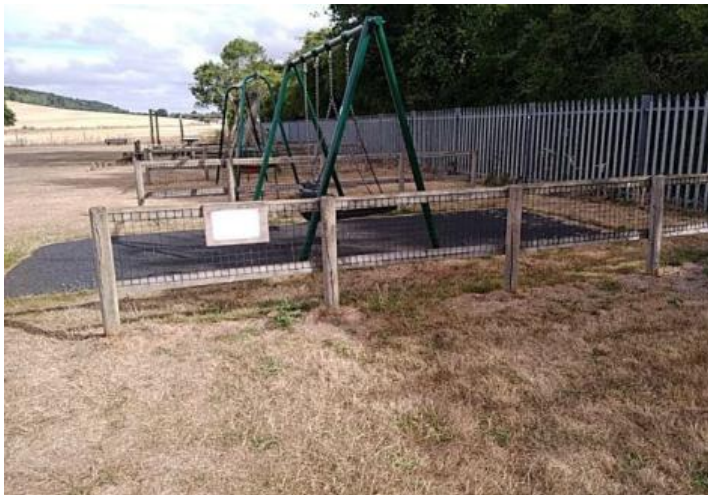
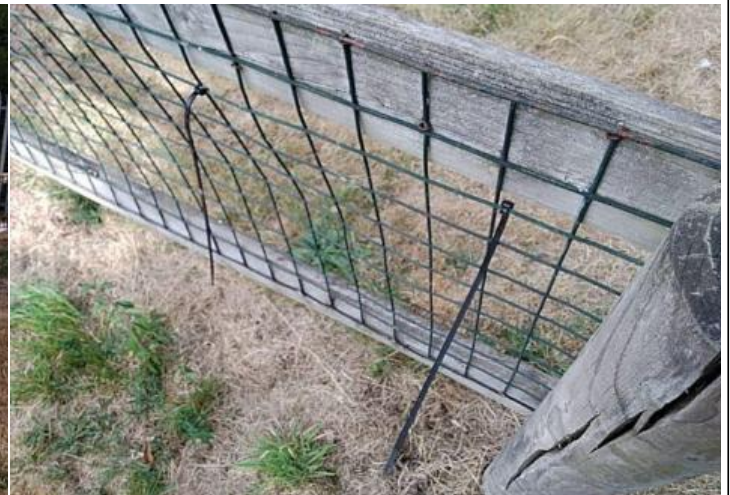
Item: Swings - Swing Barrier
Manufacturer: Not Identified

Finding: There are cable ties attached
Action: Remove

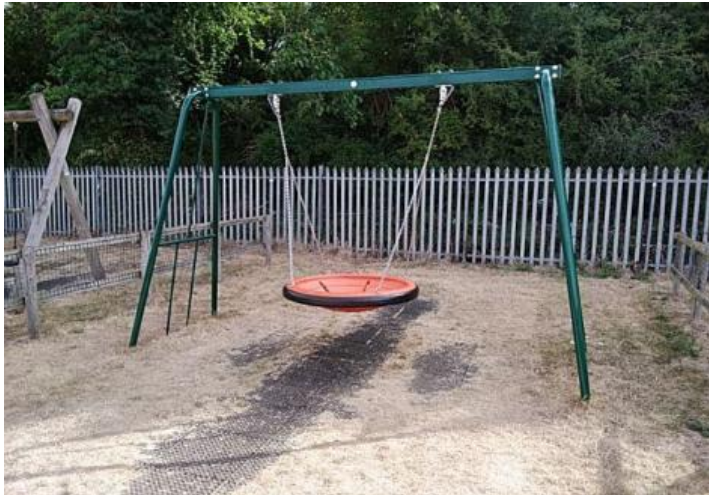
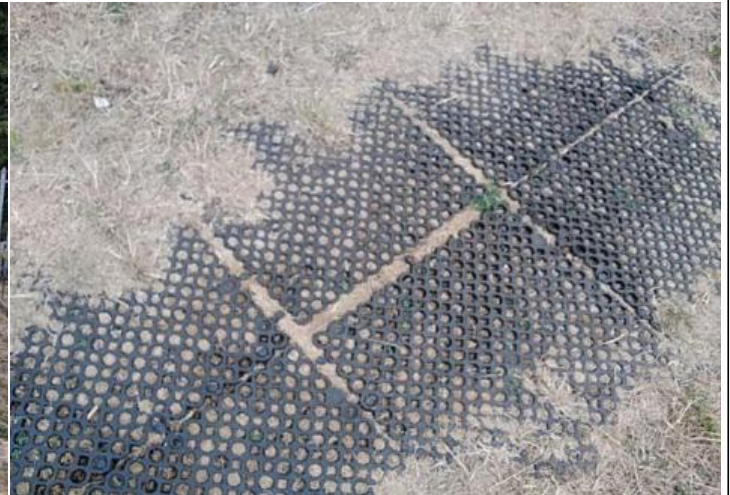
Item: Swings - Basket Swing - Type 1
Manufacturer: Sovereign Leisure

Finding: There are gaps opening between the grass mat tiles

Action: Provide additional ties or secure / reinstate surface

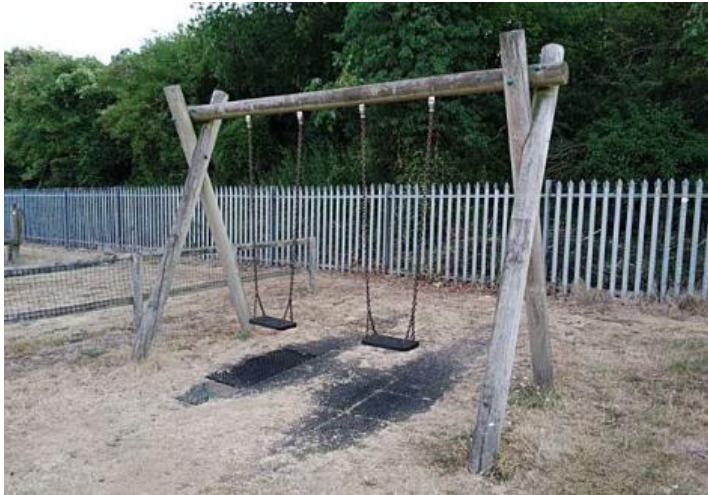
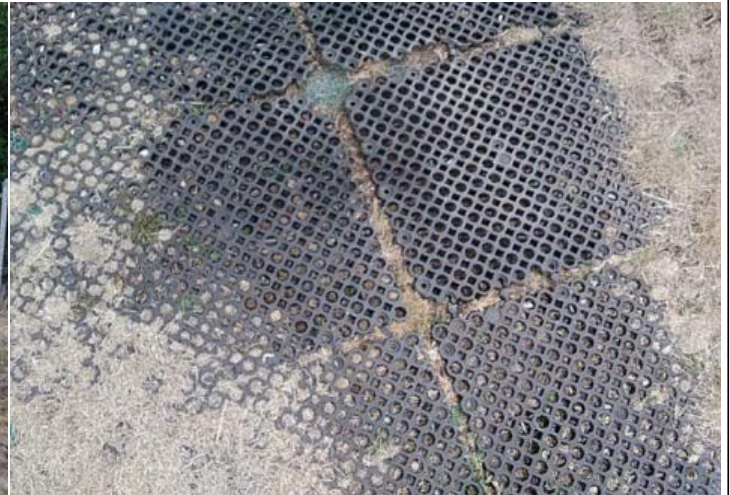
Item: Swings - 1 Bay 2 Seat (Flat)
Manufacturer: Setter Play

Finding: There are gaps opening between the grass mat tiles

Action: Provide additional ties or secure / reinstate surface

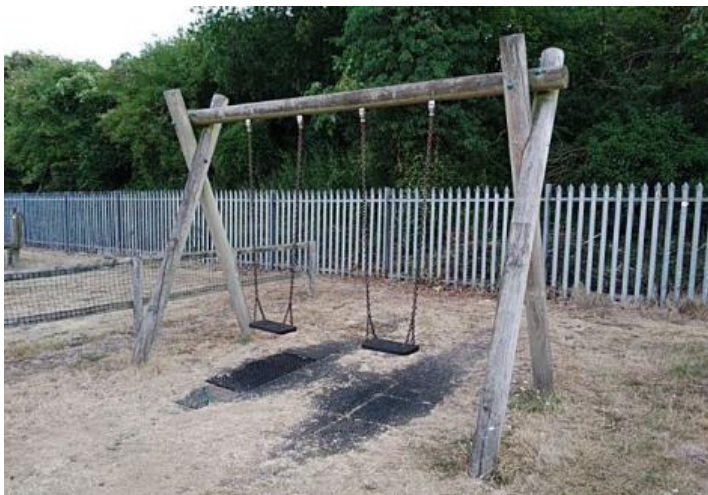
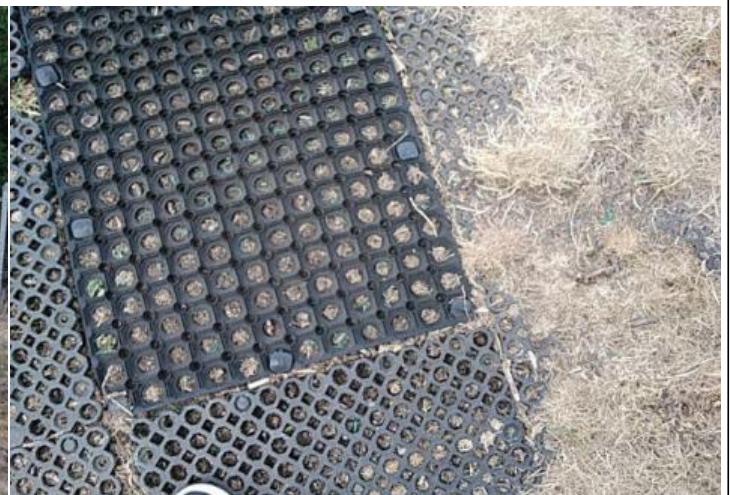
Item: Swings - 1 Bay 2 Seat (Flat)
Manufacturer: Setter Play

Finding: Fixing Pins have been installed in the impact areas of the grass mats

Action: Remove pins from impact areas

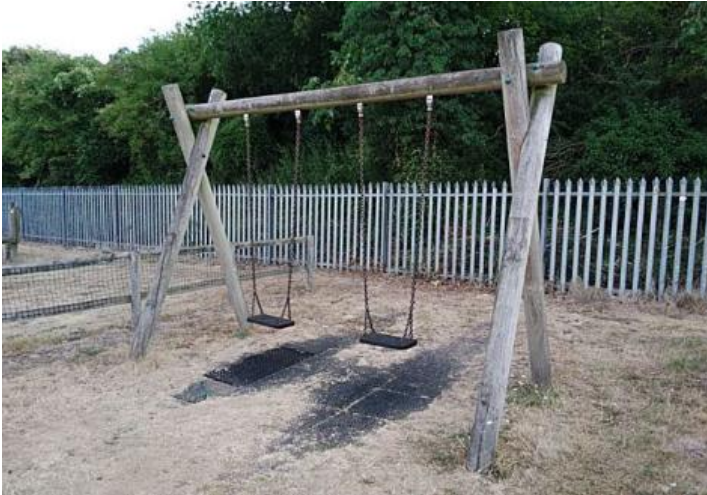
Item: Swings - 1 Bay 2 Seat (Flat)
Manufacturer: Setter Play

Finding: A number of suspension fixing(s) have worked loose

Action: Secure all loose fixings

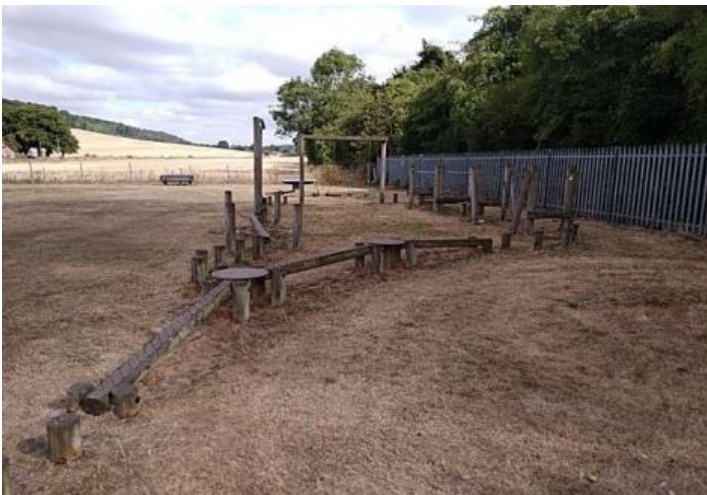
Item: Activity Equipment - Activity Trail
Manufacturer: A.E.Evans

Finding: The timber has a number of splits/shakes or air cracks and this may affect the stability or allow water ingress which will accelerate the rotting process

Action: Monitor to ensure the splits do not cross through fixing points of the structure and/or cause any instability

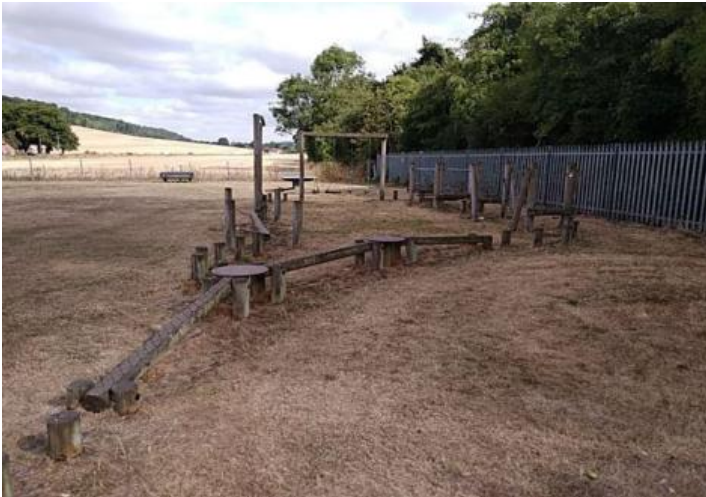
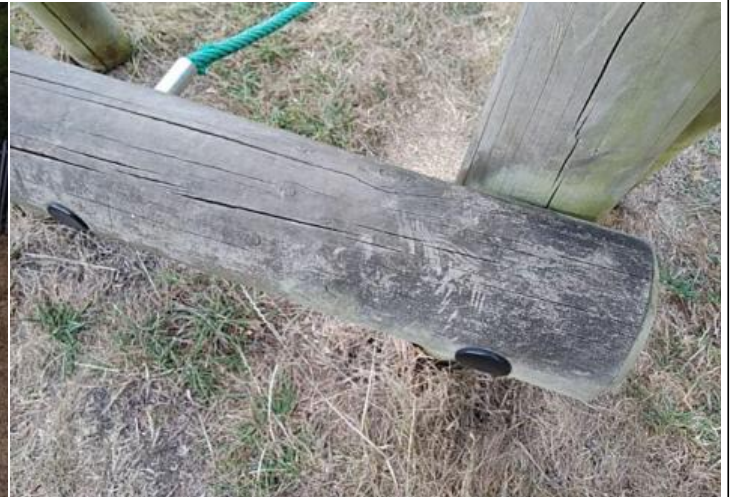
Item: Activity Equipment - Activity Trail
Manufacturer: A.E.Evans

Finding: There is algae or moss on the surface of the equipment

Action: Clean and treat appropriately

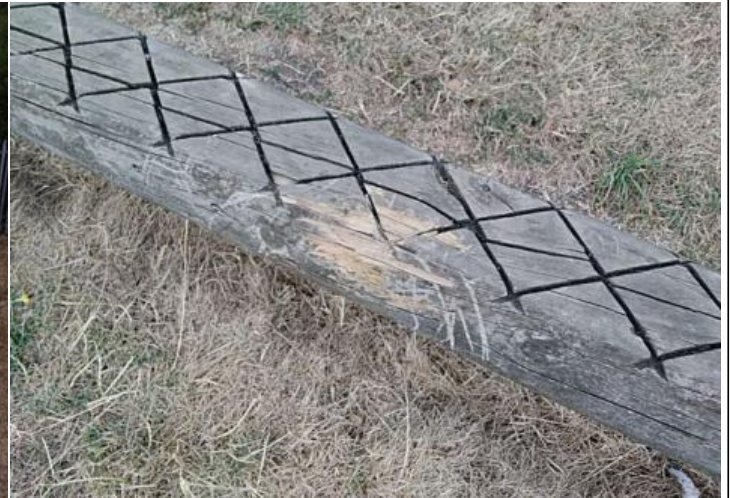
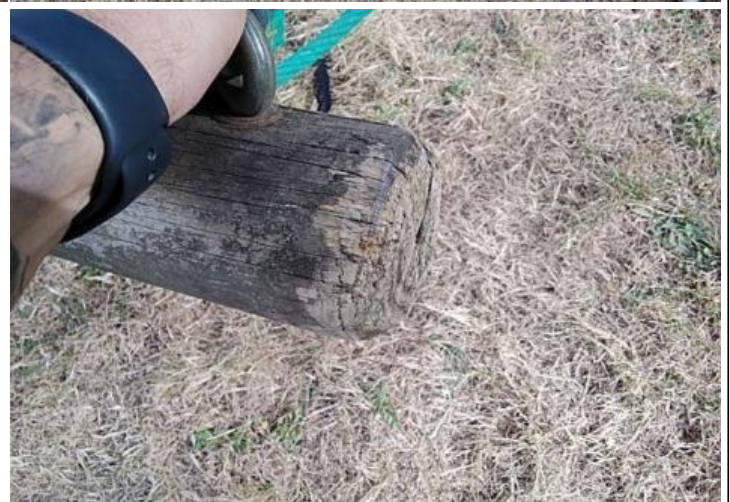
Item: Activity Equipment - Activity Trail
Manufacturer: A.E.Evans

Finding: Parts of the timber are rough or splintered

Action: Remove all rough or sharp edges

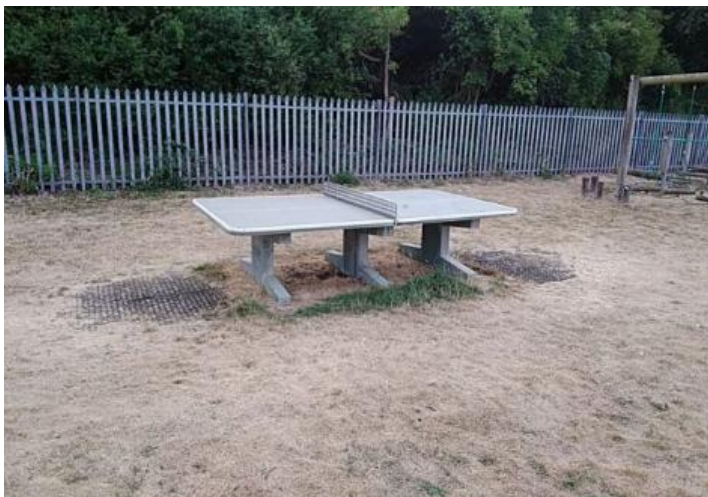
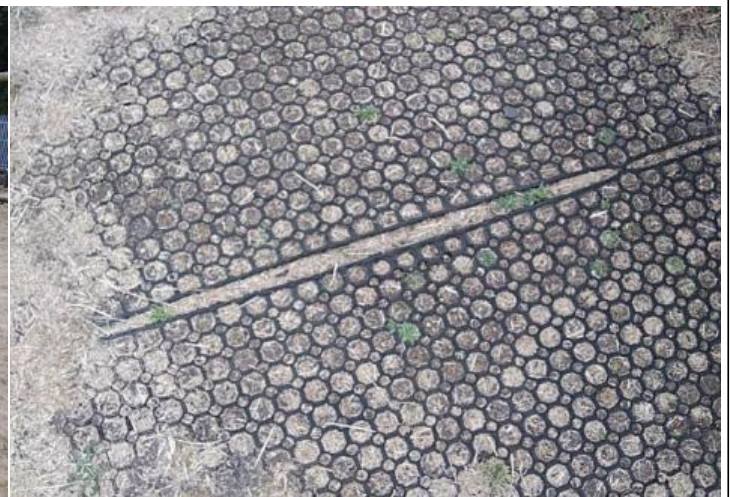
Item: Other - Table Tennis
Manufacturer: Not Identified

Finding: There are gaps opening between the grass mat tiles

Action: Provide additional ties or secure / reinstate surface

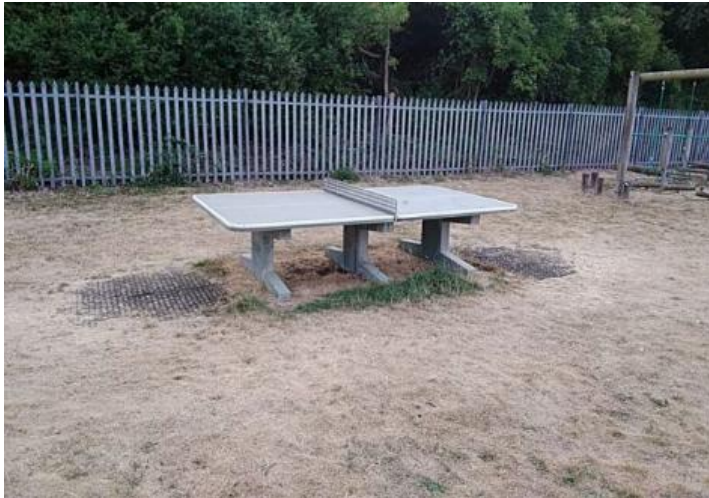
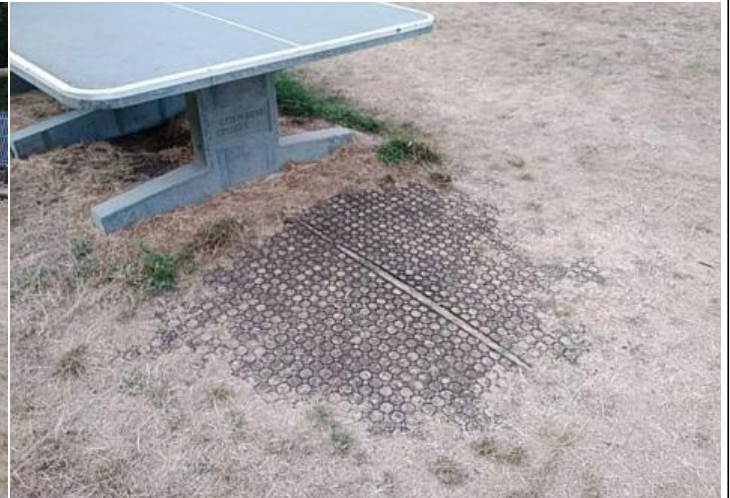
Item: Other - Table Tennis
Manufacturer: Not Identified

Finding: The grass mats are silted up, the soil is compacted and the area will become very slippery when the soil is wet. **Action:** Reinstate as required

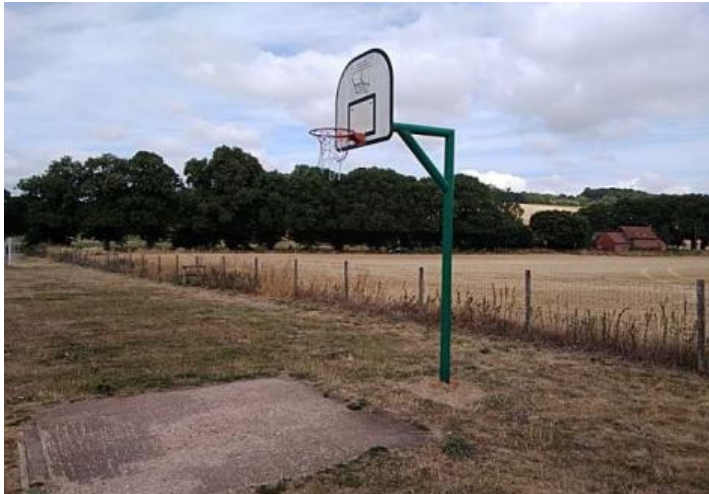
Item: Multi Use Games Area - Basketball Post
Manufacturer: Safe & Sound

Finding: There is some minor damage to the surface

Action: Monitor for any further deterioration and repair as required
