Annual Inspection

Wycombe District Council

The Pedestal Playing Field

Annual Inspection - 12 July 2017 at 13:48 Inspector: Martin Lawrence (RPII Annual Inspector)

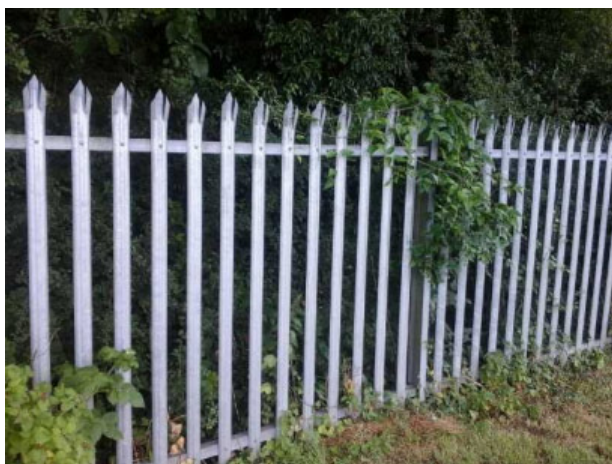
Item: Ancillary Items - Fence
Manufacturer: Not Identified
Surface Type: Grass
Equipment Compliance: N/A
Surface Area Compliance: N/A
Ref/Part Number:
Total Findings: 1

Finding 1

This item is satisfactory - no work required

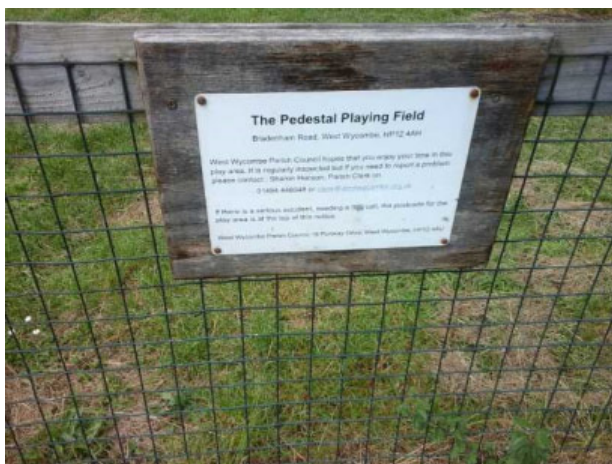
Item: Ancillary Items - Sign
Manufacturer: Owner/Operator
Surface Type: N/A
Equipment Compliance: N/A
Surface Area Compliance: N/A
Ref/Part Number:
Total Findings: 1

Finding 1

This item is satisfactory - no work required

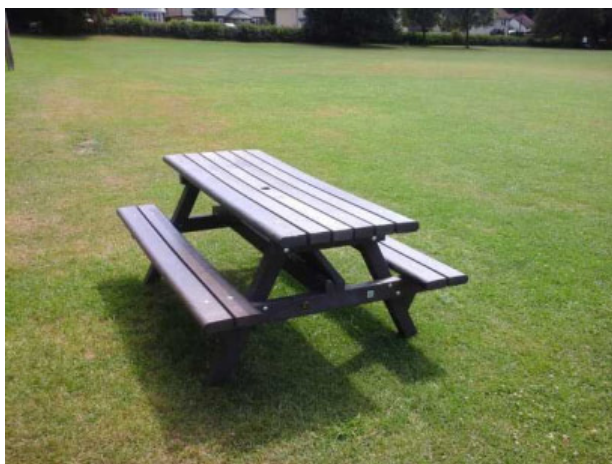
Item: Ancillary Items - Picnic Table
Manufacturer: Owner/Operator
Surface Type: N/A
Equipment Compliance: N/A
Surface Area Compliance: N/A
Ref/Part Number:
Total Findings: 1

Finding 1

This item is satisfactory - no work required

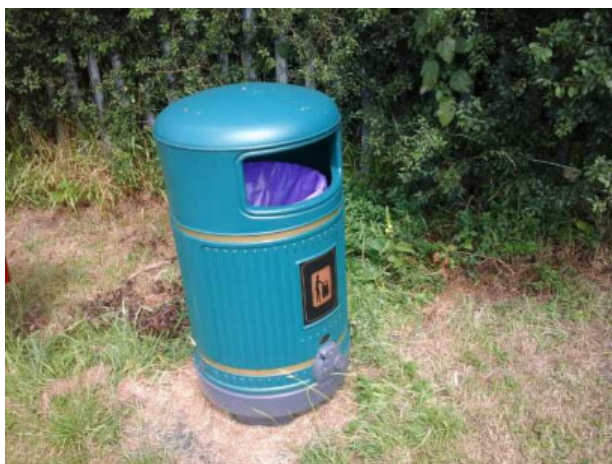
Item: Ancillary Items - Litter Bin
Manufacturer: Owner/Operator
Surface Type: N/A
Equipment Compliance: N/A
Surface Area Compliance: N/A
Ref/Part Number:
Total Findings: 1

Finding 1

This item is satisfactory - no work required

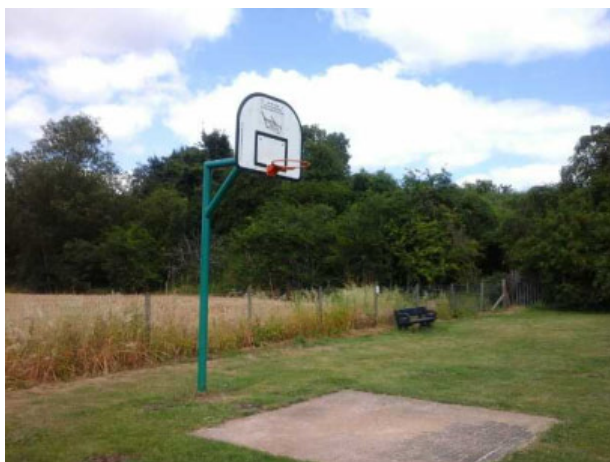
Item: Multi Use Games Area - Basketball Post
Manufacturer: Safe & Sound
Surface Type: N/A
Equipment Compliance: Yes
Surface Area Compliance: N/A
Ref/Part Number:
Total Findings: 1

Finding 1

This item is satisfactory - no work required

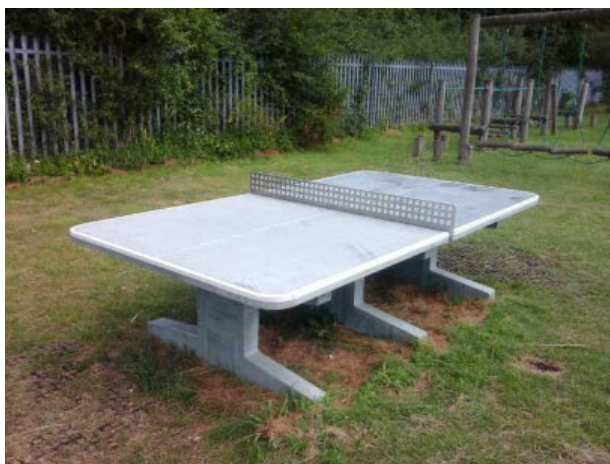
Item: Other - Table Tennis
Manufacturer: Not Identified
Surface Type: Grass
Equipment Compliance: N/A
Surface Area Compliance: N/A
Ref/Part Number:
Total Findings: 1

Finding 1

This item is satisfactory - no work required
