the **play inspection** company

Annual Inspection

Buckinghamshire Council High Wycombe

The Pedestal Playing Field

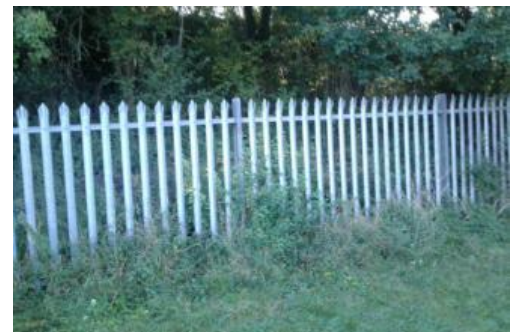
Item: Fence
Manufacturer: Not Identified
Surface Type: Grass
Item Quantity: 1
Equipment Compliance: N/A
Surface Area Compliance: N/A

This item is satisfactory - no work required -

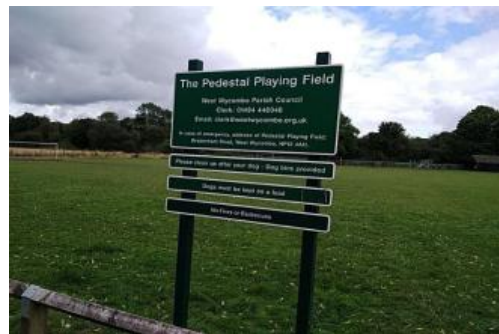
Item: Sign
Manufacturer: Owner/Operator
Surface Type: N/A
Item Quantity: 1
Equipment Compliance: N/A
Surface Area Compliance: N/A

This item is satisfactory - no work required -

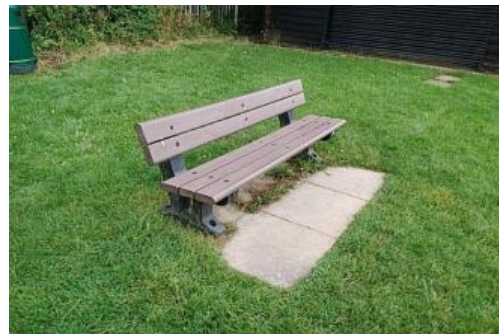
Item: Bench
Manufacturer: Owner/Operator
Surface Type: Paving Slabs
Item Quantity: 2
Equipment Compliance: N/A
Surface Area Compliance: N/A

This item is satisfactory - no work required -

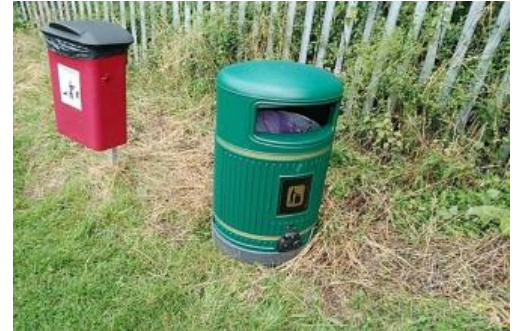
Item: Litter Bin
Manufacturer: Owner/Operator
Surface Type: Grass
Item Quantity: 1
Equipment Compliance: N/A
Surface Area Compliance: N/A

This item is satisfactory - no work required -

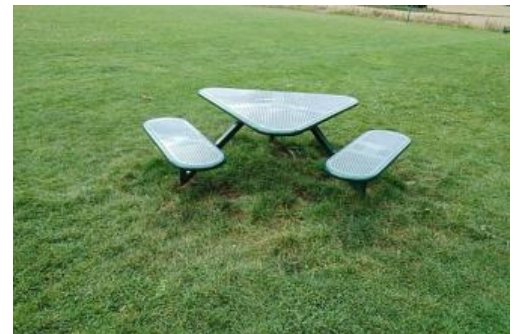
Item: Picnic Table
Manufacturer: Not Identified
Surface Type: Grass
Item Quantity: 1
Equipment Compliance: N/A
Surface Area Compliance: N/A

This item is satisfactory - no work required -

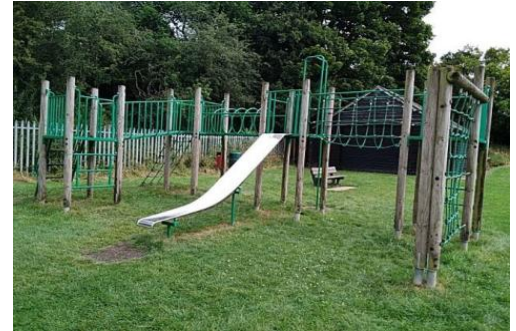
Item: Multi Play (Junior)
Manufacturer: A.E.Evans
Surface Type: Grass Matrix Tiles
Item Quantity: 1
Equipment Compliance: No
Surface Area Compliance: Yes

There is surface corrosion present on the item - Consider treating the item

The height of the slide runout is in excess of 350mm and fails the requirements of BS EN 1176: Part 3 - Monitor - No remedial work recommended

There is an opening in the barriers exceeding the width allowed (500mm) in BS EN 1176, and no guardrail has been provided; this is a low risk failure and no remedial action is required - Monitor - No remedial work recommended

There is/are finger entrapment/s in the platform and the item fails to meet the requirements of BS EN 1176 Part 1 4.2.7.6 Entrapment of fingers - Monitor - No remedial work recommended

There is/are finger entrapment/s in the net and the item fails to meet the requirements of BS EN 1176 Part 1 4.2.7.6 Entrapment of fingers - Monitor - No remedial work recommended

There are a number of dents in the slide surface - Monitor for any further deterioration and repair as required

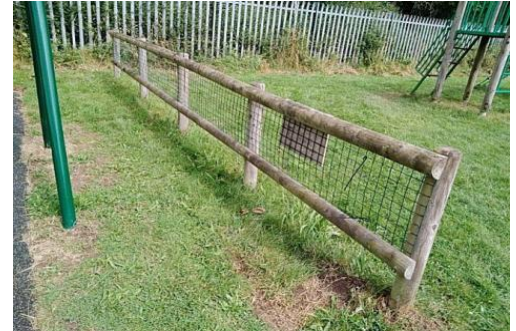
Item: Swing Barrier
Manufacturer: Not Identified
Surface Type: Grass
Item Quantity: 1
Equipment Compliance: N/A
Surface Area Compliance: N/A

The item is slightly loose in its foundations - Monitor for any further deterioration and repair as required

There is some damage to the item - Monitor for any further deterioration and repair as required

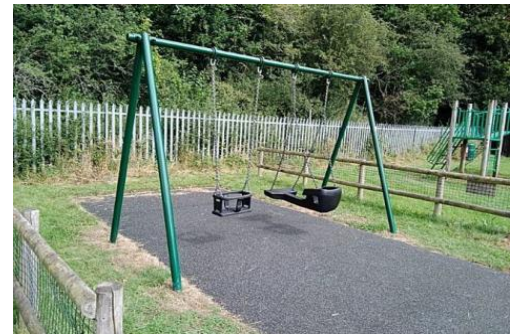
Item: 1 Bay 2 Seat Swing
Manufacturer: Wicksteed Playgrounds
Surface Type: Wet Pour
Item Quantity: 1
Equipment Compliance: Yes
Surface Area Compliance: Yes

The swing seat connectors are loose - Tighten to secure

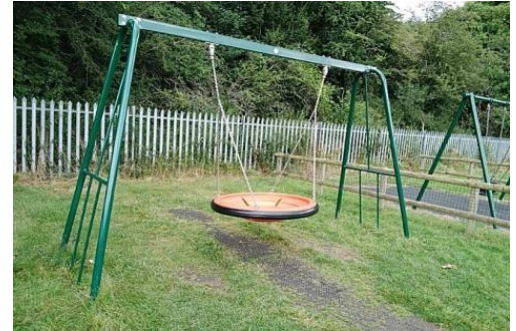
Item: Basket Swing - Type 1
Manufacturer: Sovereign Leisure
Surface Type: Grass Matrix Tiles
Item Quantity: 1
Equipment Compliance: Yes
Surface Area Compliance: Yes

There are gaps opening between the grass mat tiles -
Reinstate surface

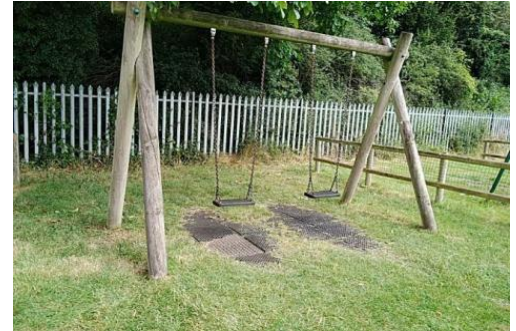
Item: 1 Bay 2 Seat (Flat)
Manufacturer: Setter Play
Surface Type: Grass Matrix Tiles
Item Quantity: 1
Equipment Compliance: No
Surface Area Compliance: Yes

There are gaps opening between the grass mat tiles - Reinstate surface

A number of fixing(s) have worked loose - Secure all loose fixings

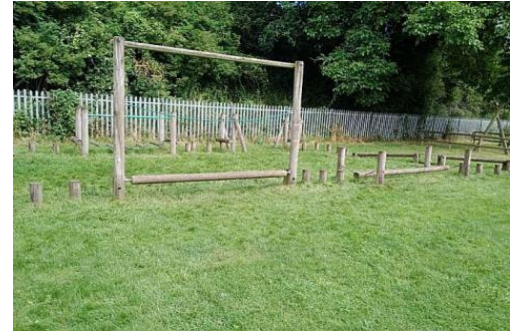
Item: Activity Trail
Manufacturer: A.E.Evans
Surface Type: Grass Matrix Tiles
Item Quantity: 1
Equipment Compliance: Yes
Surface Area Compliance: Yes

There is some strimmer / machinery damage apparent on the posts, this can penetrate the preservative applied to the timber and accelerate the rotting process - Monitor for any deterioration (rot) and replace as required

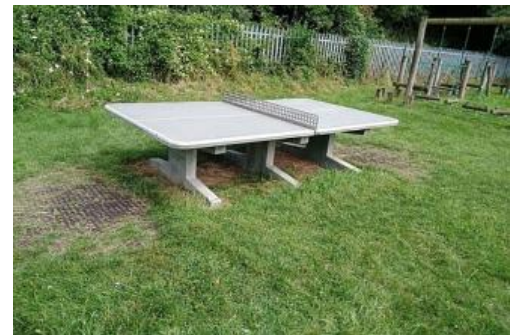
Item: Table Tennis
Manufacturer: Not Identified
Surface Type: Grass Matrix Tiles
Item Quantity: 1
Equipment Compliance: N/A
Surface Area Compliance: N/A

This item is satisfactory - no work required -

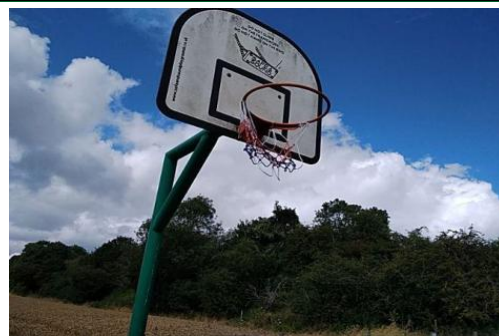
Item: Basketball Post
Manufacturer: Safe & Sound
Surface Type: Grass
Item Quantity: 1
Equipment Compliance: Yes
Surface Area Compliance: N/A

There is some damage to the net - Repair or replace

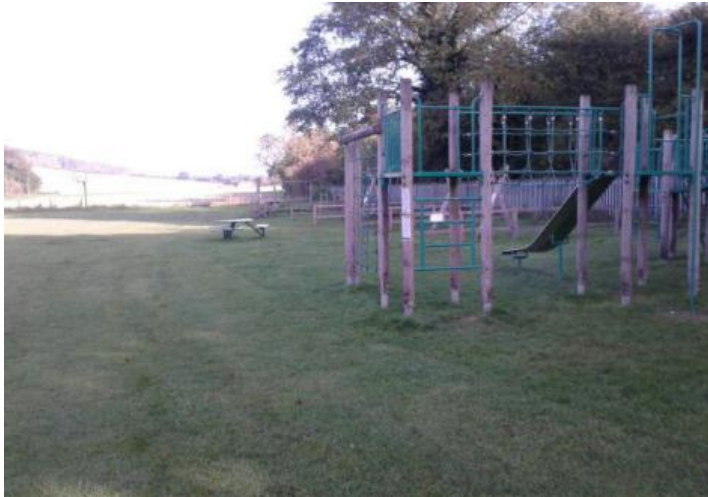
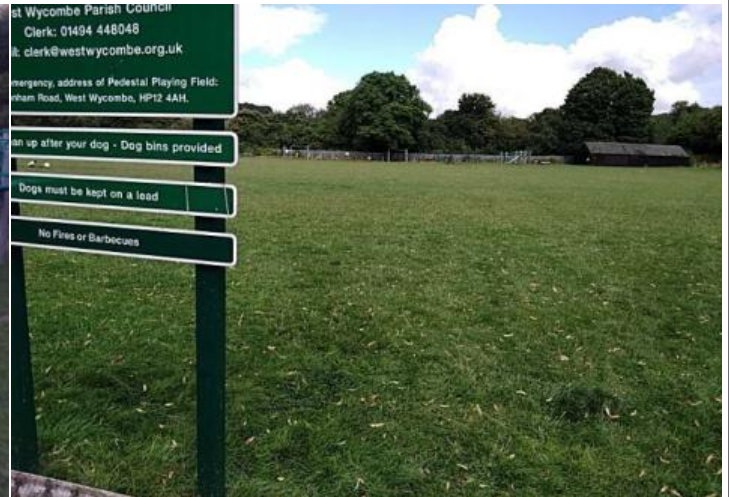
Item: Ancillary Items - Site General
Manufacturer: Owner/Operator

Finding: The site is accessible to the public during the COVID 19 pandemic. The government have released guidelines for safely re-opening these types of facilities which is available on the government website.

Action: Ensure there is an appropriate risk assessment in place and review regularly
