the play inspection company

Annual Inspection

Buckinghamshire Council High Wycombe

The Pedestal Playing Field

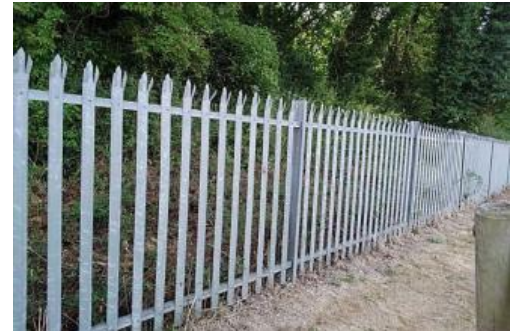
This item is satisfactory - no work required -

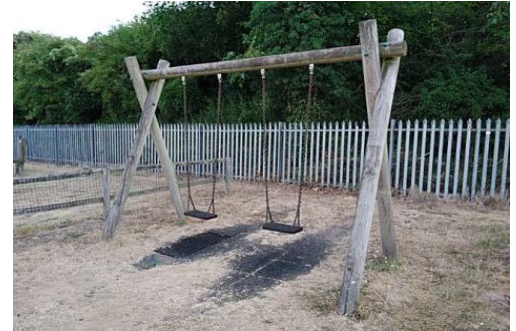
There is moderate damage to the surface - Repair the damaged areas of surfacing

A number of suspension fixing(s) have worked loose - Secure all loose fixings

There is some notable evidence of chain wear - Monitor for any further deterioration and replace when 40% worn

This design of swing joint has been known to fail on the weld connecting the joint to the threaded stud - We would recommend that the joint be dismantled and checked on a regular basis or consulting with manufacturer on whether a Secondary Safety Device can be fitted

The timber has a number of splits/shakes or air cracks and this may affect the stability or allow water ingress which will accelerate the rotting process - Monitor to ensure the splits do not cross through fixing points of the structure and/or cause any instability

The chain openings are in excess of the 8.6mm as recommended by BS EN 1176 - Monitor - No remedial work recommended

The seat has minor damage or wear - Monitor for any further deterioration and replace as required

The inspector has some concerns about the internal condition of the timber crossbeam due to discolouration and was unable to verify the structural integrity without further testing. We recommend a Resi-PD survey to establish the condition of the timber at it's core. - Contact the Play Inspection Company office for further information

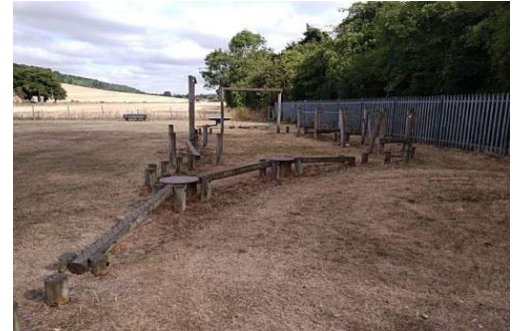
The timber has a number of splits/shakes or air cracks and this may affect the stability or allow water ingress which will accelerate the rotting process - Monitor to ensure the splits do not cross through fixing points of the structure and/or cause any instability

A number of fixing(s) have worked loose on the swinging steps - Secure all loose fixings

A number of fixing(s) have worked loose on the rotating beam brackets - Secure all loose fixings

There is some wear to the shackles. - Monitor for any further deterioration and replace when 40% worn

The ends of the beams do not have a minimum radius of 50mm as recommended in BS EN 1176 Part 1 - Monitor - no remedial action recommended

The timber is rough and worn - Sand down and treat affected areas

The ropes/nets are worn/damaged in places - Monitor for any further deterioration and repair or replace as required

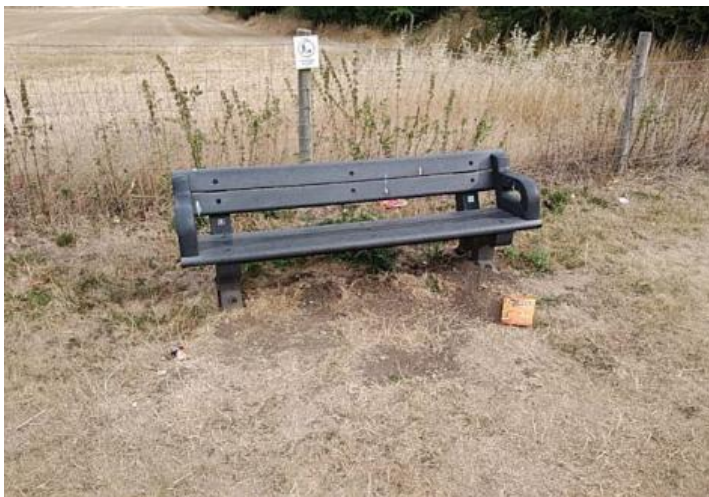
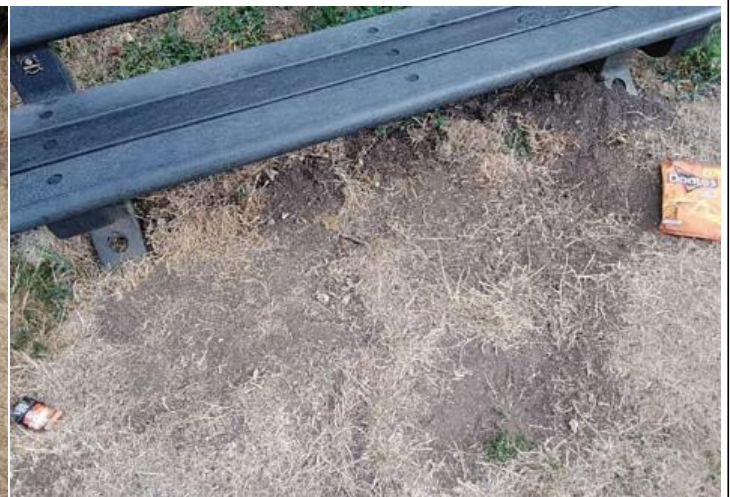
Item: Ancillary Items - Bench
Manufacturer: Owner/Operator

Finding: The area around the item has eroded and may become slippery

Action: Reinstate eroded area

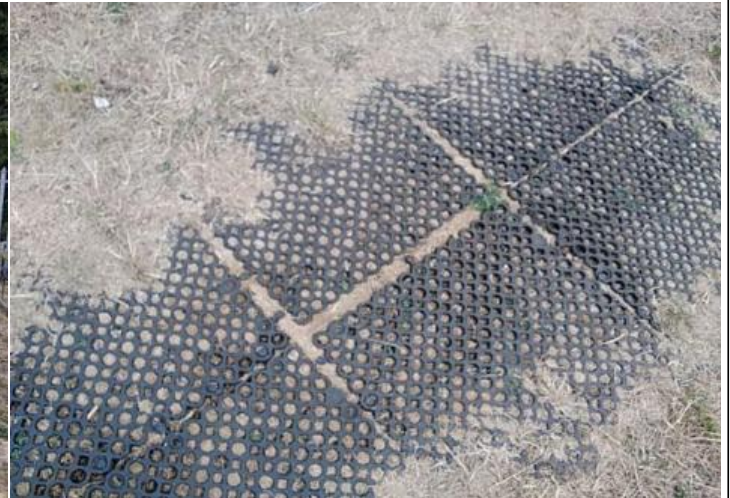
Item: Swings - Basket Swing - Type 1
Manufacturer: Sovereign Leisure

Finding: There are gaps opening between the grass mat tiles

Action: Provide additional ties or secure / reinstate surface

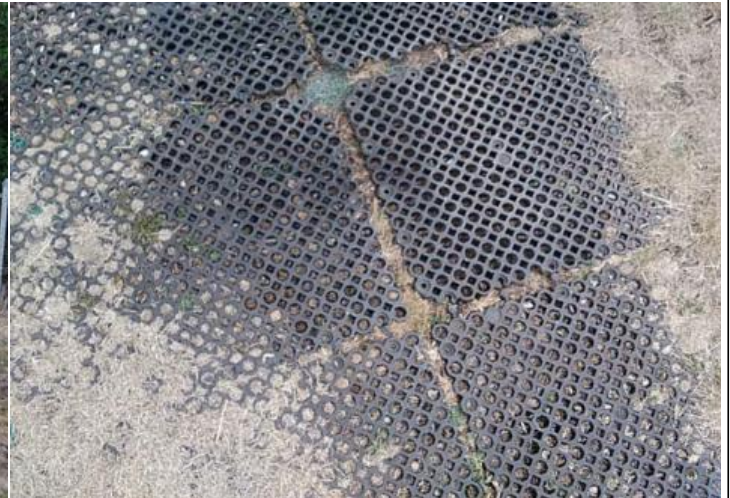
Item: Swings - 1 Bay 2 Seat (Flat)
Manufacturer: Setter Play

Finding: There are gaps opening between the grass mat tiles

Action: Provide additional ties or secure / reinstate surface

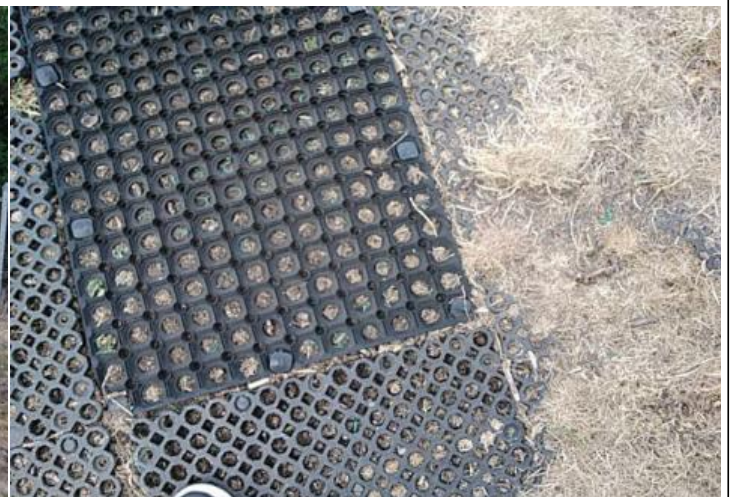
Item: Swings - 1 Bay 2 Seat (Flat)
Manufacturer: Setter Play

Finding: Fixing Pins have been installed in the impact areas of the grass mats

Action: Remove pins from impact areas

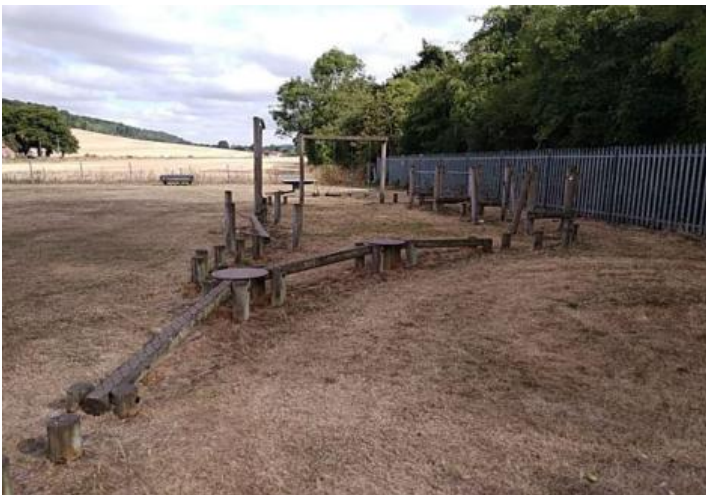
Item: Activity Equipment - Activity Trail
Manufacturer: A.E.Evans

Finding: The timber has a number of splits/shakes or air cracks and this may affect the stability or allow water ingress which will accelerate the rotting process

Action: Monitor to ensure the splits do not cross through fixing points of the structure and/or cause any instability

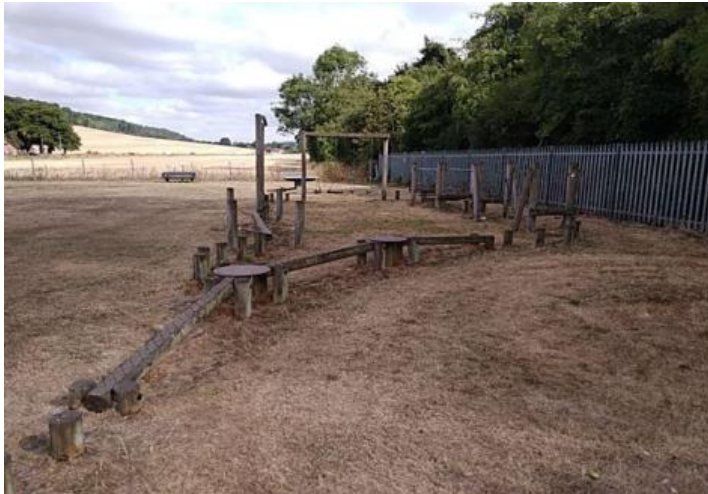
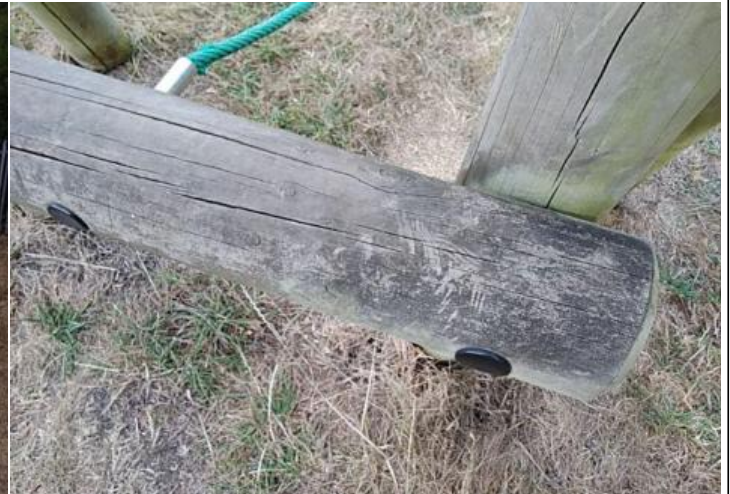
Item: Activity Equipment - Activity Trail
Manufacturer: A.E.Evans

Finding: There is algae or moss on the surface of the equipment

Action: Clean and treat appropriately

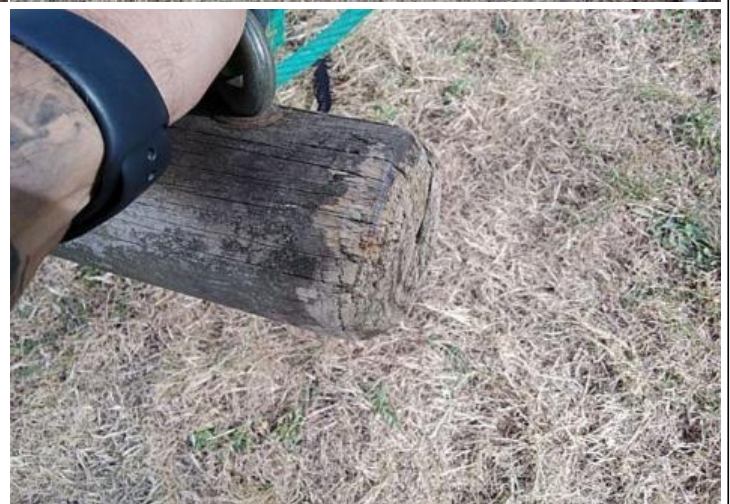
Item: Activity Equipment - Activity Trail
Manufacturer: A.E.Evans

Finding: Parts of the timber are rough or splintered

Action: Remove all rough or sharp edges

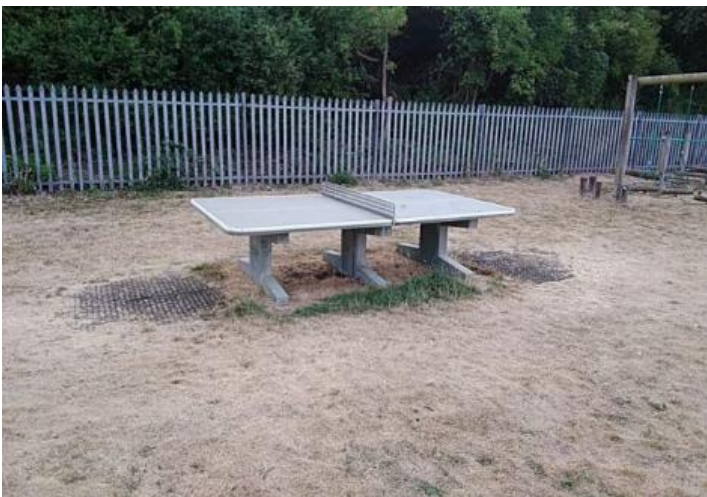
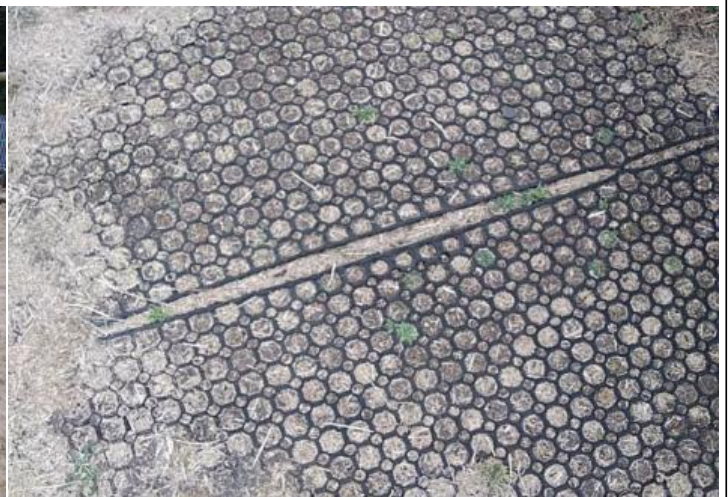
Item: Other - Table Tennis
Manufacturer: Not Identified

Finding: There are gaps opening between the grass mat tiles

Action: Provide additional ties or secure / reinstate surface
